DESIGNATED SUBSTANCES AND HAZARDOUS MATERIALS REPORT
Building Z, Algonquin College Ottawa Campus
570 Wabisheshi Private, Ottawa, Ontario

December, 2025

CM3 Project: TC1738

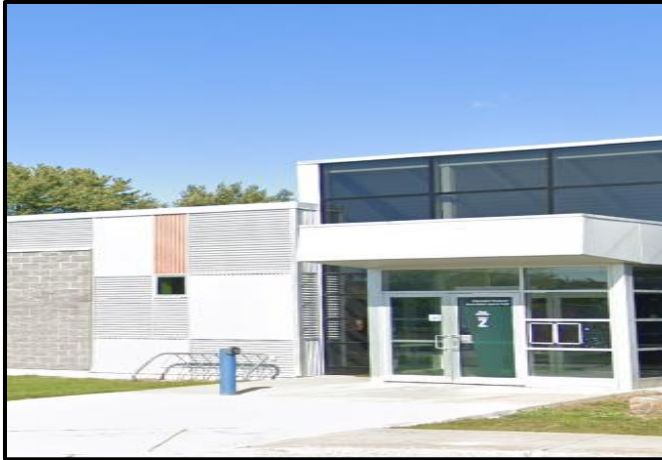
The exterior of the facility was observed to consist of sheet metal siding and a poured concrete foundation. Given the age of construction there are no concerns with regards to asbestos-containing exterior finishes; therefore, no samples were collected during the assessment.

Photograph 1: Typical view of the exterior of the building.

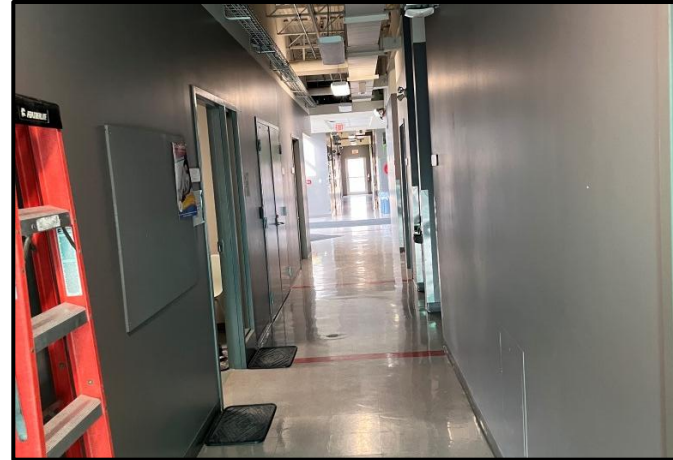
Photograph 2: Typical view of main corridor in Building Z.

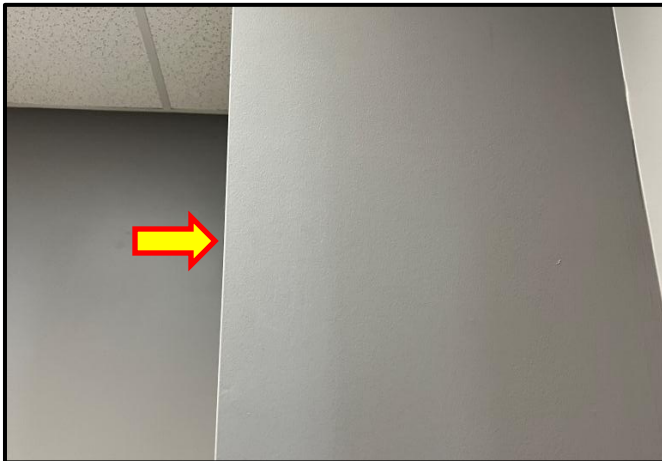
The interior wall finishes were observed to consist of drywall, concrete block and plywood panels. There are no concerns with regards to asbestos-containing interior finishes; therefore, no samples were collected as part of the assessment.

Photograph 3: View of non-asbestos containing drywall observed throughout the building.

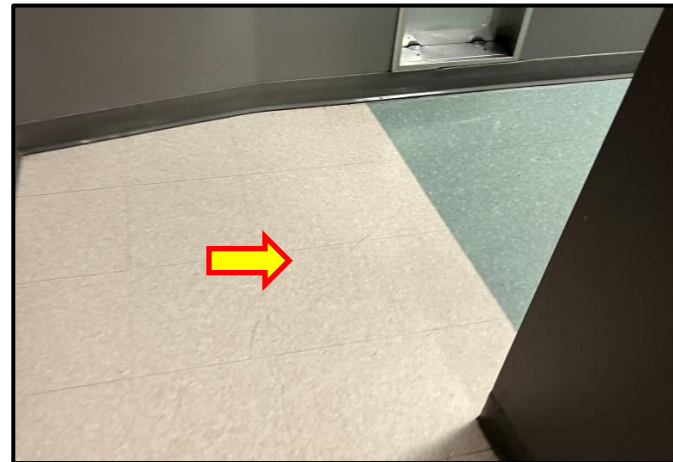
The interior flooring was observed to consist of poured concrete and vinyl floor tiles throughout. There are no concerns with regards to asbestos-containing flooring finishes; therefore, no samples were collected as part of the assessment.

Photograph 4: View of non-asbestos containing 12"x12" vinyl floor tiles.

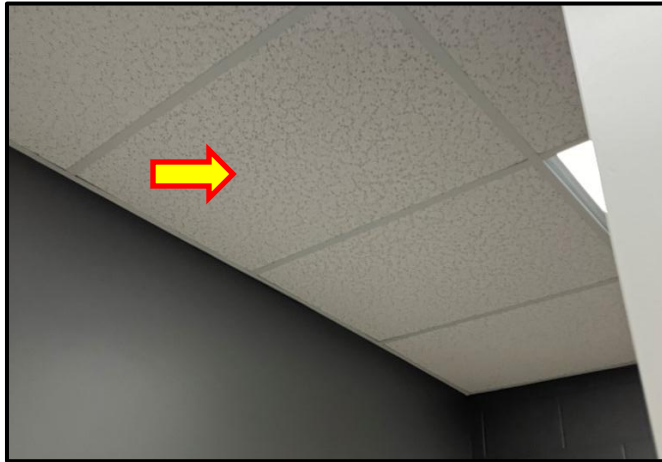
The ceilings throughout the building were observed to consist of drywall, 2'x4' acoustic ceiling tiles and steel deck. There are no concerns with regards to asbestos-containing ceiling finishes; therefore, no samples were collected during the assessment.

Photograph 5: View of non-asbestos containing 2'x4' acoustic ceiling tiles observed throughout the building.

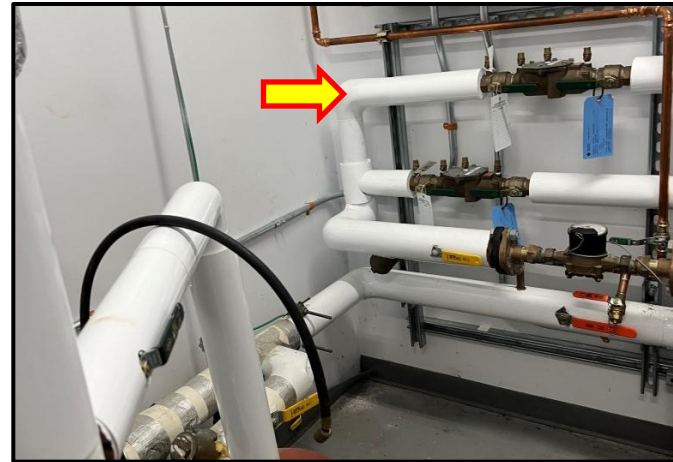
Mechanical pipes throughout the building were observed to be either uninsulated or insulated with non-asbestos applications of fibreglass and PVC. Ductwork throughout the building was observed to be either uninsulated or insulated with non-asbestos applications of fibreglass. There are no concerns with regards to asbestos-containing insulating materials; therefore, no samples were collected as part of the assessment.

Photograph 6: View of non-asbestos containing fiberglass insulation and PVC covers observed on mechanical pipes throughout the building.

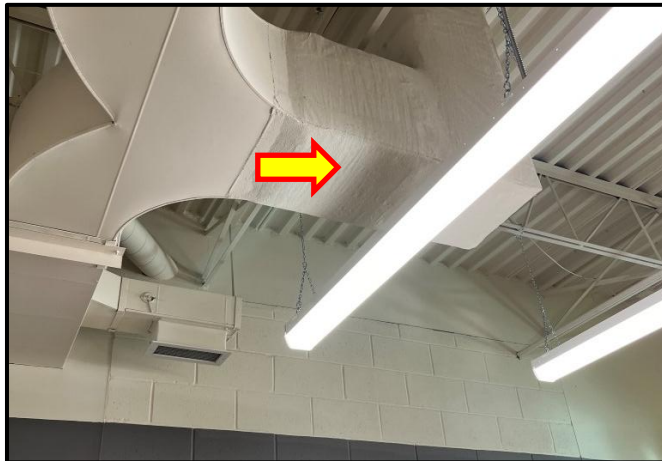
Photograph 7: View of non-asbestos containing fiberglass insulation observed on ductwork throughout the building.

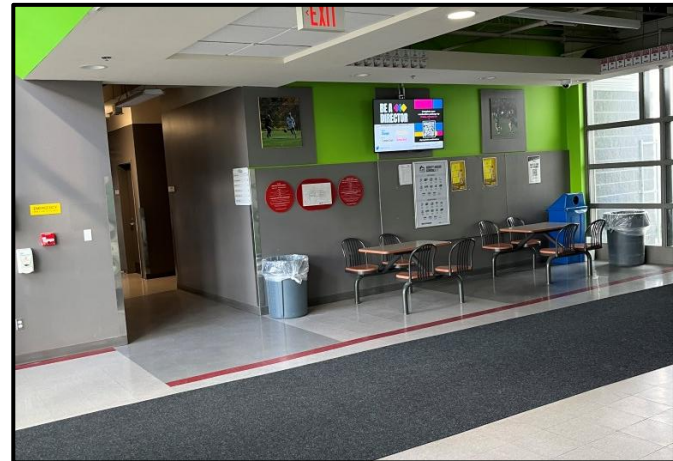
Photograph 8: Typical view of the main reception area of the building.
