DESIGNATED SUBSTANCES AND HAZARDOUS MATERIALS REPORT
Building N, Algonquin College Ottawa Campus
511 Wabisheshi Private, Ottawa, Ontario

December, 2025

CM3 Project: TC1738

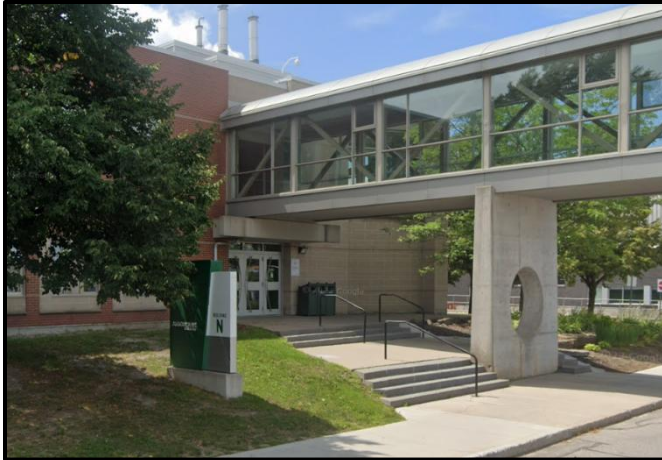
Photograph 1: Typical view of the exterior of the building.

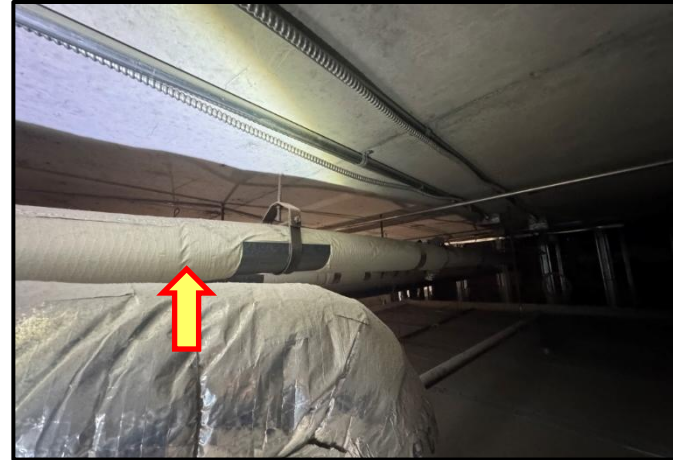
Photograph 2: View of non-asbestos fiberglass insulation observed on mechanical pipes within ceiling spaces throughout the building.

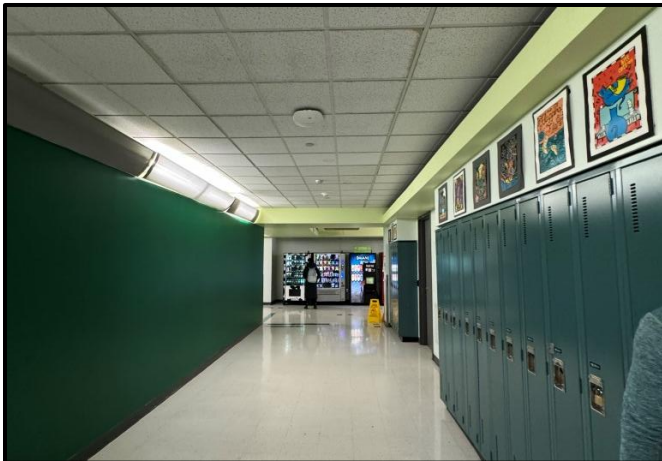
Photograph 3: Typical view of the corridors observed throughout the building.

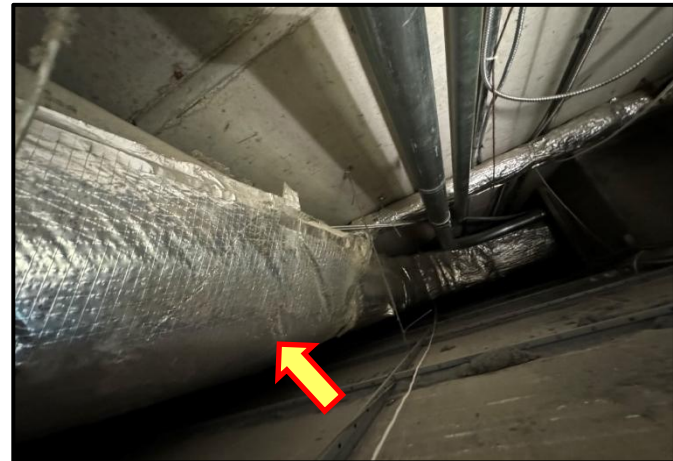
Photograph 4: View of non-asbestos fiberglass insulation observed on ductwork within ceiling spaces throughout the building.

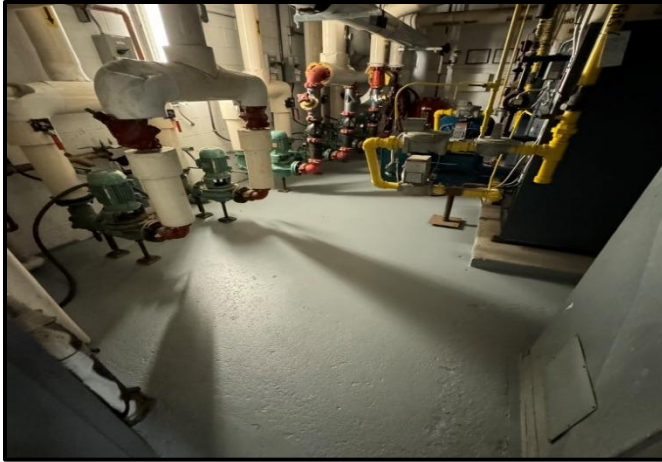
Photograph 5: View of the boiler room.

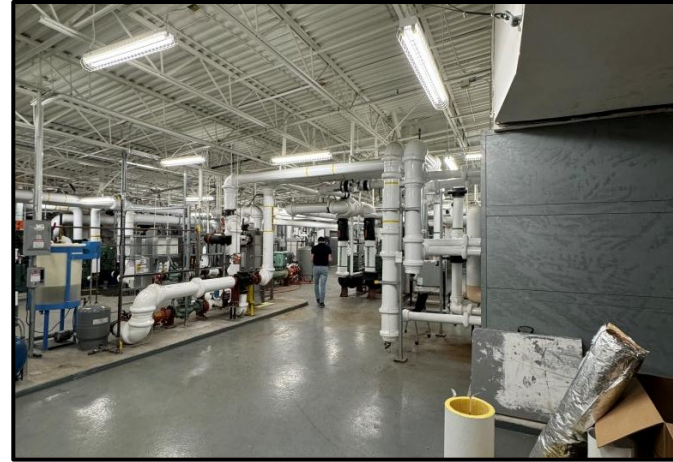
Photograph 6: View of mechanical penthouse B.

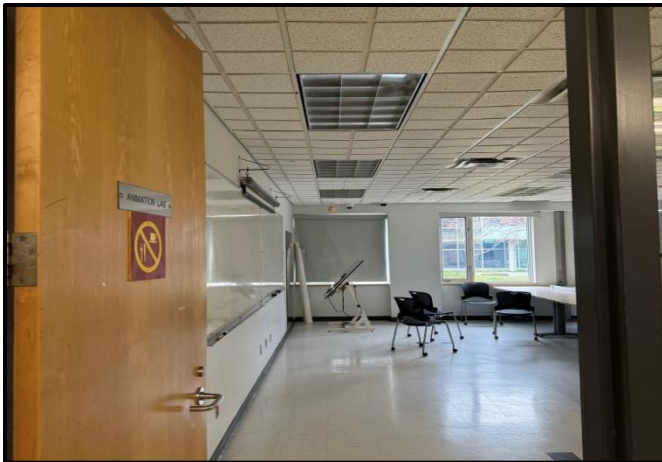
Photograph 7: Typical view of classrooms observed throughout the building.

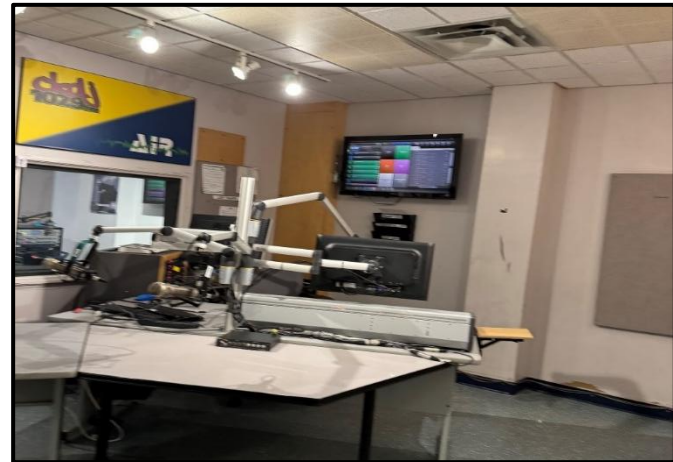
Photograph 8: Typical view of the studio spaces observed throughout Room N101.

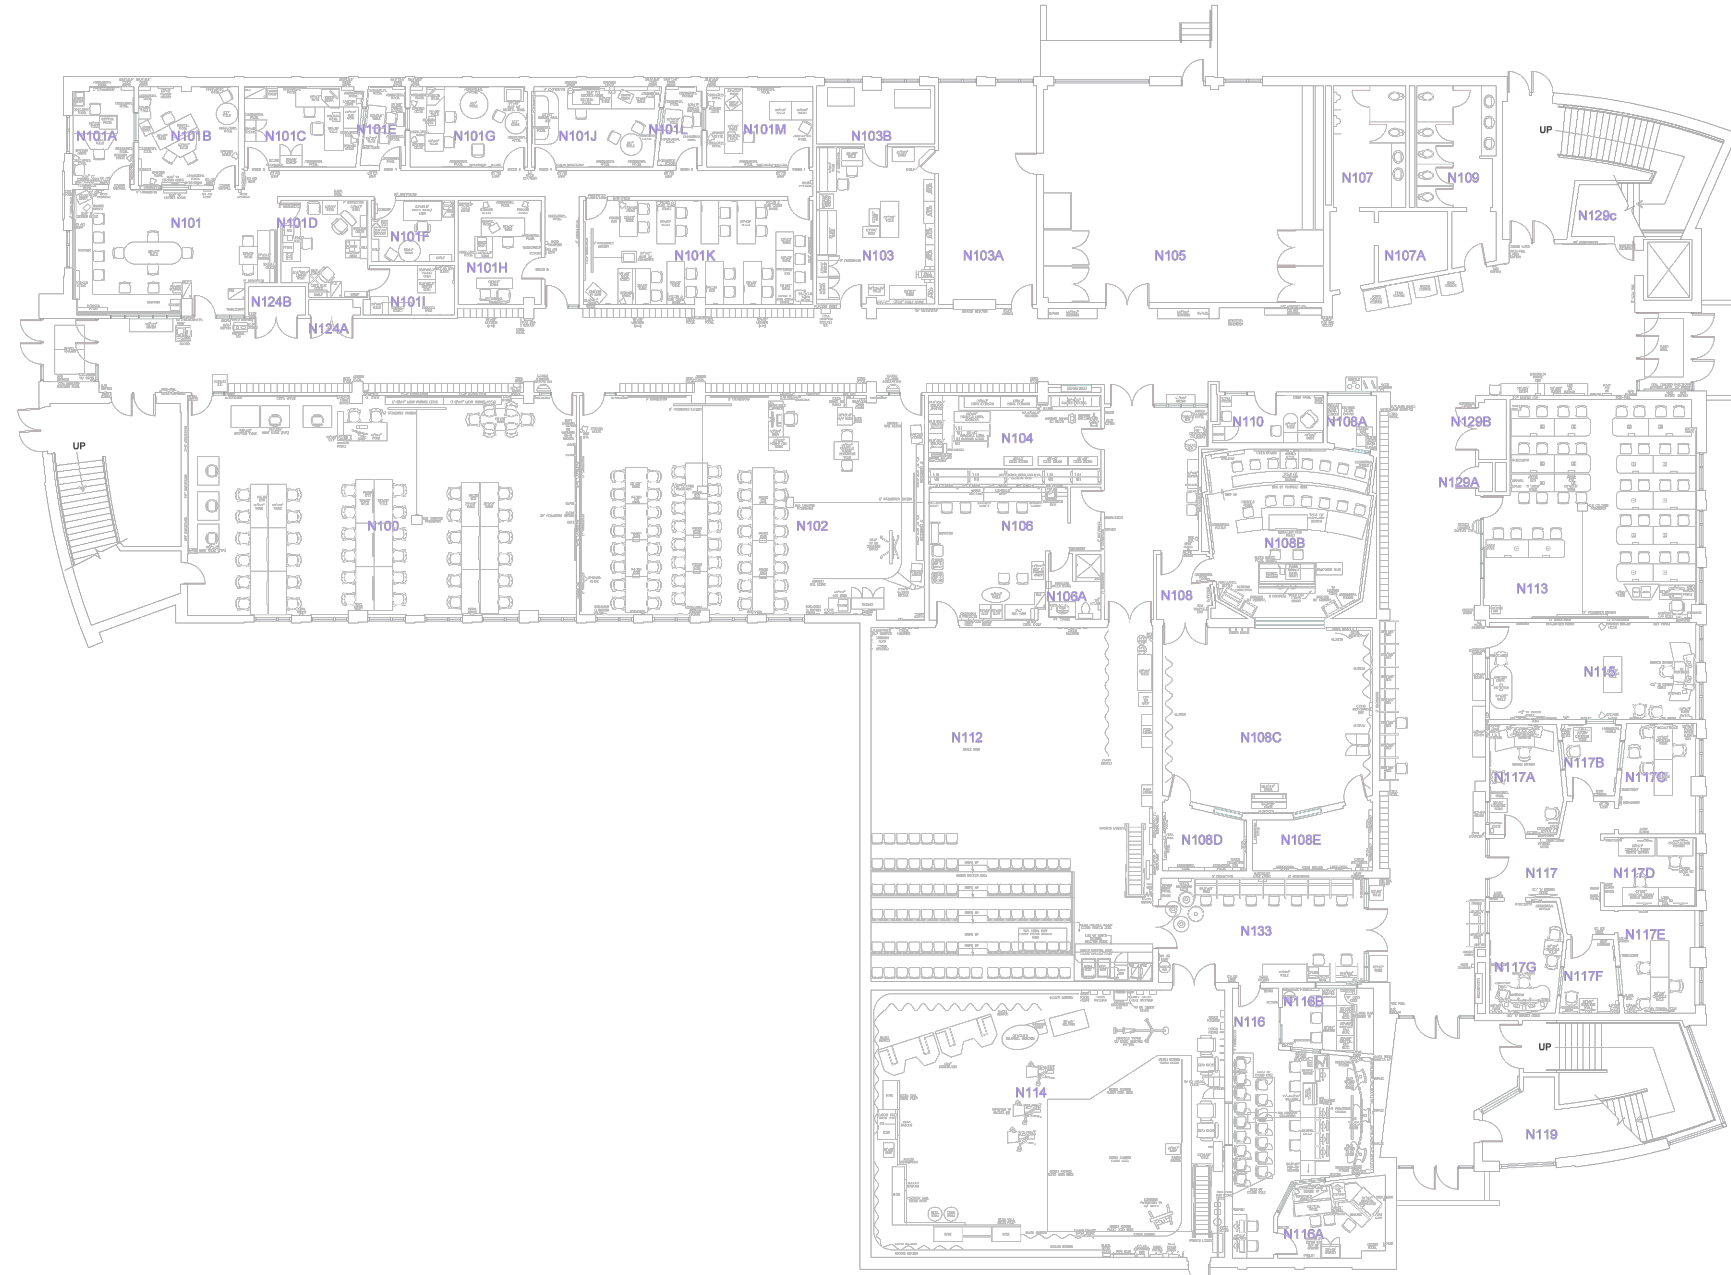
BUILDING N - 1st. FLOOR PLAN
 NOT TO SCALE

NOTES:
 - GIVEN THE AGE OF CONSTRUCTION THERE ARE NO CONCERNS WITH REGARDS TO ASBESTOS - CONTAINING MATERIALS.
 - GIVEN THE AGE OF CONSTRUCTION THERE ARE NO CONCERNS WITH REGARDS TO LEAD-CONTAINING PAINTS.

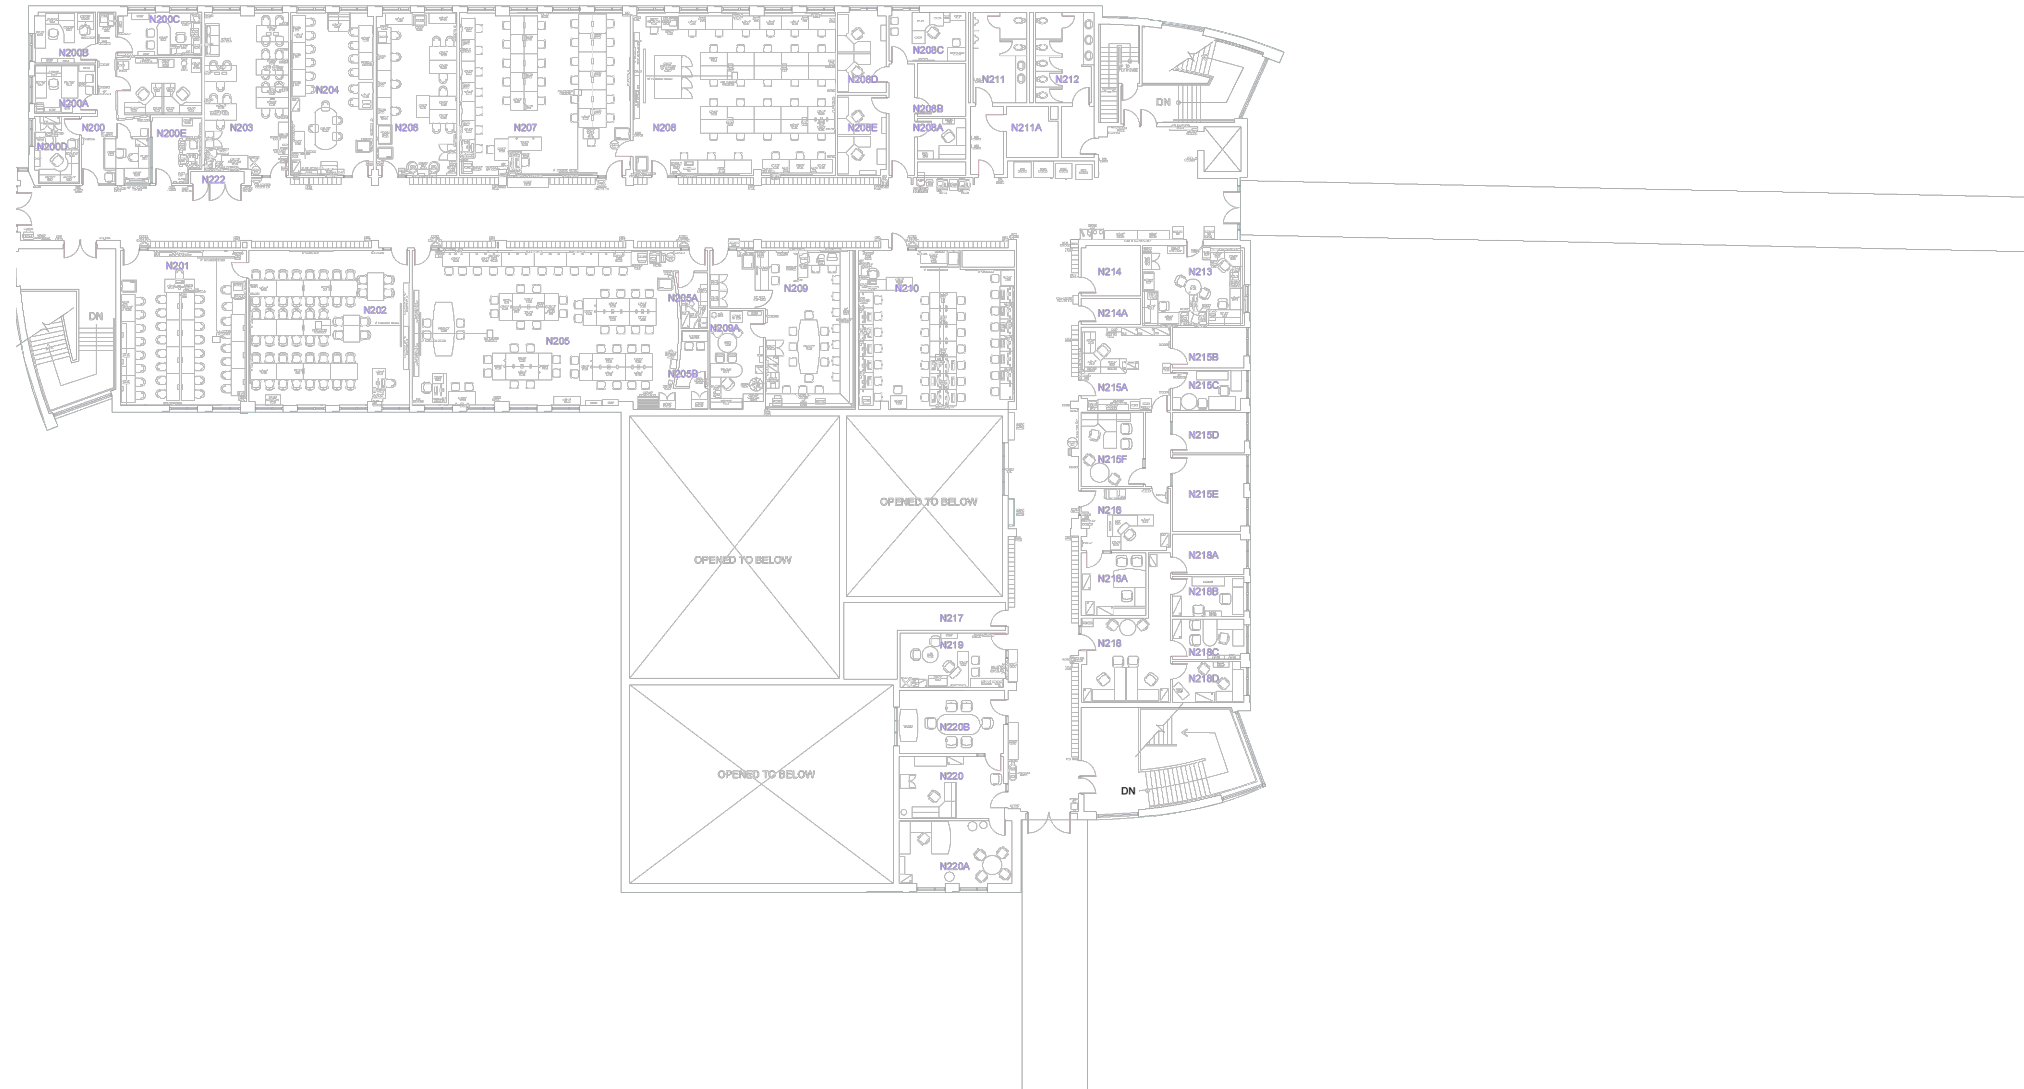
BUILDING N - 2nd. FLOOR PLAN
 NOT TO SCALE

NOTES:
 - GIVEN THE AGE OF CONSTRUCTION THERE ARE NO CONCERNS WITH REGARDS TO ASBESTOS - CONTAINING MATERIALS.
 - GIVEN THE AGE OF CONSTRUCTION THERE ARE NO CONCERNS WITH REGARDS TO LEAD-CONTAINING PAINTS.

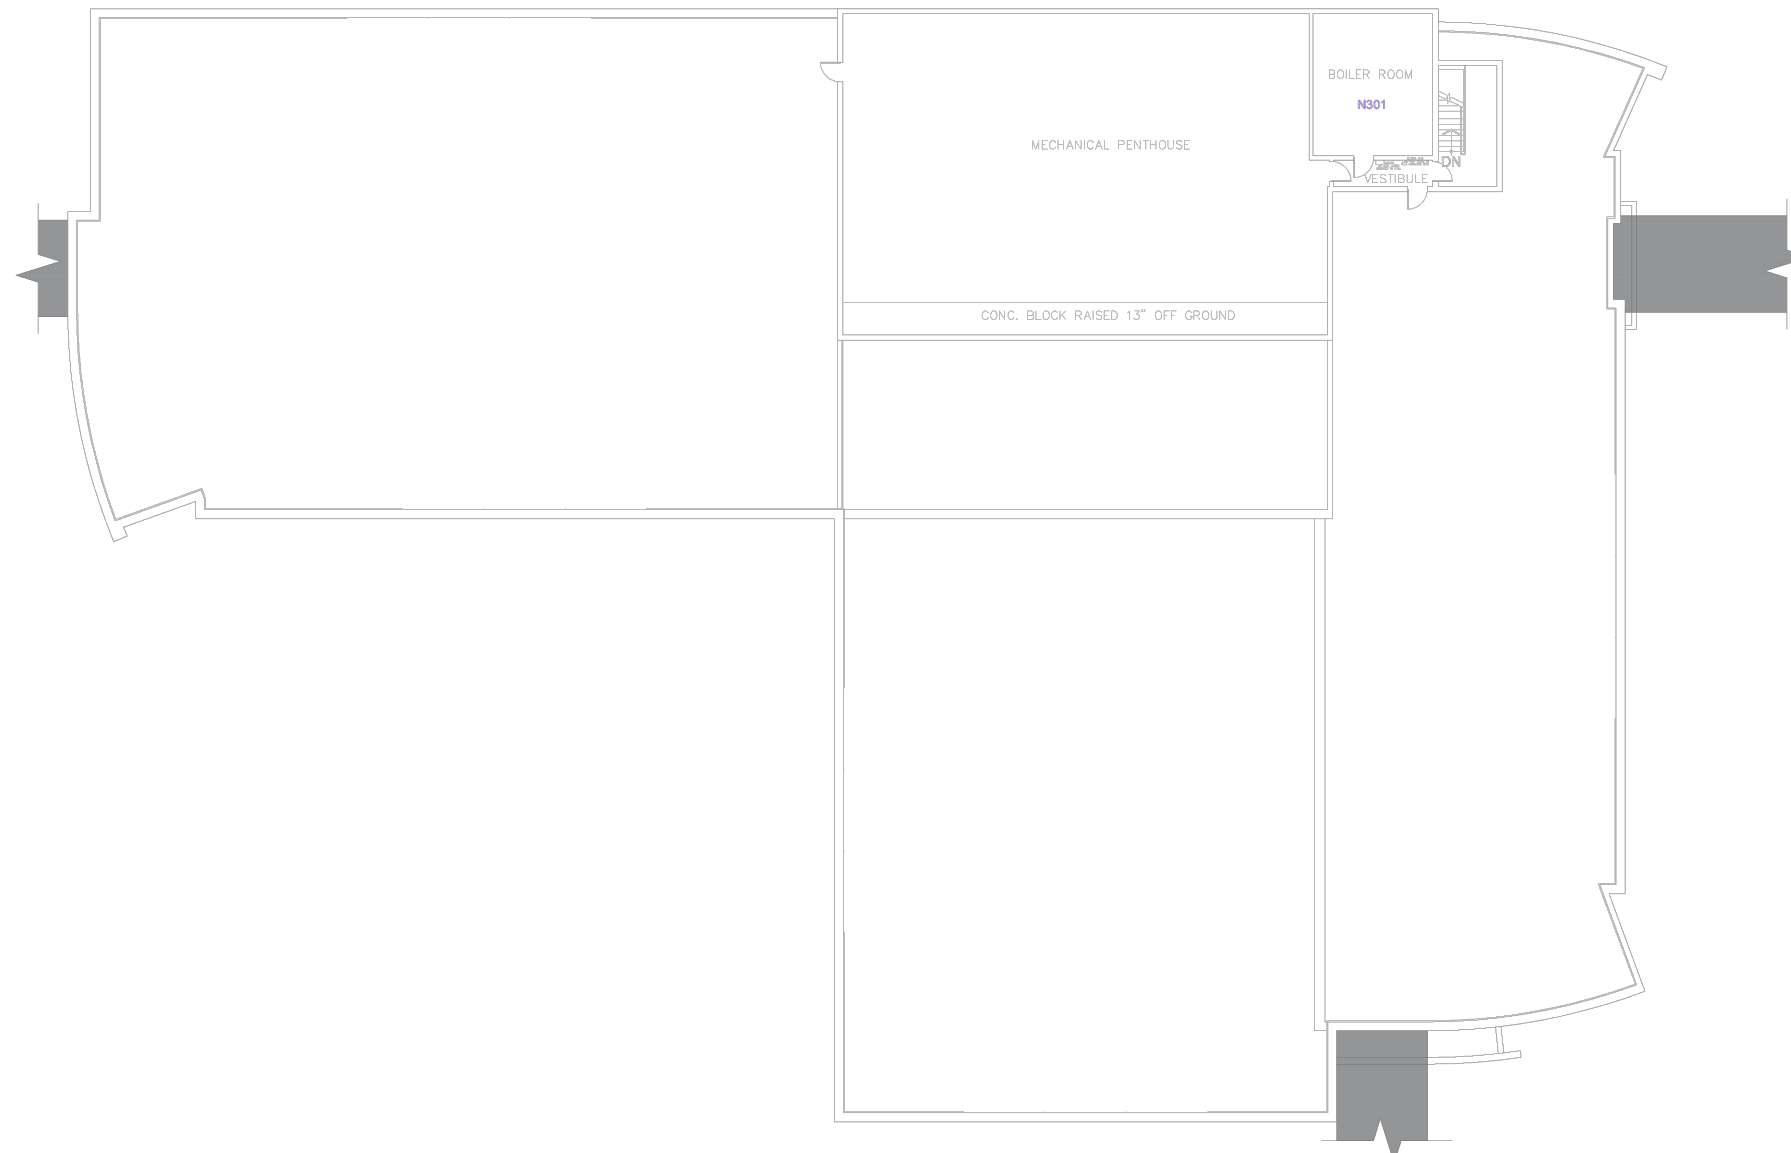
BUILDING N - 3rd. FLOOR PLAN
 NOT TO SCALE

NOTES:
 - GIVEN THE AGE OF CONSTRUCTION THERE ARE NO CONCERNS WITH REGARDS TO ASBESTOS - CONTAINING MATERIALS.
 - GIVEN THE AGE OF CONSTRUCTION THERE ARE NO CONCERNS WITH REGARDS TO LEAD-CONTAINING PAINTS.
