DESIGNATED SUBSTANCES AND HAZARDOUS MATERIALS REPORT
Building T, Algonquin College Ottawa Campus
505 Wabisheshi Private, Ottawa, Ontario

December, 2025

CM3 Project: TC1738

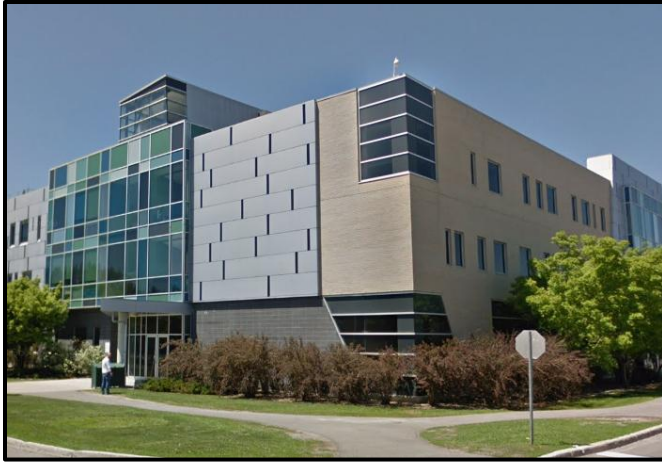
Photograph 1: Typical view of the exterior of the building.

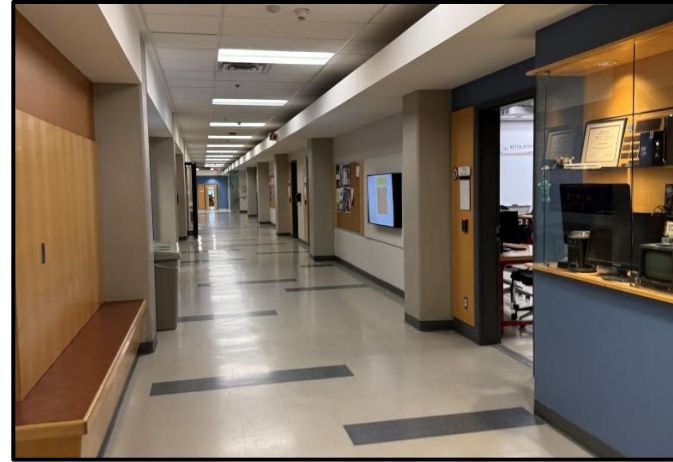
Photograph 2: Typical view of the first-floor corridor.

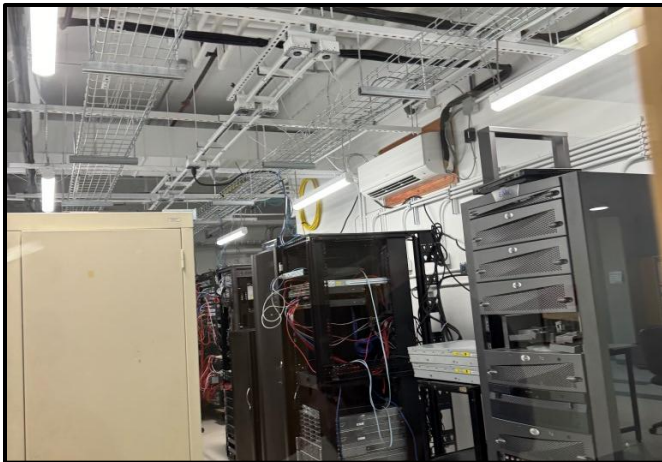
Photograph 3: View of Room T120.

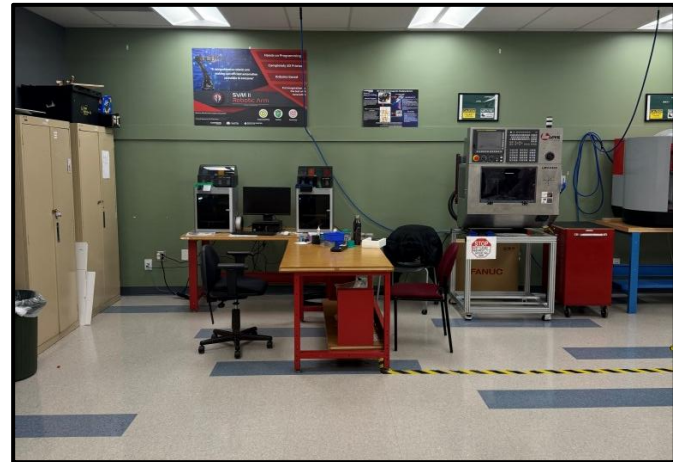
Photograph 4: View of Room T228.

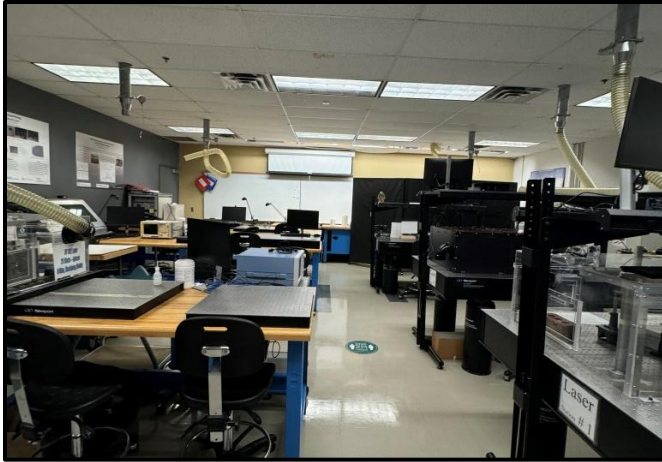
Photograph 5: View of Room T329.

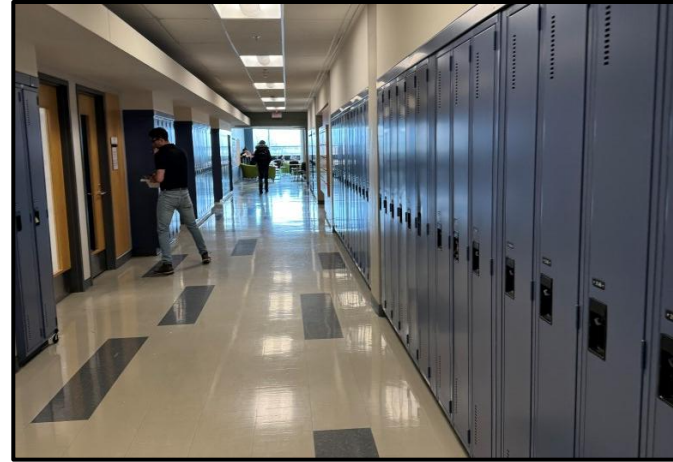
Photograph 6: Typical view of the third-floor corridor.

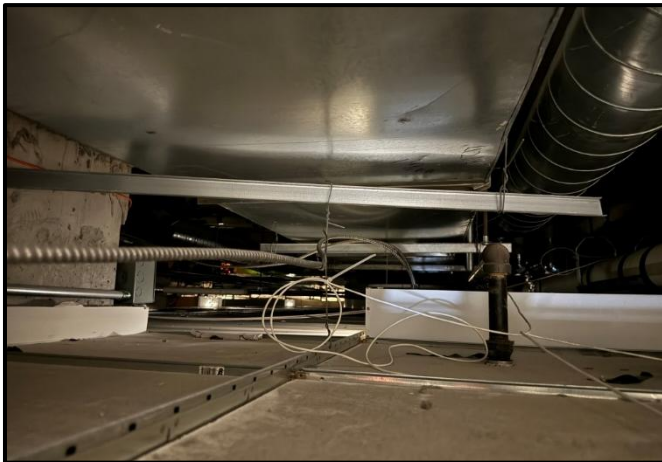
Mechanical pipes throughout the building were observed to be either uninsulated or insulated with non-asbestos applications of fibreglass and PVC. Applications of sprayed fireproofing were observed in ceiling spaces throughout the building. Ductwork throughout the building was observed to be uninsulated with applications of mastic. No suspect asbestos-containing insulating materials were observed during the assessment; therefore, no samples were collected.

Photograph 7: View of uninsulated ductwork observed in ceiling spaces.

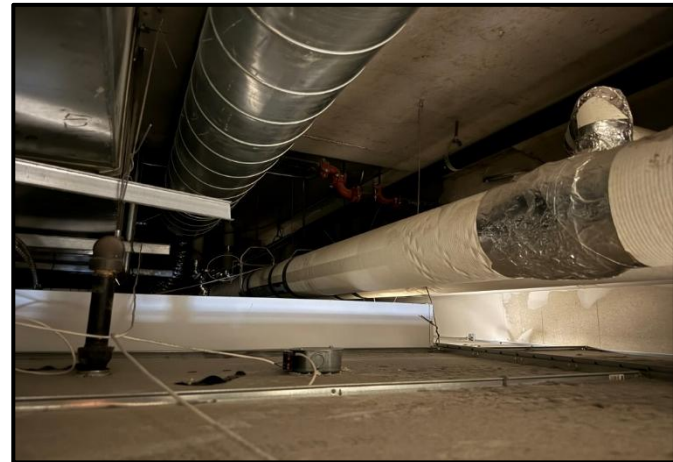
Photograph 8: View of mechanical pipes insulated with non-asbestos fiberglass observed in ceiling spaces.
