**DESIGNATED SUBSTANCES AND HAZARDOUS MATERIALS REPORT**  
**Building H, Algonquin College Ottawa Campus**  
**706 Wajashk Private, Ottawa, Ontario**

**February, 2026**

**CM3 Project: TC1738**

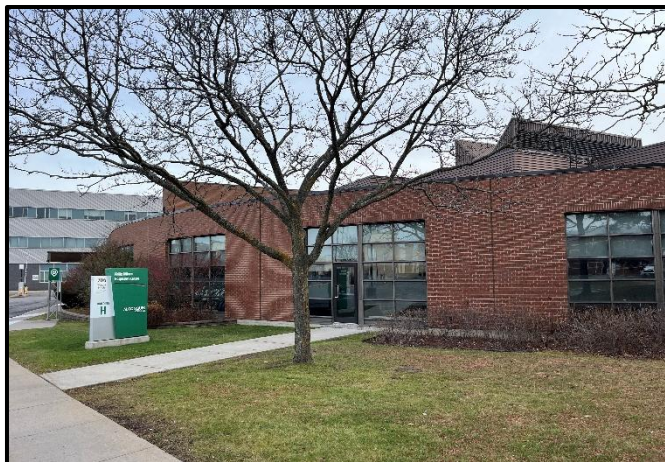
Photograph 1: Typical view of the exterior of the building.

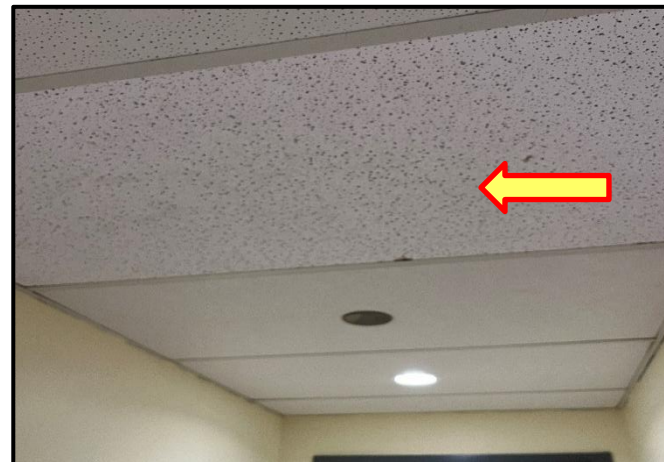
The ceilings throughout the building were observed to consist of drywall, 2'x4' acoustic ceiling tiles and steel deck. The majority of the acoustic ceiling tiles were observed to be date stamped 2013 or later and therefore pose no concern with regards to asbestos content.

Photograph 2: View of non-asbestos containing acoustic ceiling tiles observed throughout the building.

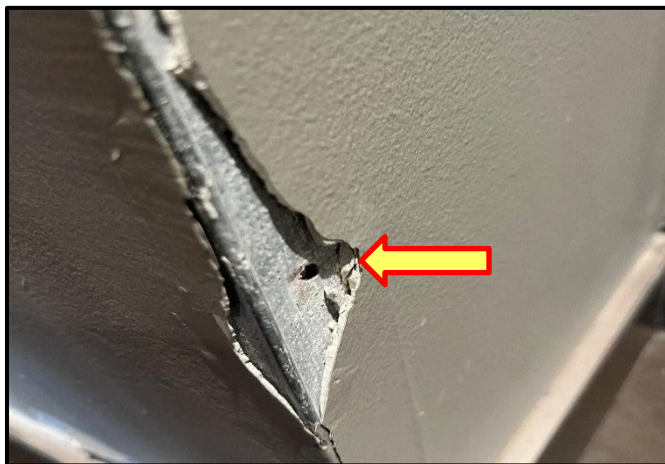
As noted above the drywall joint compound samples analyzed pose no concern with regards to asbestos content.

Photograph 3: View of non-asbestos containing drywall joint compound observed throughout the building.

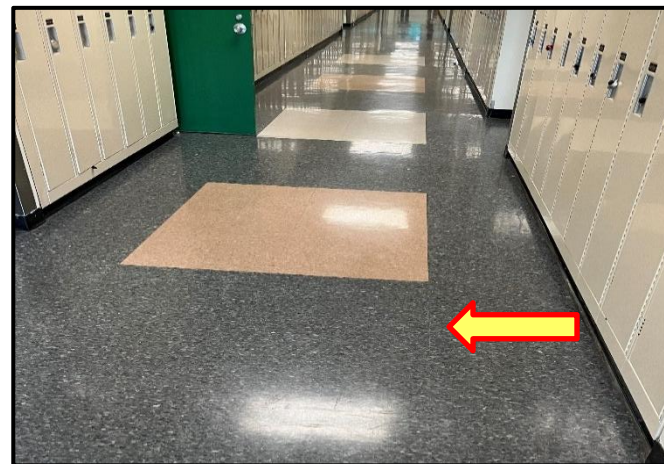
Photograph 4: View of non-asbestos containing 12"x12" vinyl floor tiles.

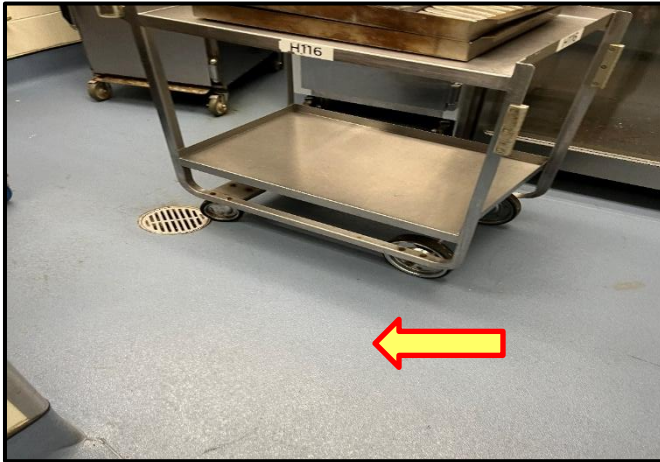
Photograph 5: View of non-asbestos containing sheet vinyl flooring observed throughout the building.

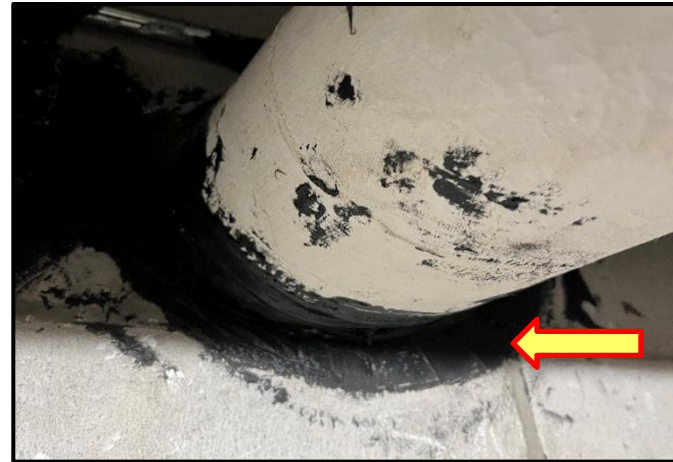
Photograph 6: View of non-asbestos containing mastic observed at pipe penetrations.

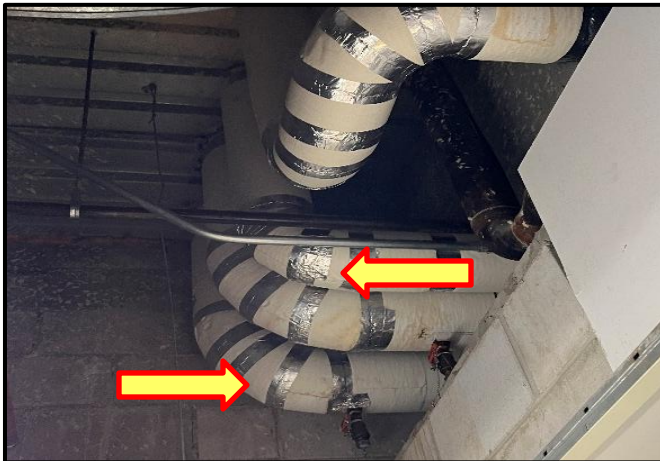
Mechanical pipes throughout the building were observed to be either uninsulated or insulated with non-asbestos applications of fibreglass. Ductwork throughout the building was observed to be uninsulated. Applications of mastic were observed on ductwork throughout and also on pipe penetrations throughout. Applications of sprayed fireproofing were observed in ceiling spaces throughout the building.

Photograph 7: View of non-asbestos containing fiberglass insulation observed on mechanical pipes throughout the building.

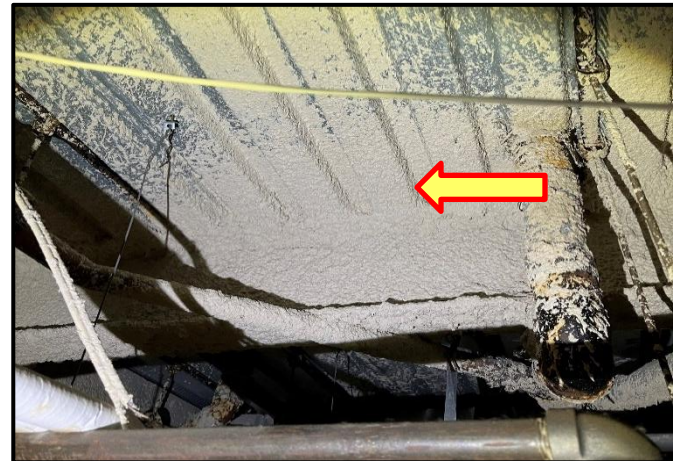
Photograph 8: View of non-asbestos containing sprayed fireproofing observed in ceiling spaces throughout the building.

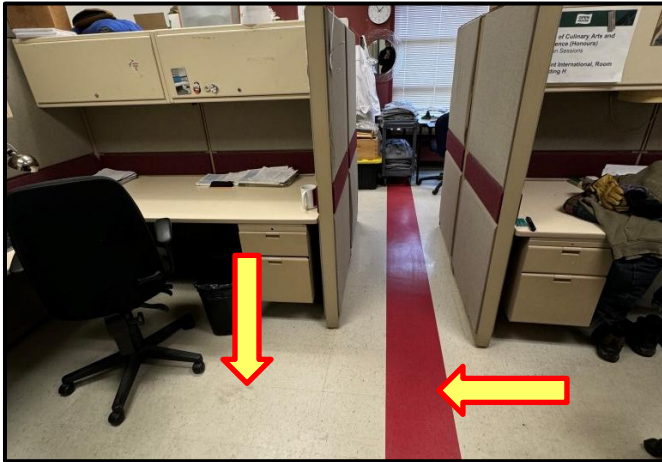
Photograph 9: View of non-asbestos containing 12"x12" vinyl floor tiles.

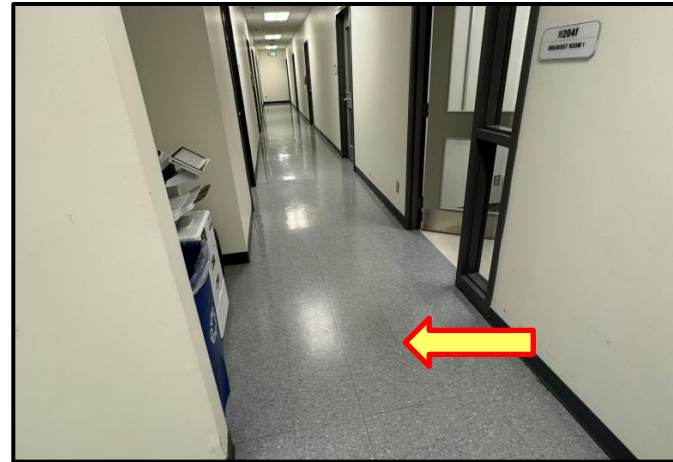
Photograph 10: View of non-asbestos containing 12"x12" Grey vinyl floor tiles.

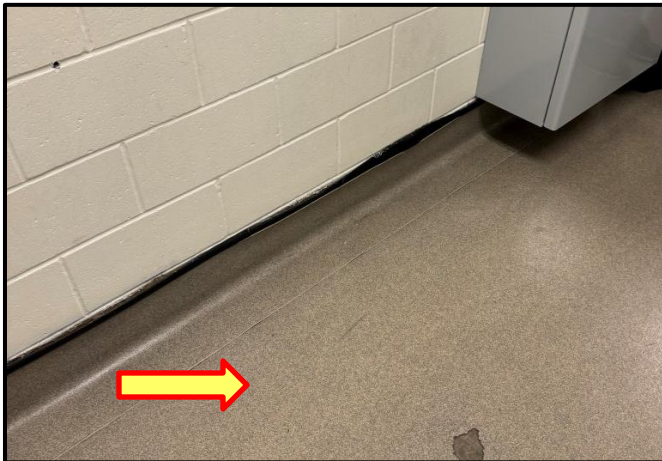
Photograph 11: View of non-asbestos containing brown/beige sheet vinyl flooring.

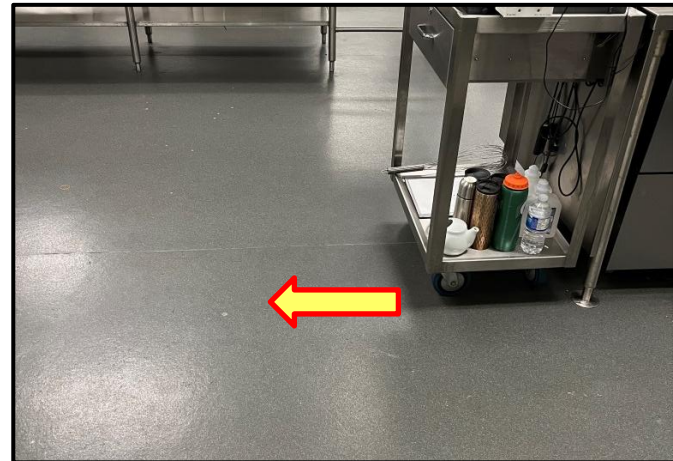
Photograph 12: View of non-asbestos containing grey sheet vinyl flooring.

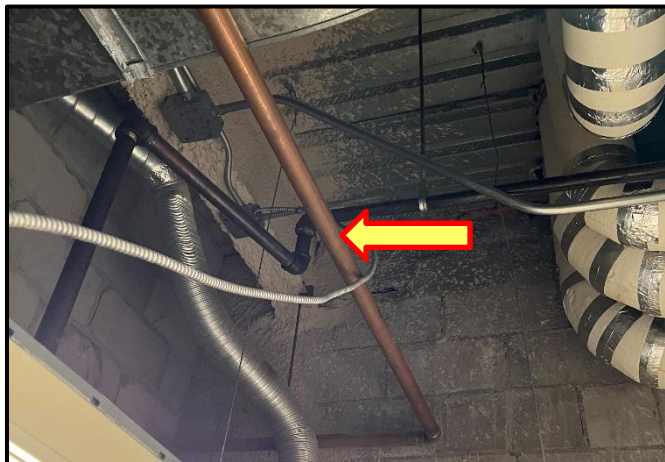
Photograph 13: View of potentially lead-containing copper piping observed throughout the building in ceiling spaces.

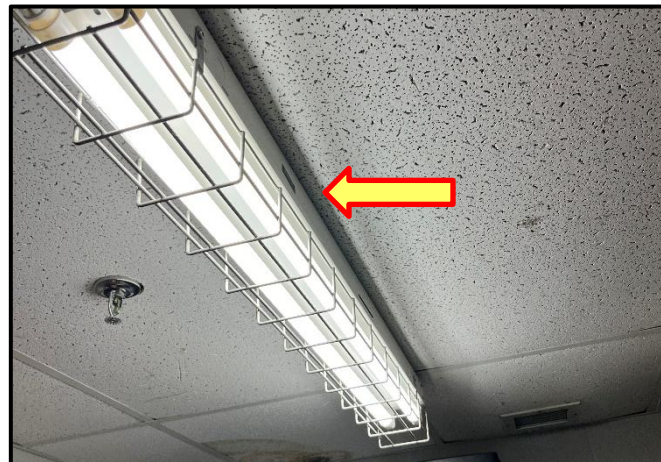
Mercury may be commonly found in thermostats, fluorescent lamp tubes and High Intensity Discharge (HID) light bulbs. Mercury or mercury vapour within light fixtures, thermometers, thermostats and electrical switches poses no risks to workers or occupants provided that the mercury containers remain intact and undisturbed.

Photograph 14: View of potentially mercury containing fluorescent lighting observed throughout the building.
