DESIGNATED SUBSTANCES AND HAZARDOUS MATERIALS REPORT
Algonquin College Perth Campus
7 Craig Street, Perth, Ontario

December 17, 2025

CM3 Project: TC1738

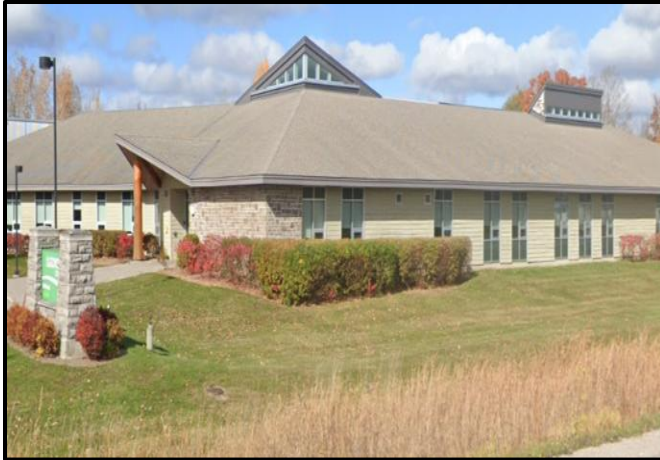
The exterior finishes of Building A were observed to consist of brick masonry, a poured concrete foundation and vinyl siding. There are no concerns with regards to asbestos-containing exterior finishes.

Photograph 1: Typical view of the exterior of Building A.

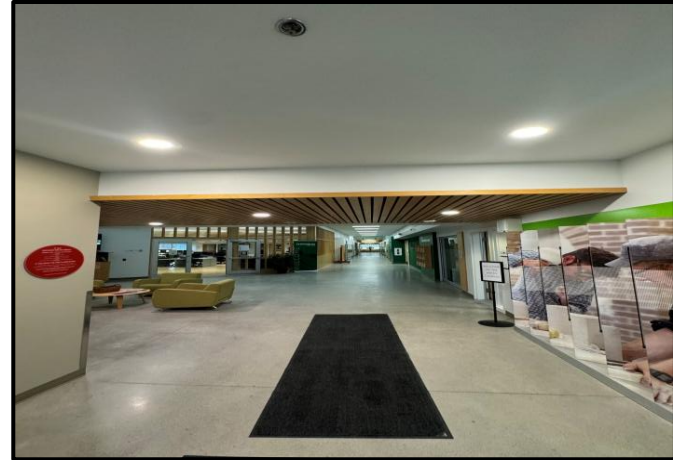
Photograph 2: Typical view of the main entrance and connected corridor located in Building A.

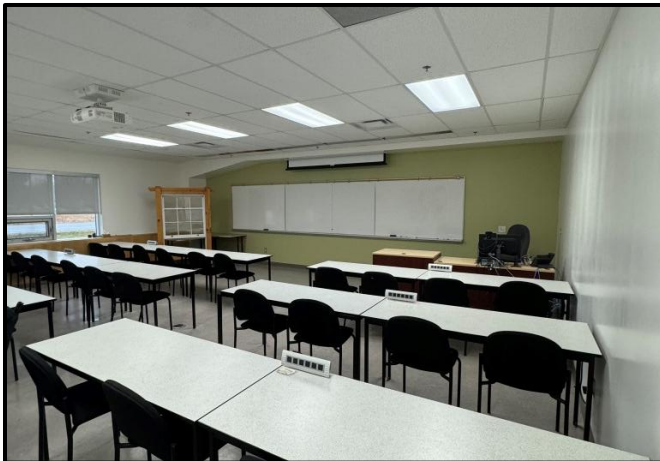
Photograph 3: View of classroom 103 located in Building A.

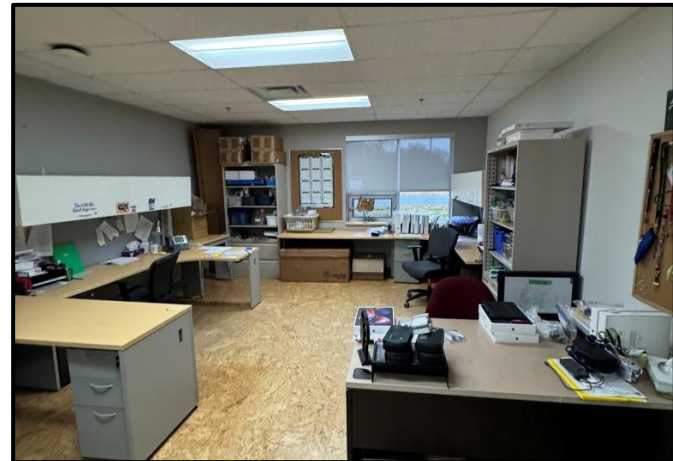
Photograph 4: Typical view of offices observed throughout Building A.

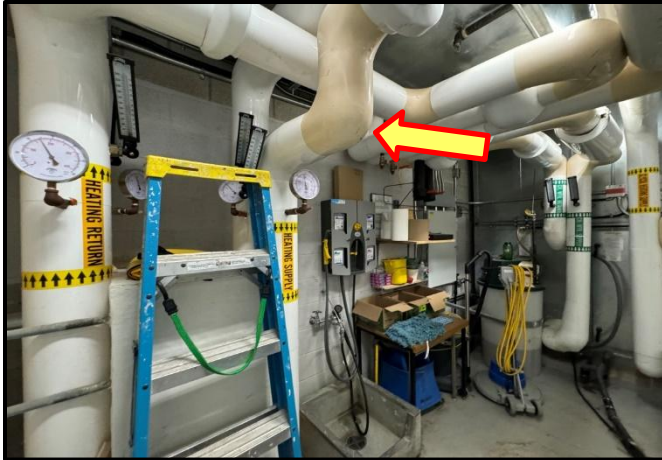
Mechanical pipes throughout Building A were observed to be either uninsulated or insulated with non-asbestos applications of fibreglass and PVC pipe fittings were observed on mechanical pipes in areas throughout the building. Ductwork was observed to be either uninsulated or insulated with non-asbestos applications of fibreglass. Applications of mastic were observed on ductwork throughout the building. There are no concerns with regards to asbestos-containing insulating materials.

Photograph 5:View of PVC mechanical pipe fittings observed in Room 121 located in Building A.

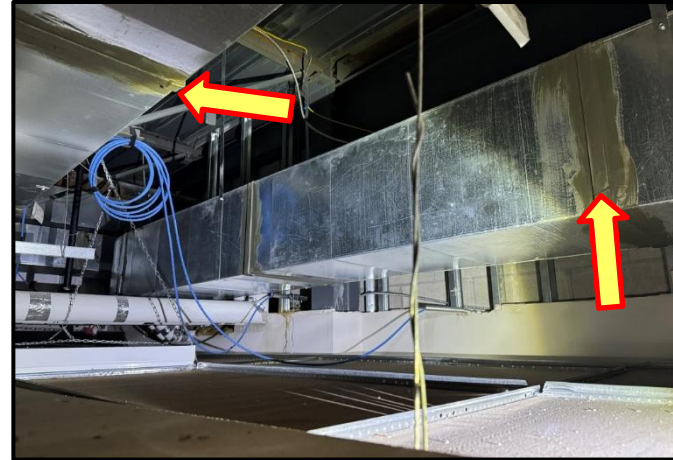
Photograph 6:View of mastic observed on uninsulated ductwork throughout Building A.

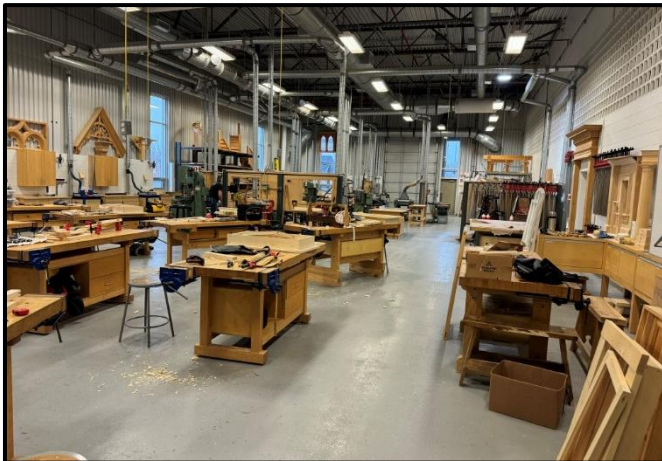
Photograph 7:View of the joinery shop in Room 136 located in Building A.

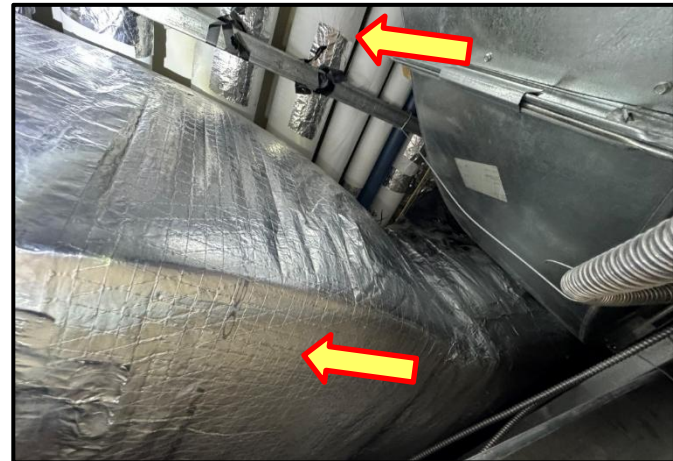
Photograph 8:View of fiberglass insulation observed on ductwork and mechanical pipes in ceiling spaces throughout Building A.

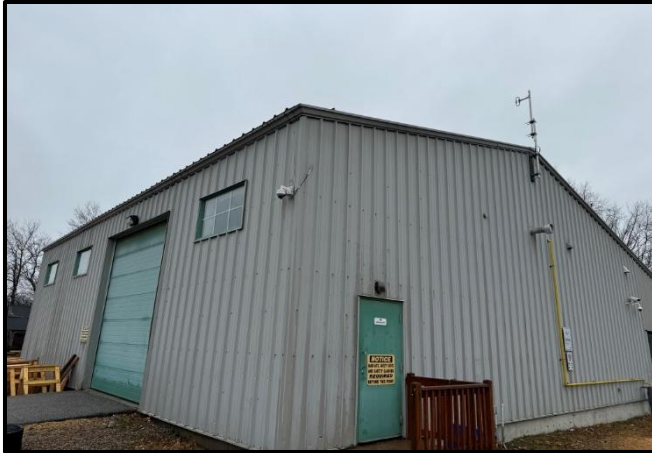
The exterior finishes of Building B were observed to consist of sheet metal siding, a poured concrete foundation and a pitched roof system finished with sheet metal. There are no concerns with regards to asbestos-containing exterior finishes.

Photograph 9: Typical view of the exterior of Building B (Carpentry Workshop).

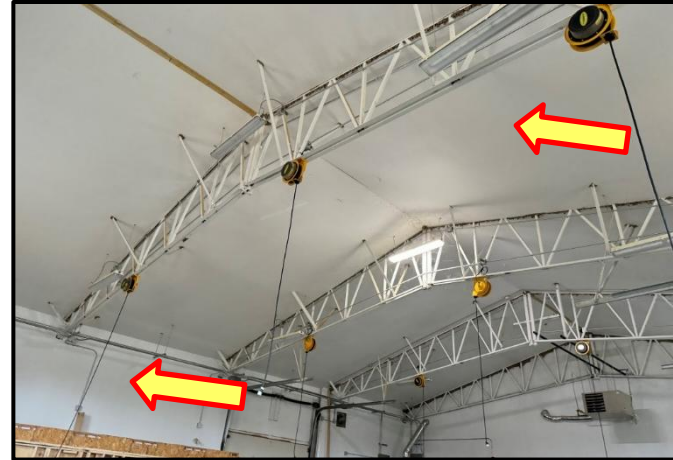
The interior wall finishes of Building B were observed to consist of drywall and plywood panels throughout the building. Three samples of drywall joint compound (DJC-01A-C) were collected from throughout the building and submitted for asbestos content analysis. Analytical results indicate no asbestos is present in the samples analyzed.

Photograph 10: View of non-asbestos containing drywall joint compound observed on ceilings and walls throughout Building B.

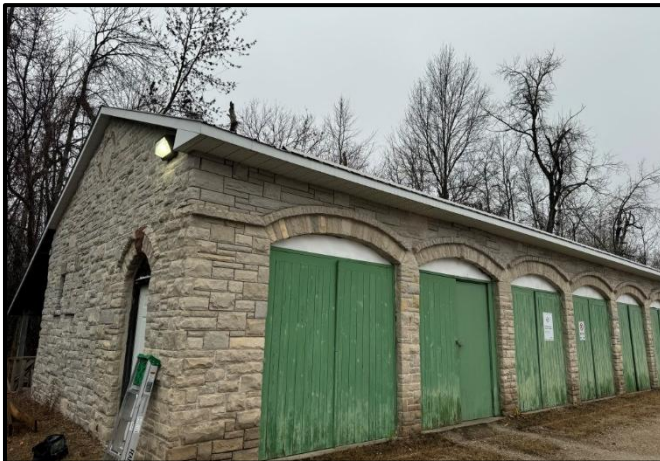
The exterior finishes of Building C were observed to consist of brick masonry and a pitched roof system finished with sheet metal. There are no concerns with regards to asbestos-containing exterior finishes.

Photograph 11: Typical view of the exterior of Building C (Masonry Storage).

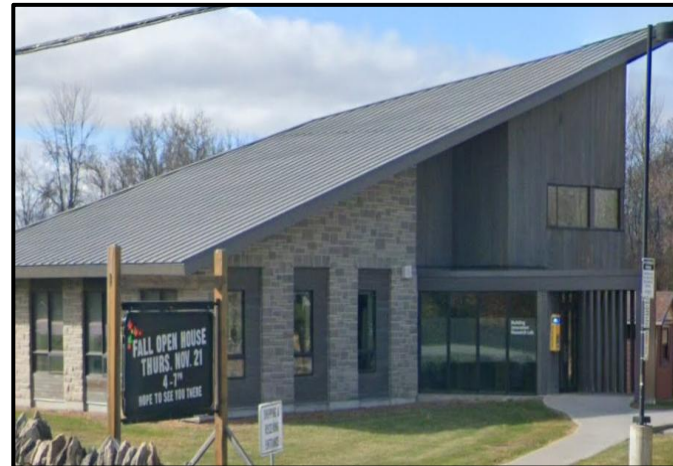
The exterior finishes of the Residential Living Lab were observed to consist of brick masonry, a poured concrete foundation and a pitched roof system finished with sheet metal. There are no concerns with regards to asbestos-containing exterior finishes.

Photograph 12: Typical view of the exterior of the Residential Living Lab building.

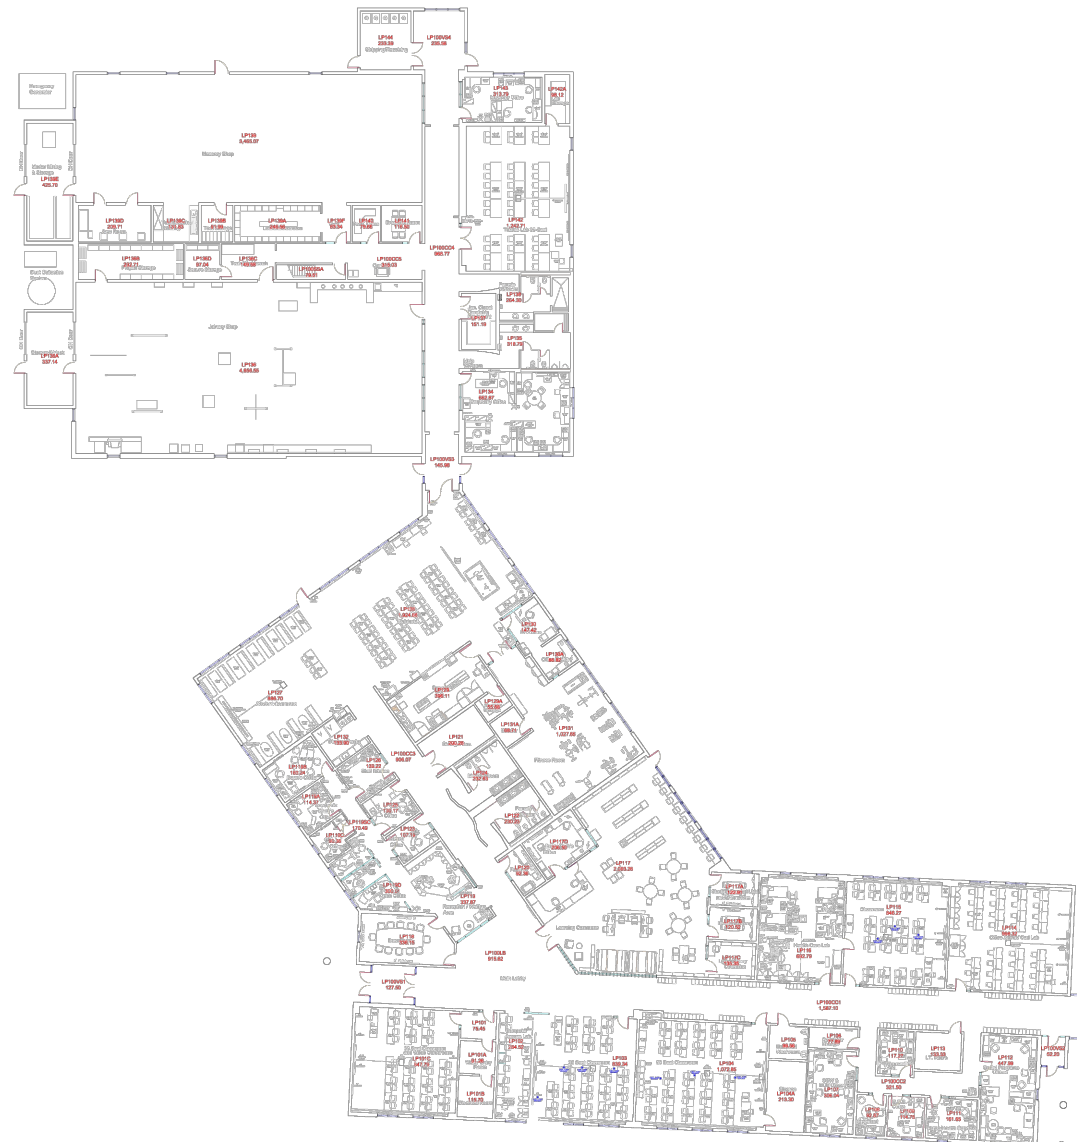
PERTH CAMPUS - 1st. FLOOR PLAN

NOTES:
- NO ASBESTOS-CONTAINING MATERIAL WAS OBSERVED.

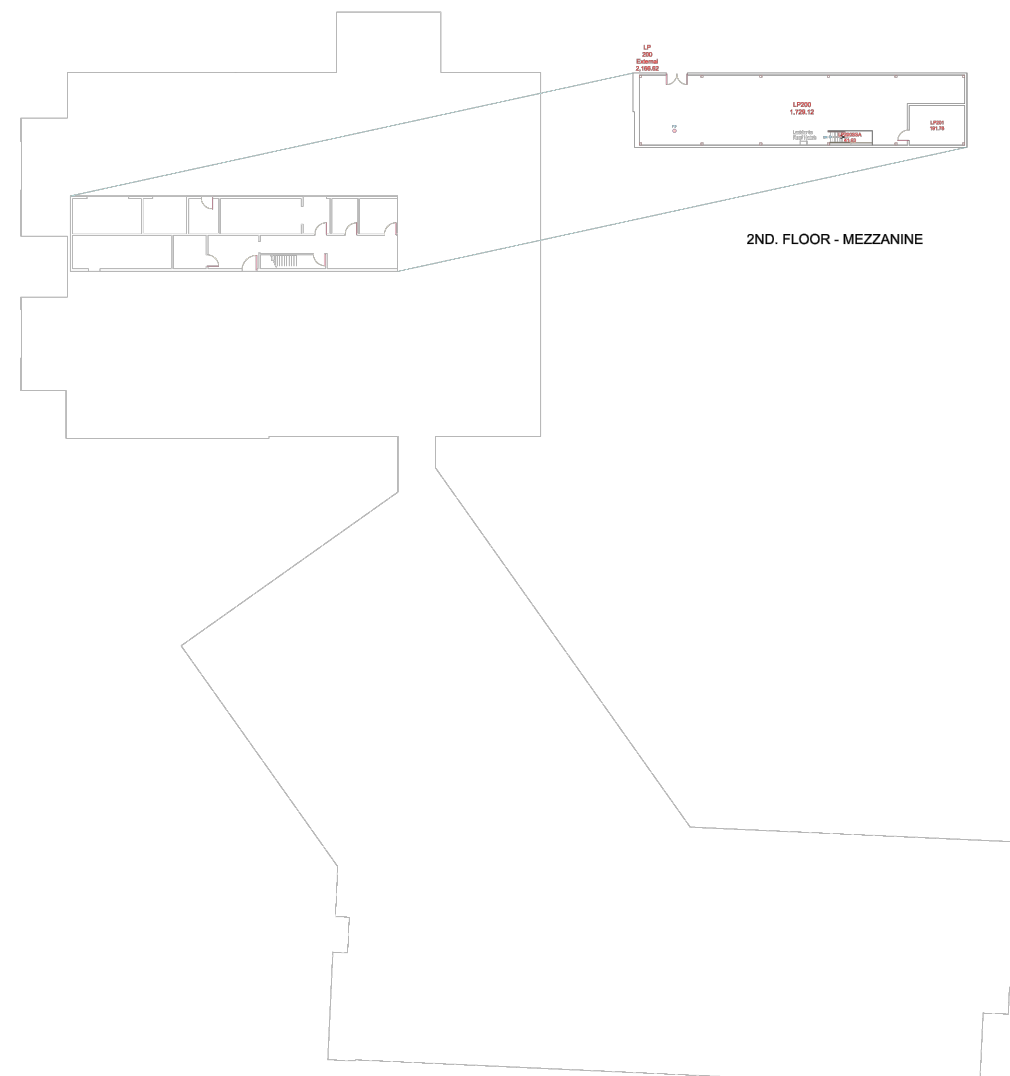
PERTH CAMPUS - 2nd FLOOR PLAN

NOTES:
 - NO ASBESTOS-CONTAINING MATERIAL WAS OBSERVED.
