DESIGNATED SUBSTANCES AND HAZARDOUS MATERIALS REPORT
Building G, Algonquin College Ottawa Campus
727 Wajashk Private, Ottawa, Ontario

Algonquin College
1385 Woodroffe Avenue
Ottawa, Ontario
K2G 1V8

March 2026

CM3 Project: TC1738

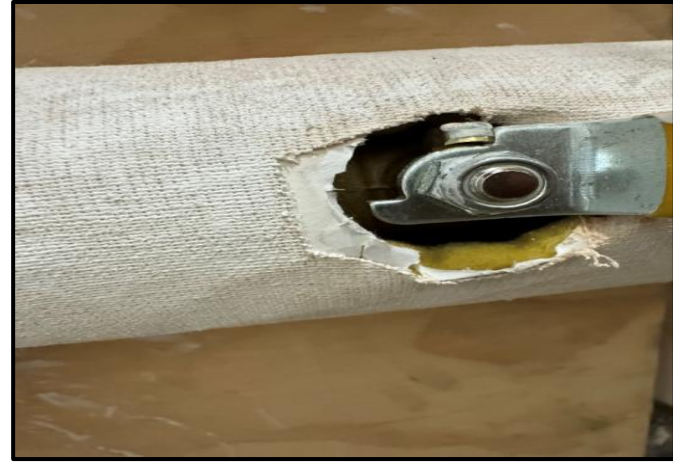
Mechanical pipes throughout the building were observed to be uninsulated or insulated with non-asbestos applications of fibreglass insulation with PVC elbow fittings. Ductwork throughout the building was observed to be uninsulated or insulated with non-asbestos applications of fibreglass. There are no concerns with regards to asbestos-containing insulating materials.

Photograph 2:View of mechanical pipes insulated with non-asbestos applications of fiberglass.

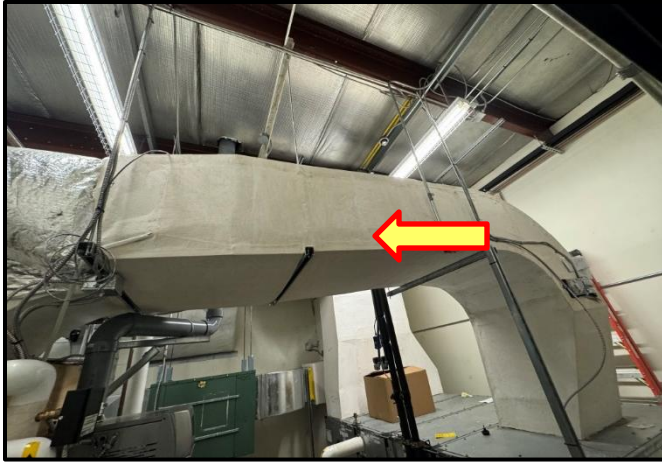
Photograph 5: View of non-asbestos fiberglass insulation observed on ductwork.

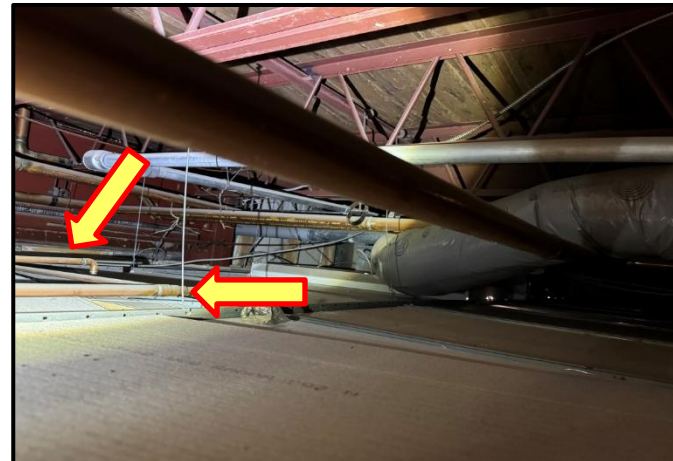
Photograph 8: View of potentially lead-containing copper pipes observed in ceiling spaces throughout the building.

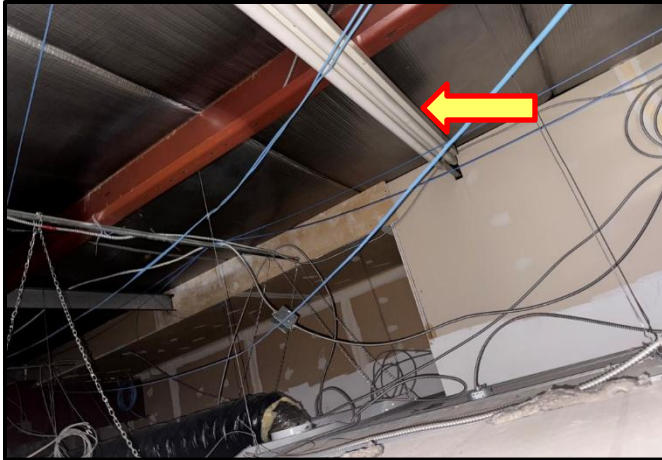
Mercury may be commonly found in thermostats, fluorescent lamp tubes and High Intensity Discharge (HID) light bulbs. Mercury or mercury vapour within light fixtures, thermometers, thermostats and electrical switches poses no risks to workers or occupants provided that the mercury containers remain intact and undisturbed.

Photograph 9: View of potentially mercury containing fluorescent lighting observed above the suspended grid ceiling in Room 201.
