DESIGNATED SUBSTANCES AND HAZARDOUS MATERIALS REPORT
Building J, Algonquin College Ottawa Campus
225 Adjudjak Private, Ottawa, Ontario

March 2026

CM3 Project: TC1738

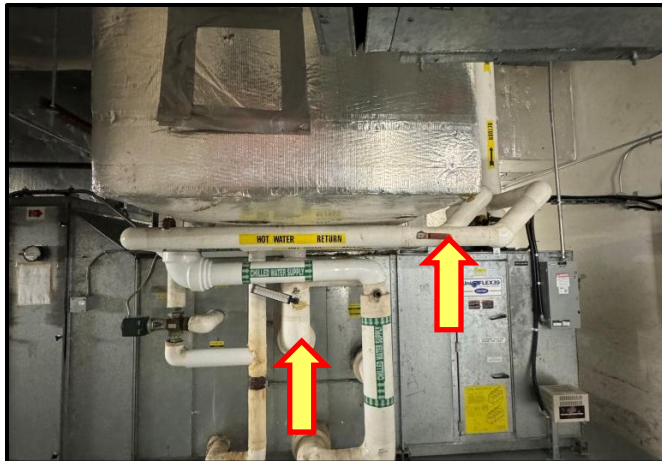
Photograph 7: View of non-asbestos fiberglass and PVC insulation observed on water lines within the mechanical penthouse.

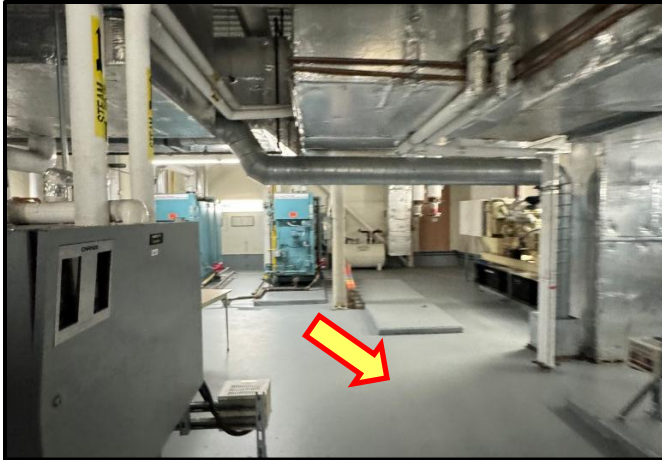
Photograph 9: View of lead-containing grey paint observed in the Chiller Plant Area (Room J400) .

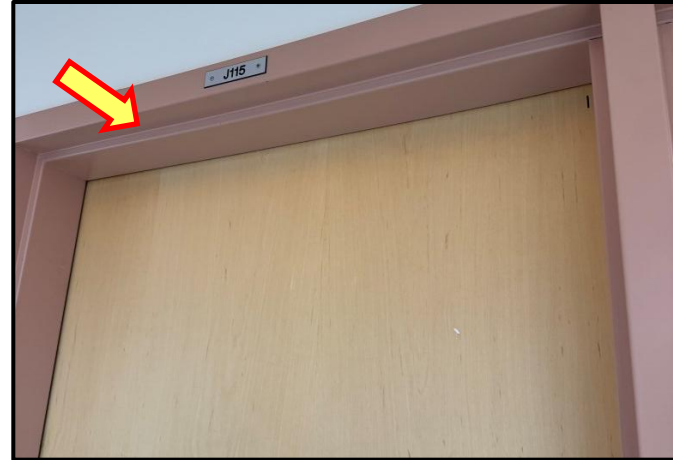
Photograph 10: View of lead-containing pink door frame paint observed throughout the building.

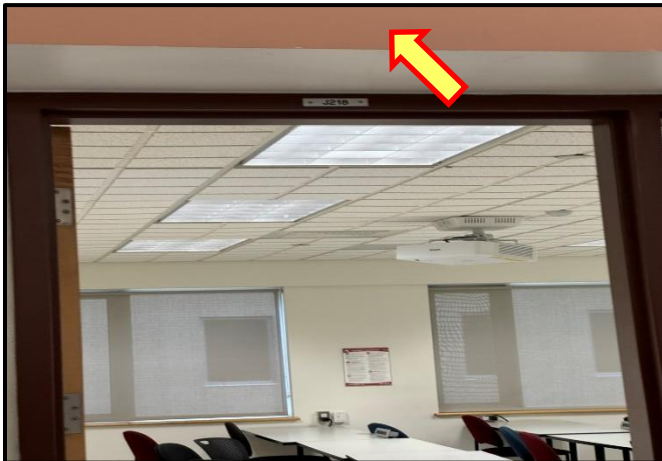
Photograph 11: View of lead-containing pink paint observed on walls .

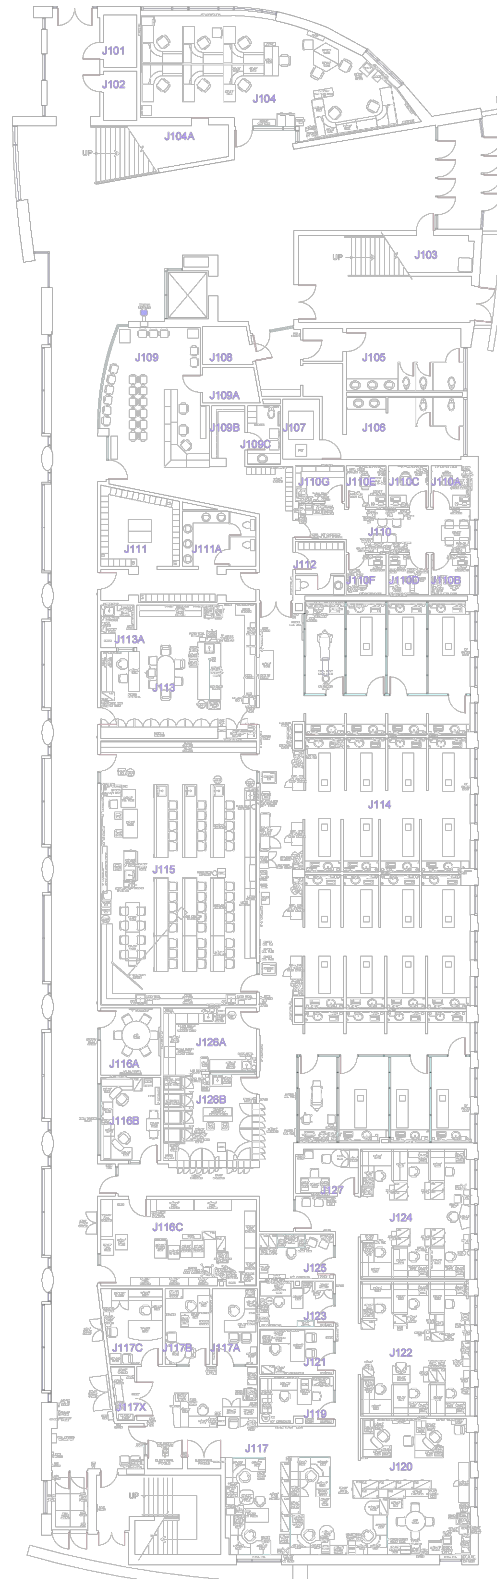
BUILDING J - 1st. FLOOR PLAN NOT TO SCALE

NOTES:
 - GIVEN THE AGE OF CONSTRUCTION THERE ARE NO CONCERNS WITH REGARDS TO ASBESTOS - CONTAINING MATERIALS.
 - LIGHT PINK DOORS AND FRAMES, PINK WALLS, WHITE WALLS AND CEILINGS AND GREY FLOOR PAINTS ARE LEAD-CONTAINING PAINTS.

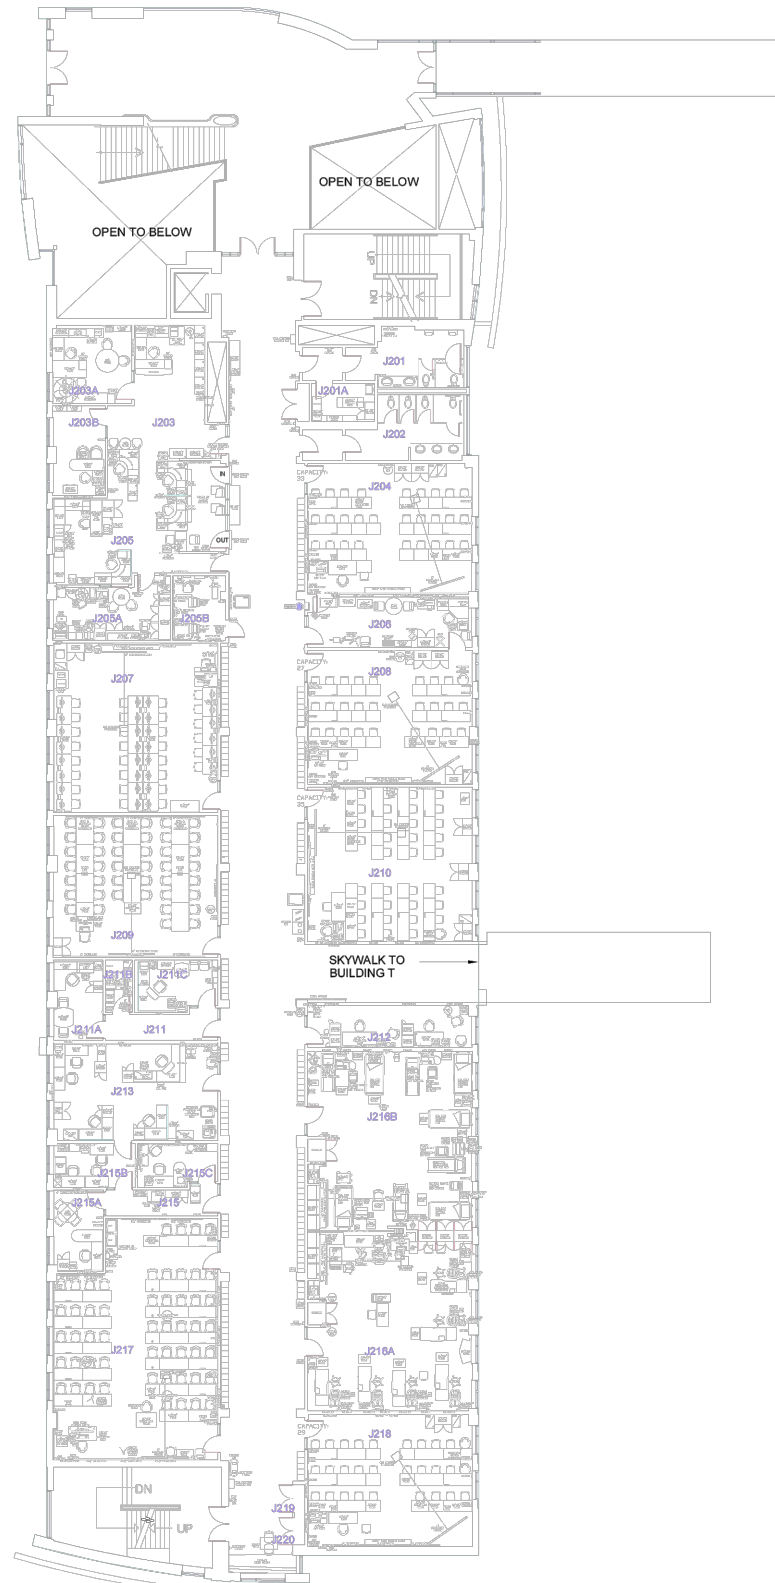
BUILDING J - 2nd. FLOOR PLAN NOT TO SCALE

NOTES:
 - GIVEN THE AGE OF CONSTRUCTION THERE ARE NO CONCERNS WITH REGARDS TO ASBESTOS - CONTAINING MATERIALS.
 - LIGHT PINK DOORS AND FRAMES, PINK WALLS, WHITE WALLS AND CEILINGS AND GREY FLOOR PAINTS ARE LEAD-CONTAINING PAINTS.

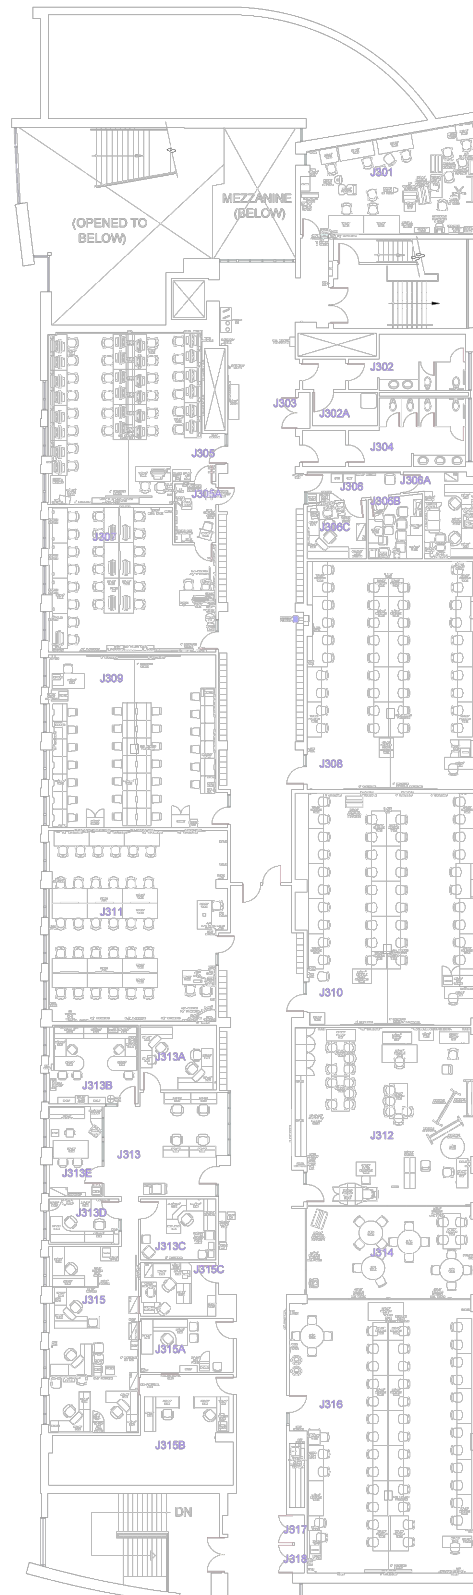
BUILDING J - 3rd. FLOOR PLAN NOT TO SCALE

NOTES:
 - GIVEN THE AGE OF CONSTRUCTION THERE ARE NO CONCERNS WITH REGARDS TO ASBESTOS - CONTAINING MATERIALS.
 - LIGHT PINK DOORS AND FRAMES, PINK WALLS, WHITE WALLS AND CEILINGS AND GREY FLOOR PAINTS ARE LEAD-CONTAINING PAINTS.

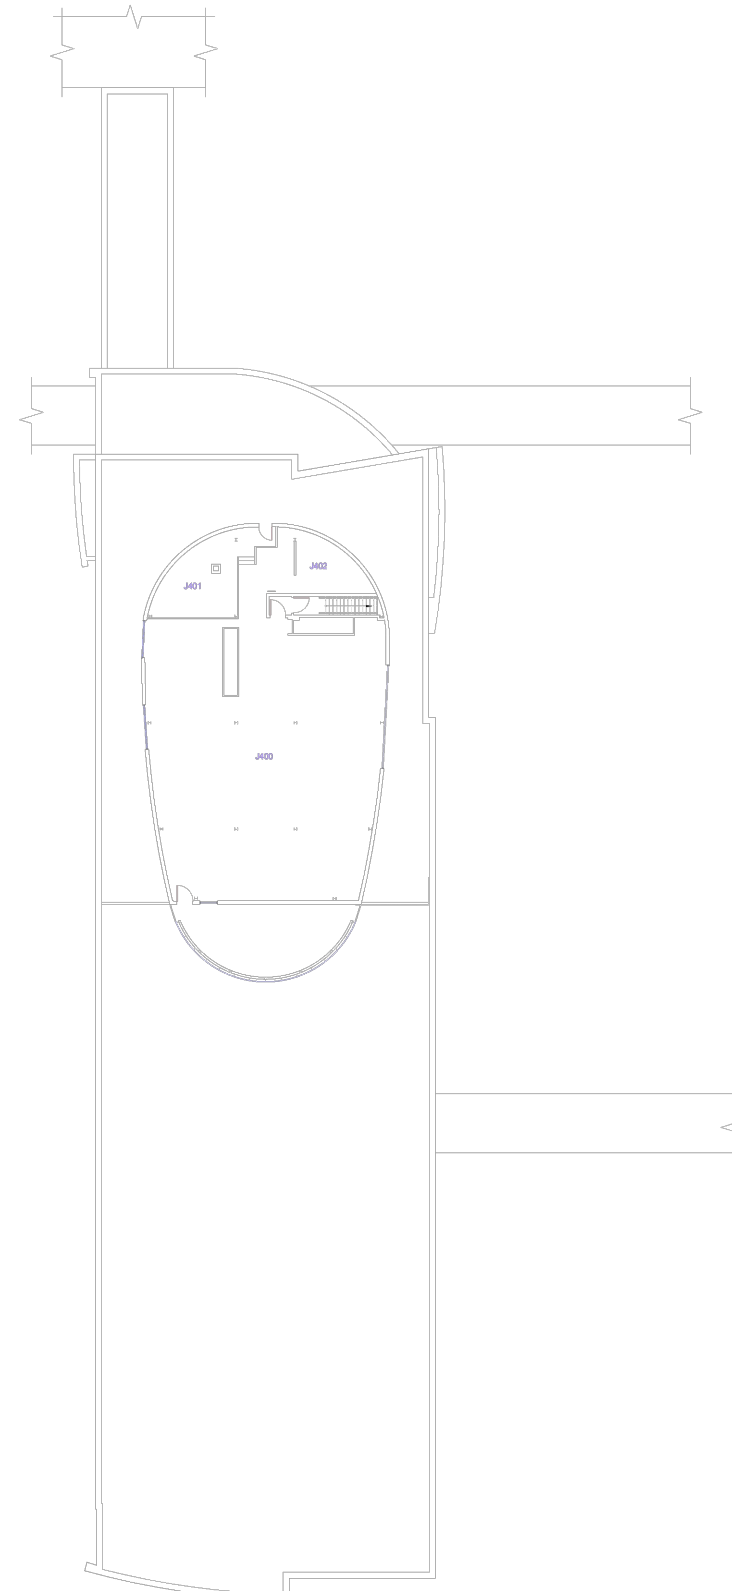
BUILDING J - 4th. FLOOR PLAN NOT TO SCALE

NOTES:
 - GIVEN THE AGE OF CONSTRUCTION THERE ARE NO CONCERNS WITH REGARDS TO ASBESTOS - CONTAINING MATERIALS.
 - LIGHT PINK DOORS AND FRAMES, PINK WALLS, WHITE WALLS AND CEILINGS AND GREY FLOOR PAINTS ARE LEAD-CONTAINING PAINTS.
