DESIGNATED SUBSTANCE REPORT

Building K, Algonquin College Ottawa Campus 201 Adjidjàk Private, Ottawa, Ontario

March 2026

CM3 Project: TC1738

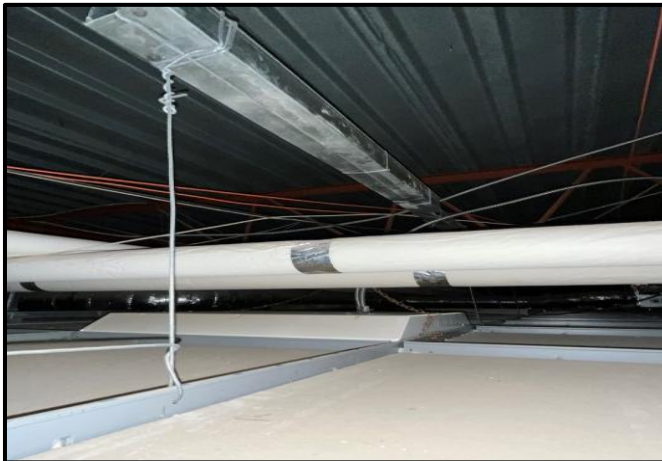
Mechanical pipes throughout the building were observed to be either uninsulated or insulated with non-asbestos applications of fibreglass. Ductwork throughout the building was observed to be uninsulated. There are no concerns with regards to asbestos-containing insulating materials; therefore, no samples were collected as part of the assessment.

Photograph 3: View of non-asbestos containing fiberglass insulation observed on mechanical pipes throughout.

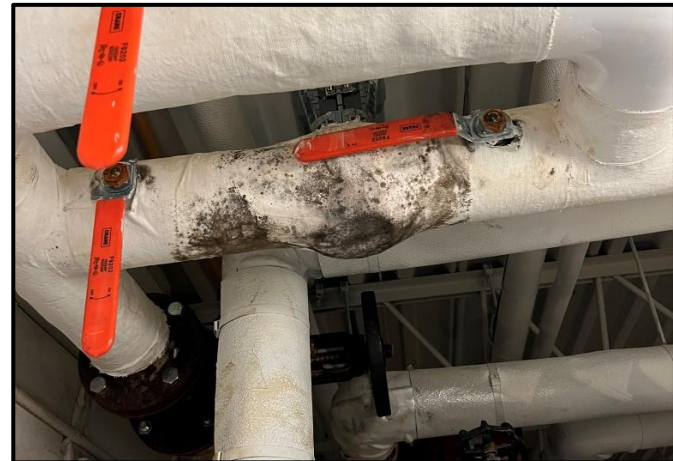
Suspected mould growth was observed on mechanical pipe insulation in the mechanical room.

Photograph 4: View of suspect mould impacts on mechanical pipe fittings observed in the Mechanical Room.
