DESIGNATED SUBSTANCE REPORT
Building M, Algonquin College Ottawa Campus
200 Adjidjàk Private, Ottawa, Ontario

DESIGNATED SUBSTANCE REPORT
Building M, Algonquin College Ottawa Campus
200 Adjidjàk Private
Ottawa, Ontario

CM3 Project: TC1738

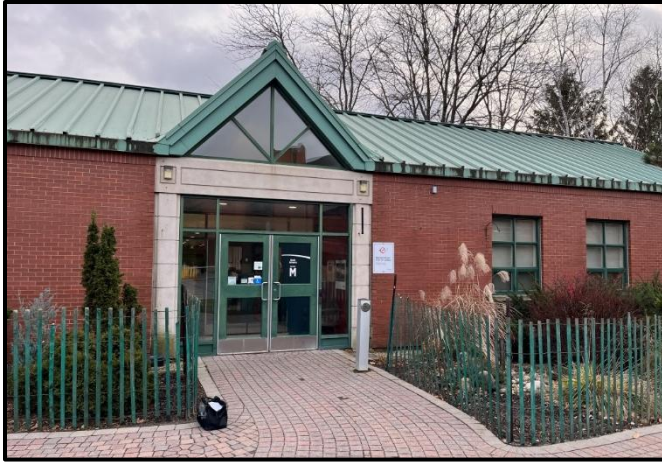
The exterior finishes throughout the building were observed to consist of brick masonry and a sheet metal sloped roof system. There are no concerns with regards to asbestos-containing exterior finishes.

Photograph 1: Typical view of the exterior of the building.

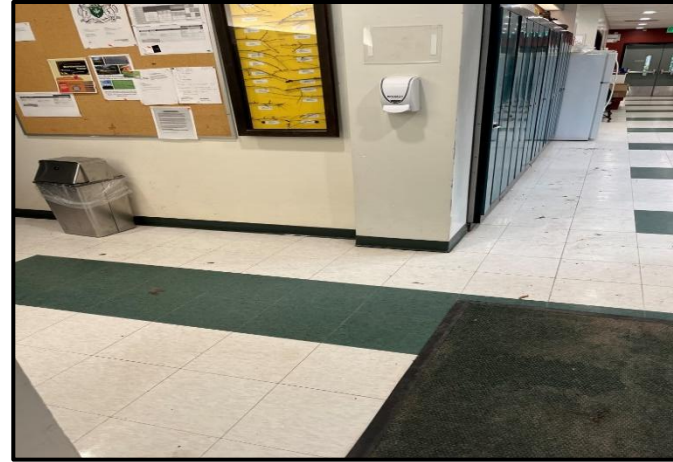
Photograph 2: Typical view of the corridors observed throughout the building.

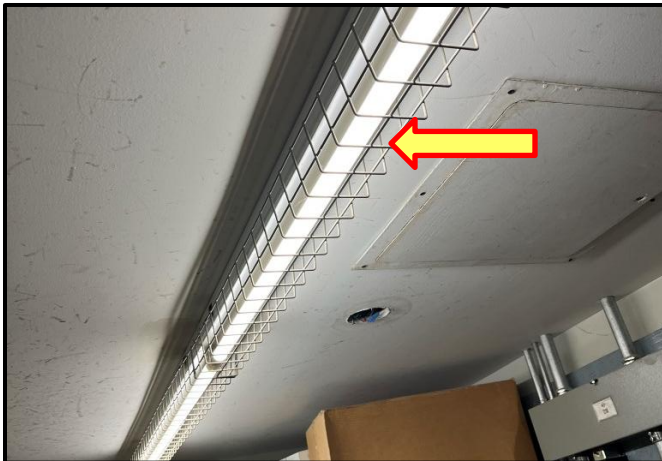
Mercury may be commonly found in thermostats, fluorescent lamp tubes and High Intensity Discharge (HID) light bulbs. Mercury or mercury vapour within light fixtures, thermometers, thermostats and electrical switches poses no risks to workers or occupants provided that the mercury containers remain intact and undisturbed.

Photograph 3: View of potentially mercury containing fluorescent lighting observed throughout the building.

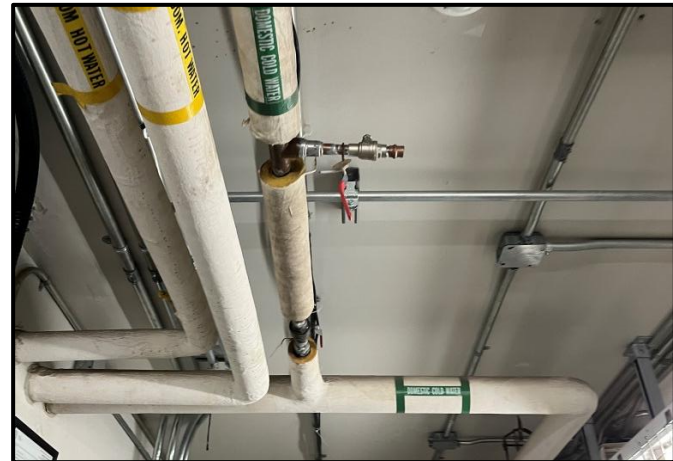
Mechanical pipes throughout the building were observed to be insulated with non-asbestos containing applications of fibreglass and PVC. Ductwork throughout the building was observed to be uninsulated. There are no concerns with regards to asbestos-containing insulating materials.

Photograph 4: View of non-asbestos fiberglass insulation observed on mechanical pipes throughout the building.

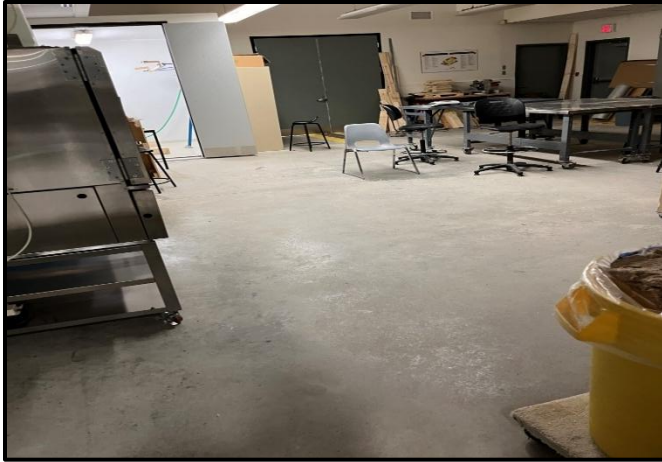
Photograph 5:View of Room M112.

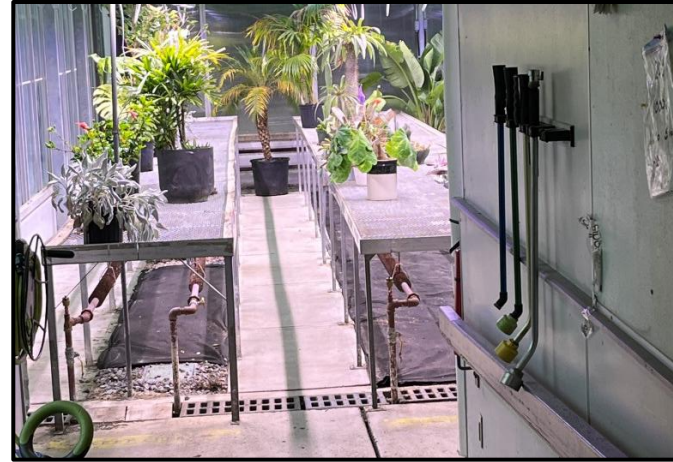
Photograph 6:View of the greenhouses observed within the building.
