DESIGNATED SUBSTANCES AND HAZARDOUS MATERIALS REPORT
Building A, Algonquin College Ottawa Campus
2420 Navaho Drive, Ottawa, Ontario

DESIGNATED SUBSTANCES AND HAZARDOUS MATERIALS REPORT
Building A, Algonquin College Ottawa Campus
2420 Navaho Drive
Ottawa, Ontario

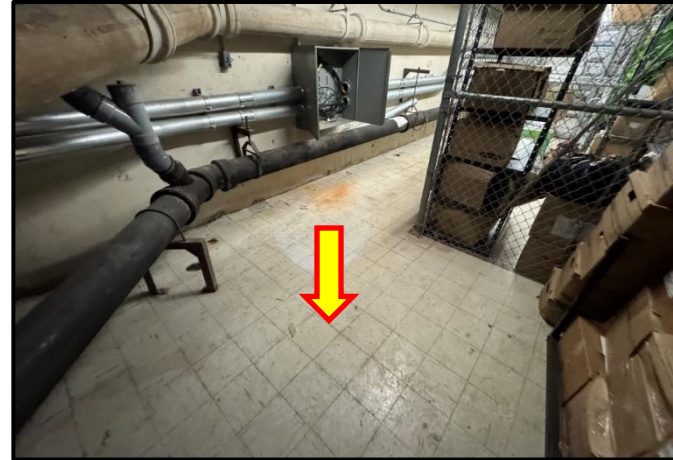
Photograph 2: View of asbestos-containing 9"x9" beige vinyl floor tiles observed in the basement corridor.

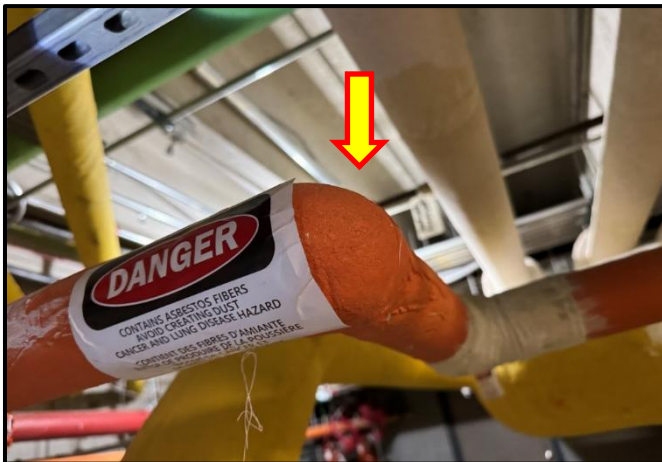
Photograph 3: View of asbestos-containing paring cement mechanical pipe elbow fittings observed throughout the basement tunnels.

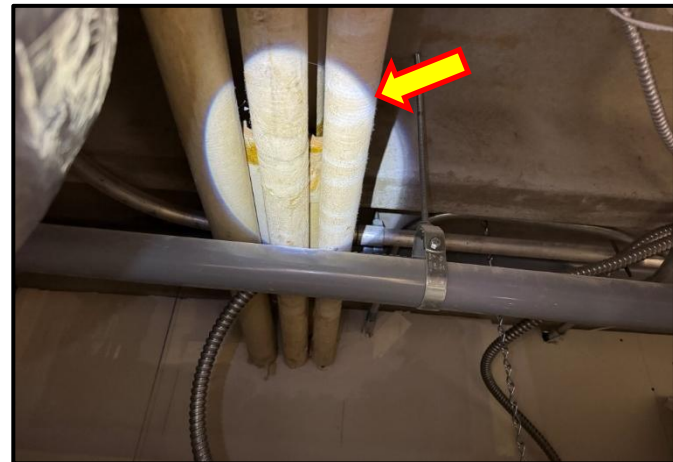
Photograph 4: View of asbestos-containing pipe insulation observed in the ceiling space of Room A1021.

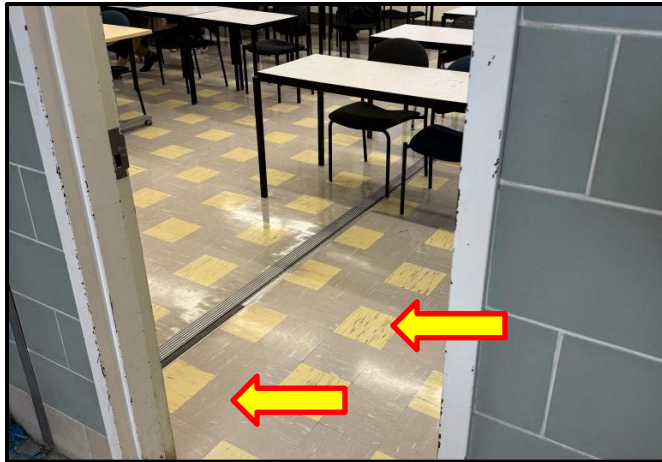
Photograph 5: View of asbestos-containing grey and yellow 9"x9" vinyl floor tiles observed in Room A2111.

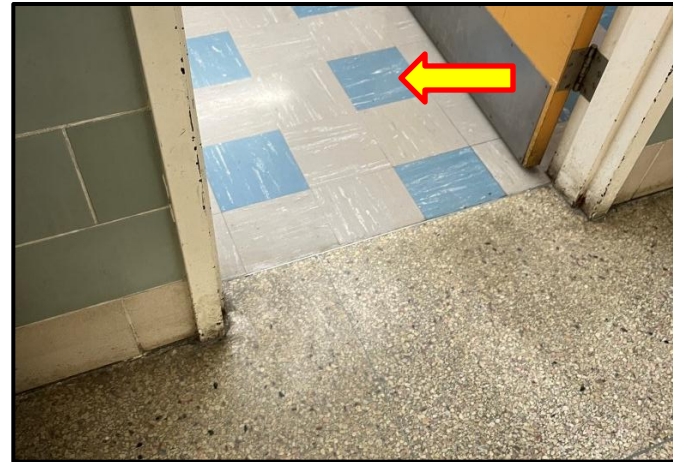
Photograph 6: View of asbestos-containing light blue and grey 9"x9" vinyl floor tiles observed in Room A2113.

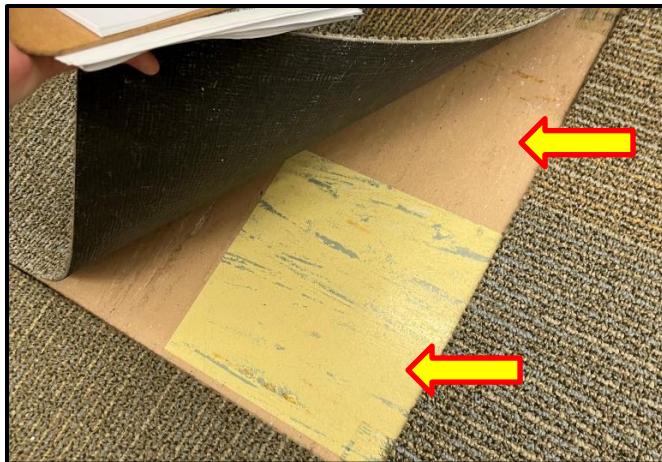
Photograph 7: View of asbestos-containing light brown and yellow 9"x9" vinyl floor tiles observed under carpet tiles in Room A2127.

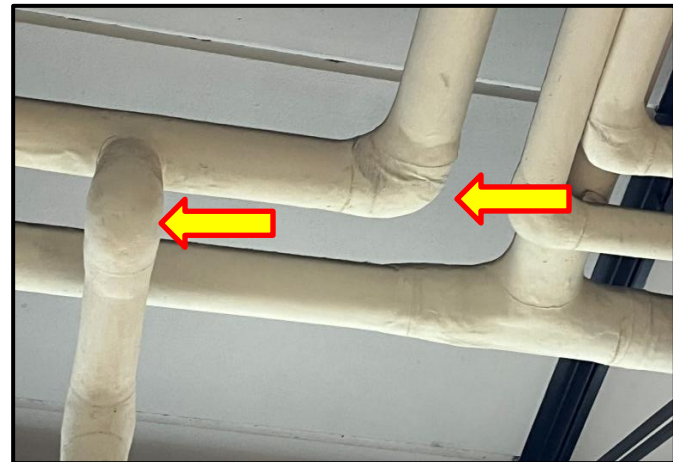
Photograph 8: View of asbestos-containing paring cement elbow fittings observed in Room A1445.

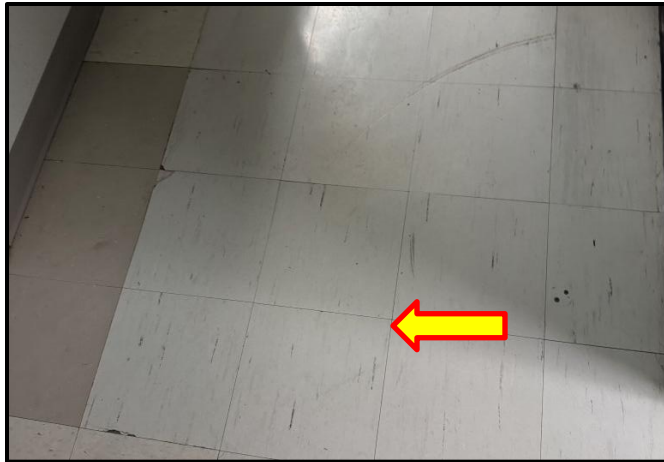
Photograph 9:View of asbestos-containing grey 12"x12" vinyl floor tiles observed in Room A1451c.

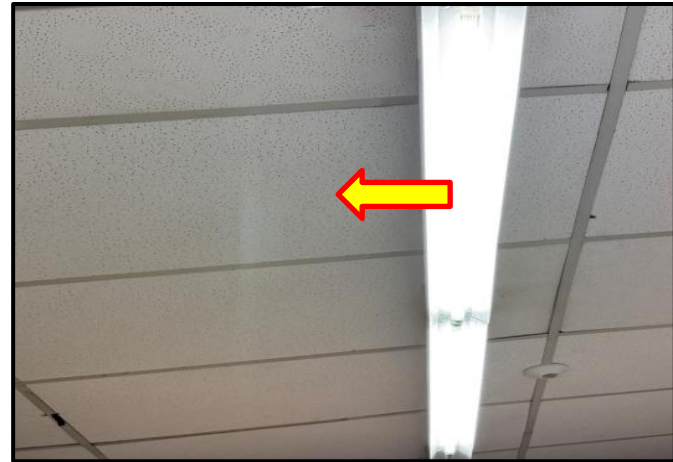
Photograph 10:View of asbestos-containing 2'x4' acoustic ceiling tiles observed in Room A1207.

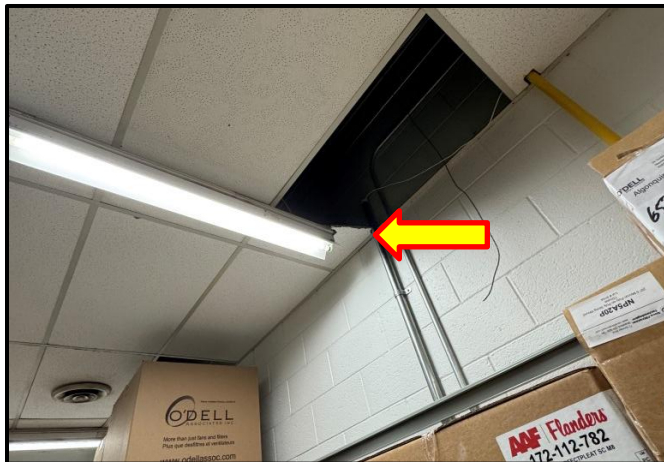
Photograph 11: View of damaged asbestos-containing 2'x4' acoustic ceiling tile observed in Room A1207.

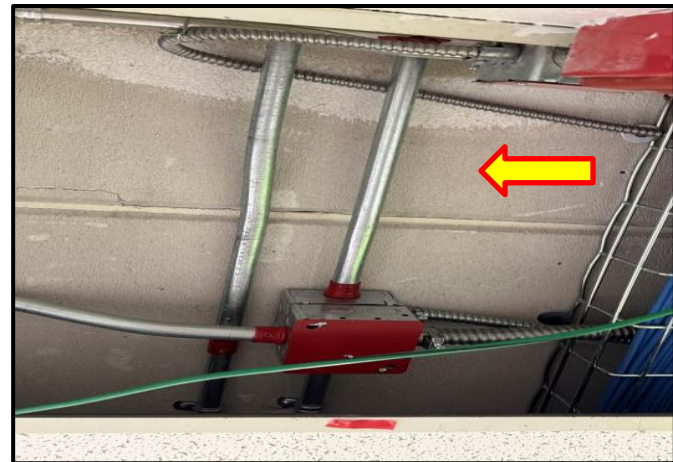
Photograph 12:Typical view of siporex observed in ceiling spaces throughout the building.

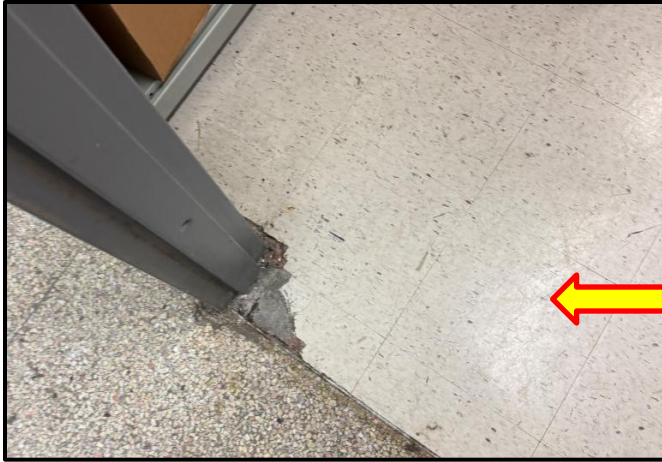
Photograph 13:View of asbestos-containing 12"x12" white vinyl floor tiles with black and grey streaks observed in Room A2114.
