DESIGNATED SUBSTANCES AND HAZARDOUS MATERIALS REPORT
Building P, Algonquin College Ottawa Campus
520 Wabisheshi Private, Ottawa, Ontario

March 2026

CM3 Project: TC1738

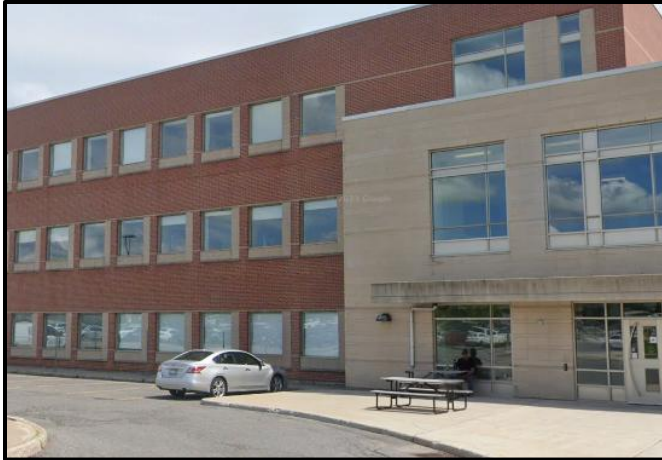
The exterior of the facility was observed to consist mainly of brick masonry, metal siding and a concrete foundation. There are no concerns with regards to asbestos-containing exterior finishes.

Photograph 1: Typical view of the exterior of the building.

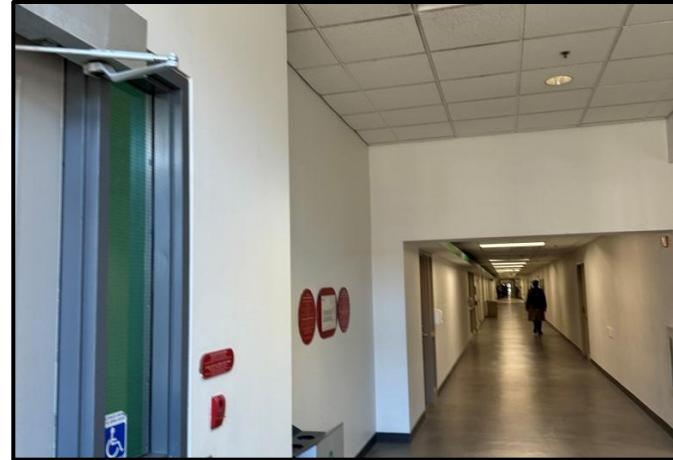
Photograph 2: Typical view of the first-floor corridor.

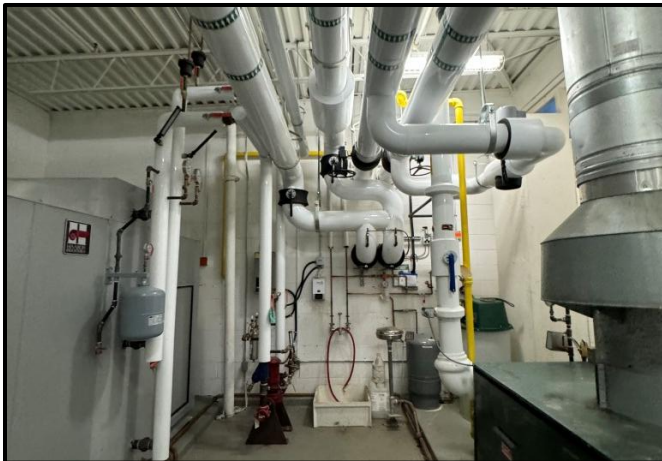
Photograph 3: View of mechanical pipes insulated with fiberglass and PVC located in the second-floor mechanical room.

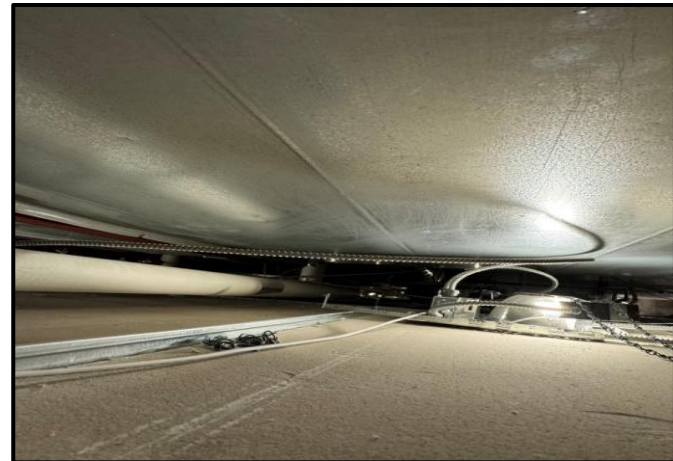
Mechanical pipes throughout the building were observed to be either uninsulated or insulated with non-asbestos applications of fiberglass. Ductwork throughout the building was observed to be uninsulated with applications of mastic observed on ductwork throughout. Applications of sprayed fireproofing were observed on steel deck in ceiling spaces throughout the building. There are no concerns with regards to asbestos-containing insulating materials.

Photograph 4: View of mechanical pipes insulated with non-asbestos fiberglass within the ceiling spaces.

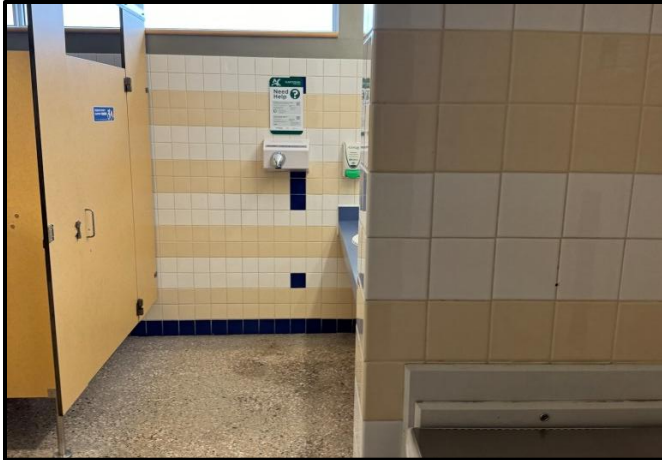
Photograph 5: Typical view of the washrooms observed throughout the building.

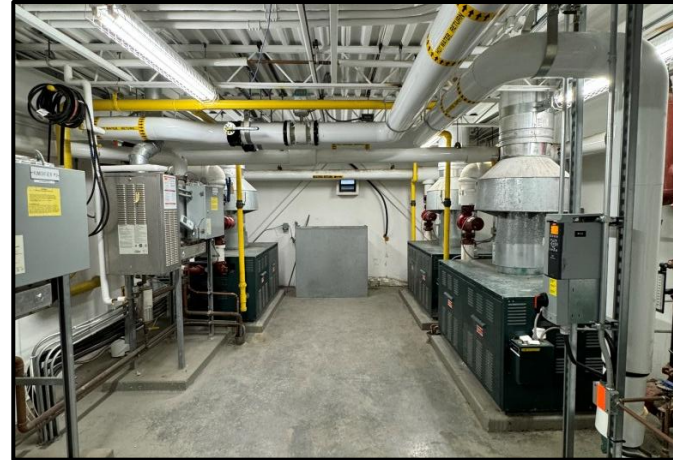
Photograph 6: View of mechanical penthouse B.

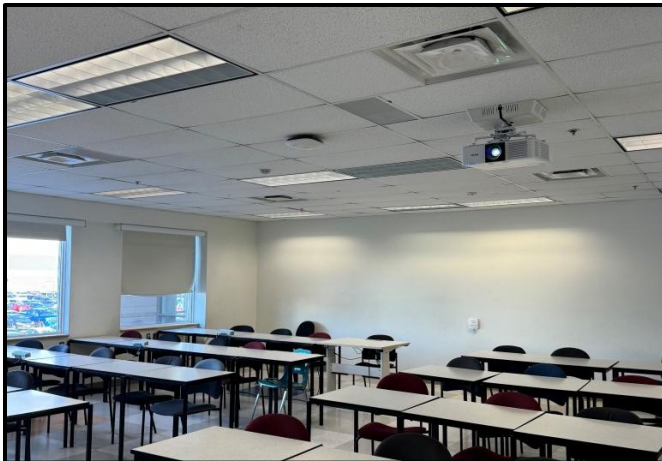
Photograph 7: Typical view of the classrooms observed throughout the building.

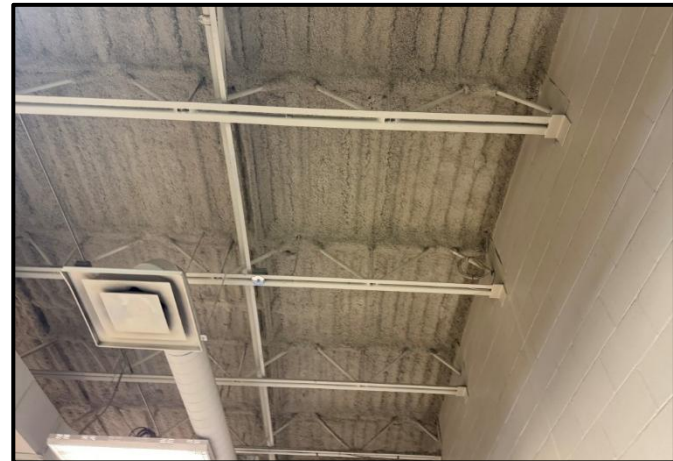
Photograph 8: Typical view of sprayed on fireproofing observed in ceiling spaces throughout the building.

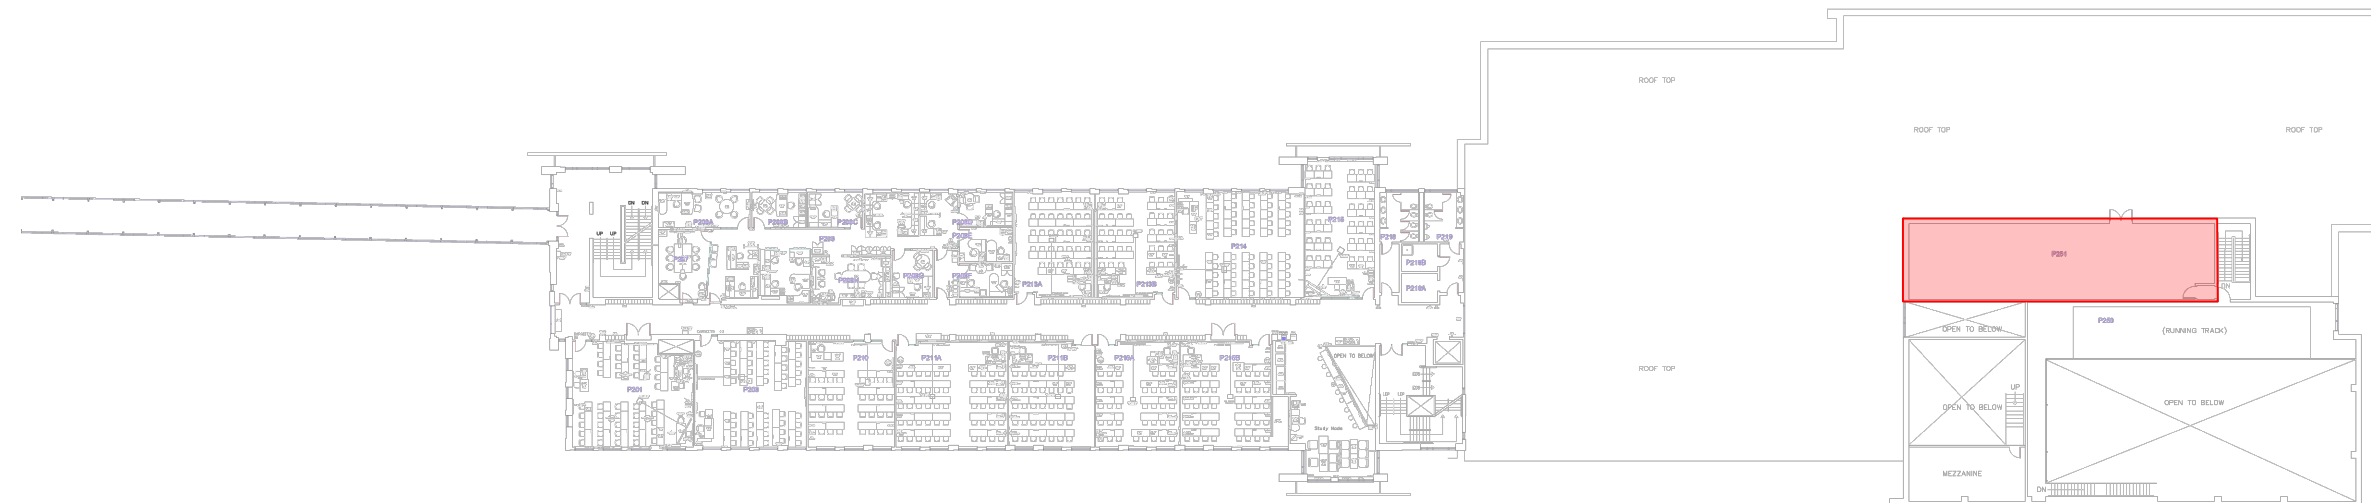
BUILDING P - 2nd. FLOOR PLAN
NOT TO SCALE

- LEAD CONTAMINATION CONCERNS WITHIN SHOOTING RANGE (ROOM P250) AND SECOND FLOOR MECHANICAL ROOM P251 SERVICING SHOOTING RANGE
