**DESIGNATED SUBSTANCES AND HAZARDOUS MATERIALS REPORT**  
**Building D, Algonquin College Ottawa Campus**  
**706 Wajashk Private, Ottawa, Ontario**

**DESIGNATED SUBSTANCES AND HAZARDOUS MATERIALS REPORT**  
**Building D, Algonquin College Ottawa Campus**  
**706 Wajashk Private**  
**Ottawa, Ontario**

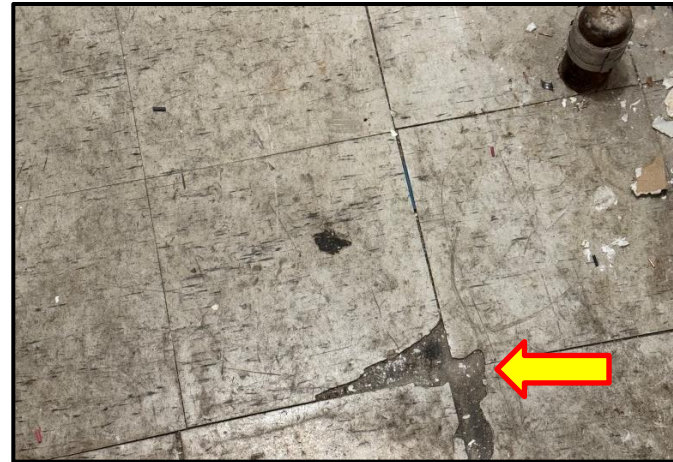
Photograph 2: View of damaged asbestos-containing 12"x12" beige vinyl floor tiles with black streaks observed in Room D117.

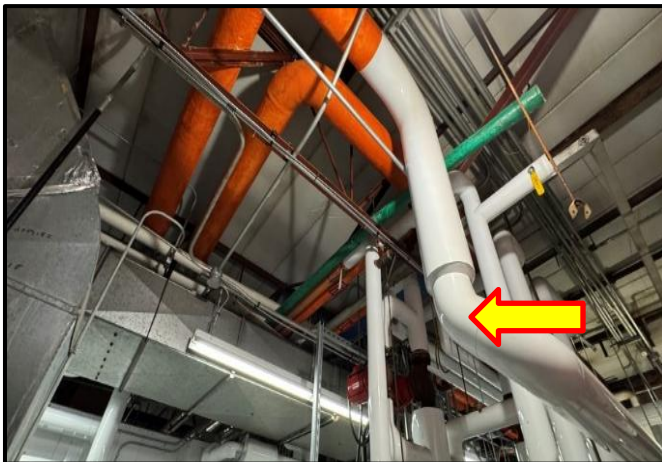
Photograph 3: View of the non-asbestos fiberglass and PVC mechanical pipe fittings observed to in Mechanical Penthouse D200.

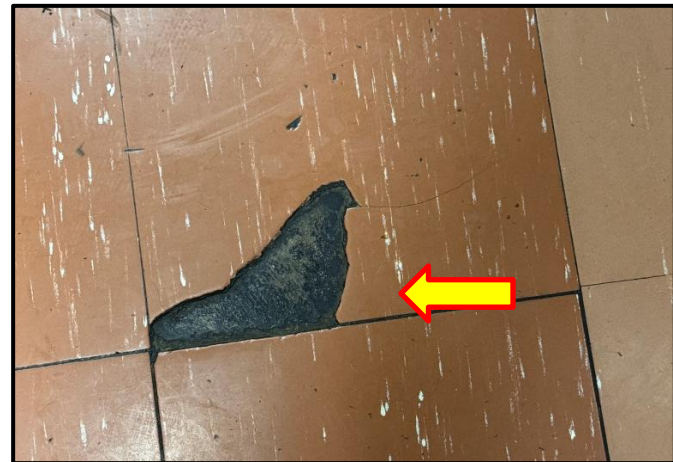
Photograph 4: View of damaged asbestos-containing 12"x12" red vinyl flooring tiles observed in Room D108.

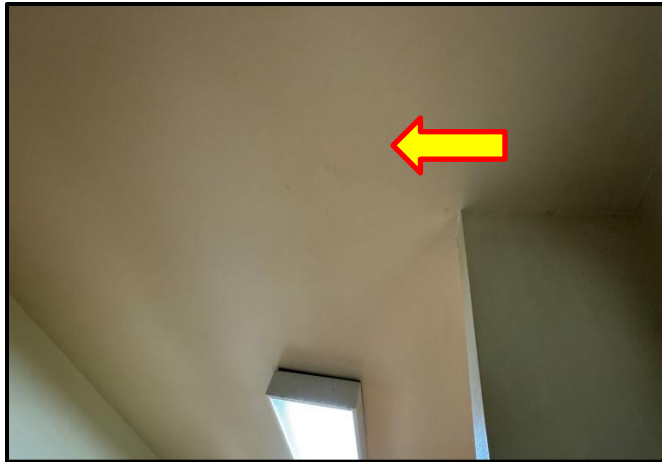
Photograph 5: View of asbestos-containing ceiling plaster observed in Room D106.

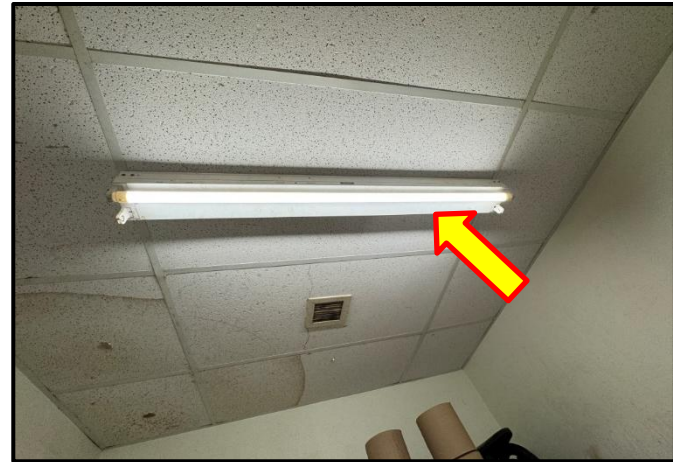
Photograph 6: Typical view of mercury containing fluorescent lighting observed throughout the building.

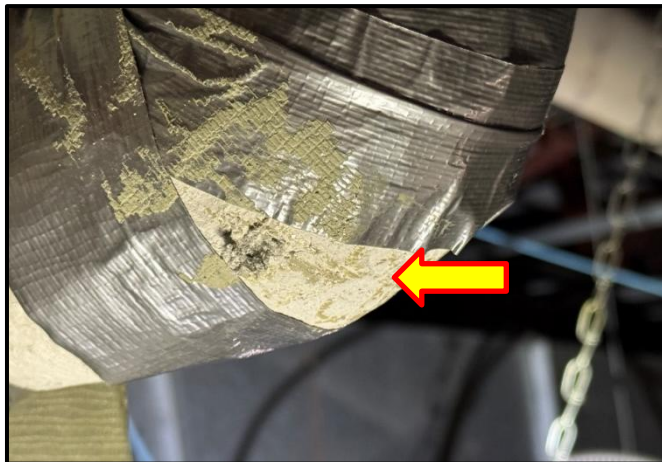
Photograph 7: View of damaged asbestos-containing paring cement mechanical pipe fitting observed in the ceiling space of Room D101D.

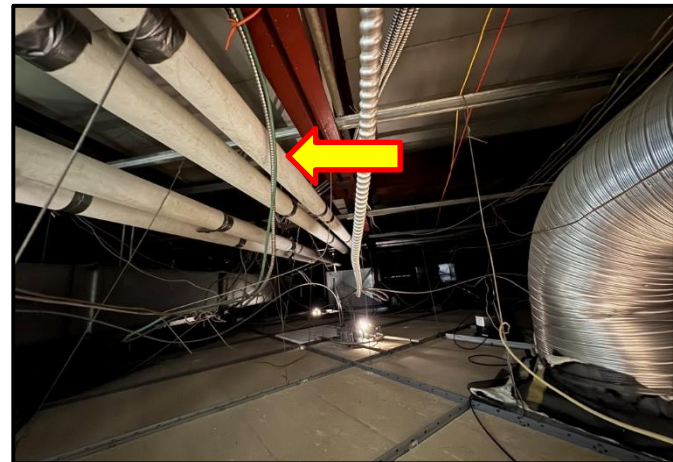
Photograph 8: View of asbestos-containing aircell pipe insulation observed on mechanical pipe straight runs in the ceiling of Room D101D.

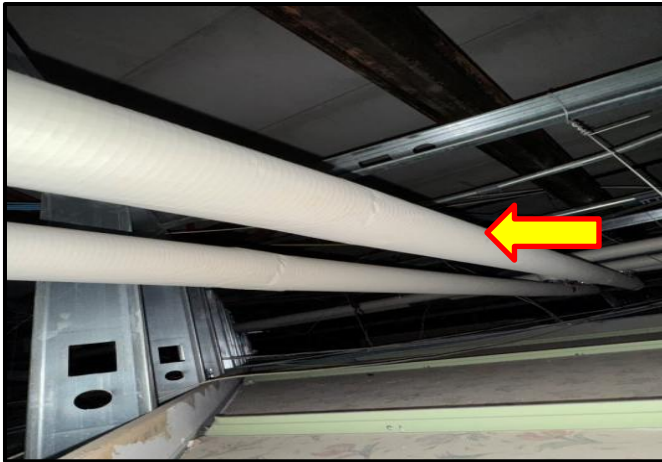
Photograph 9:View of non-asbestos containing fiberglass insulation observed on mechanical pipe straight runs throughout the building.

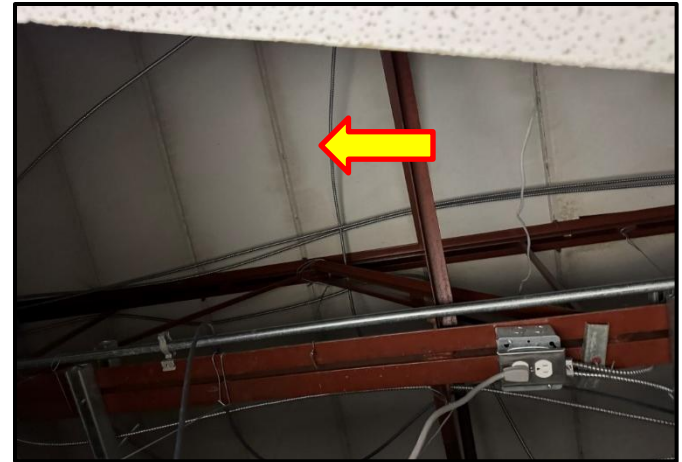
Photograph 10:View of presumed ACM siporex observed above ceiling spaces throughout the building.

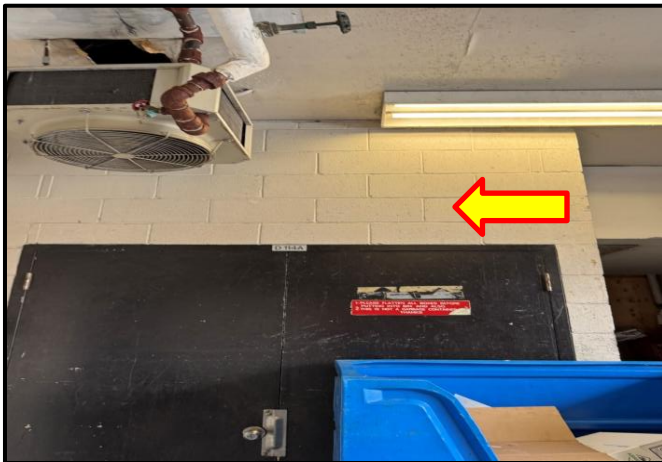
Photograph 11:View of lead-containing beige paint observed on block walls in Room D114.

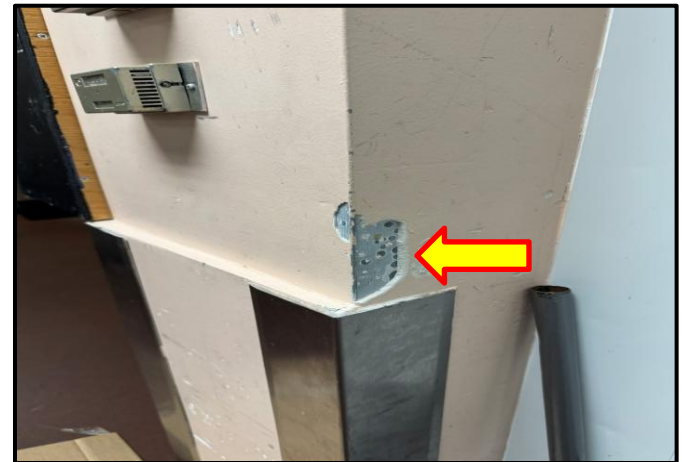
Photograph 12:View of damaged asbestos-containing drywall in Room 112.

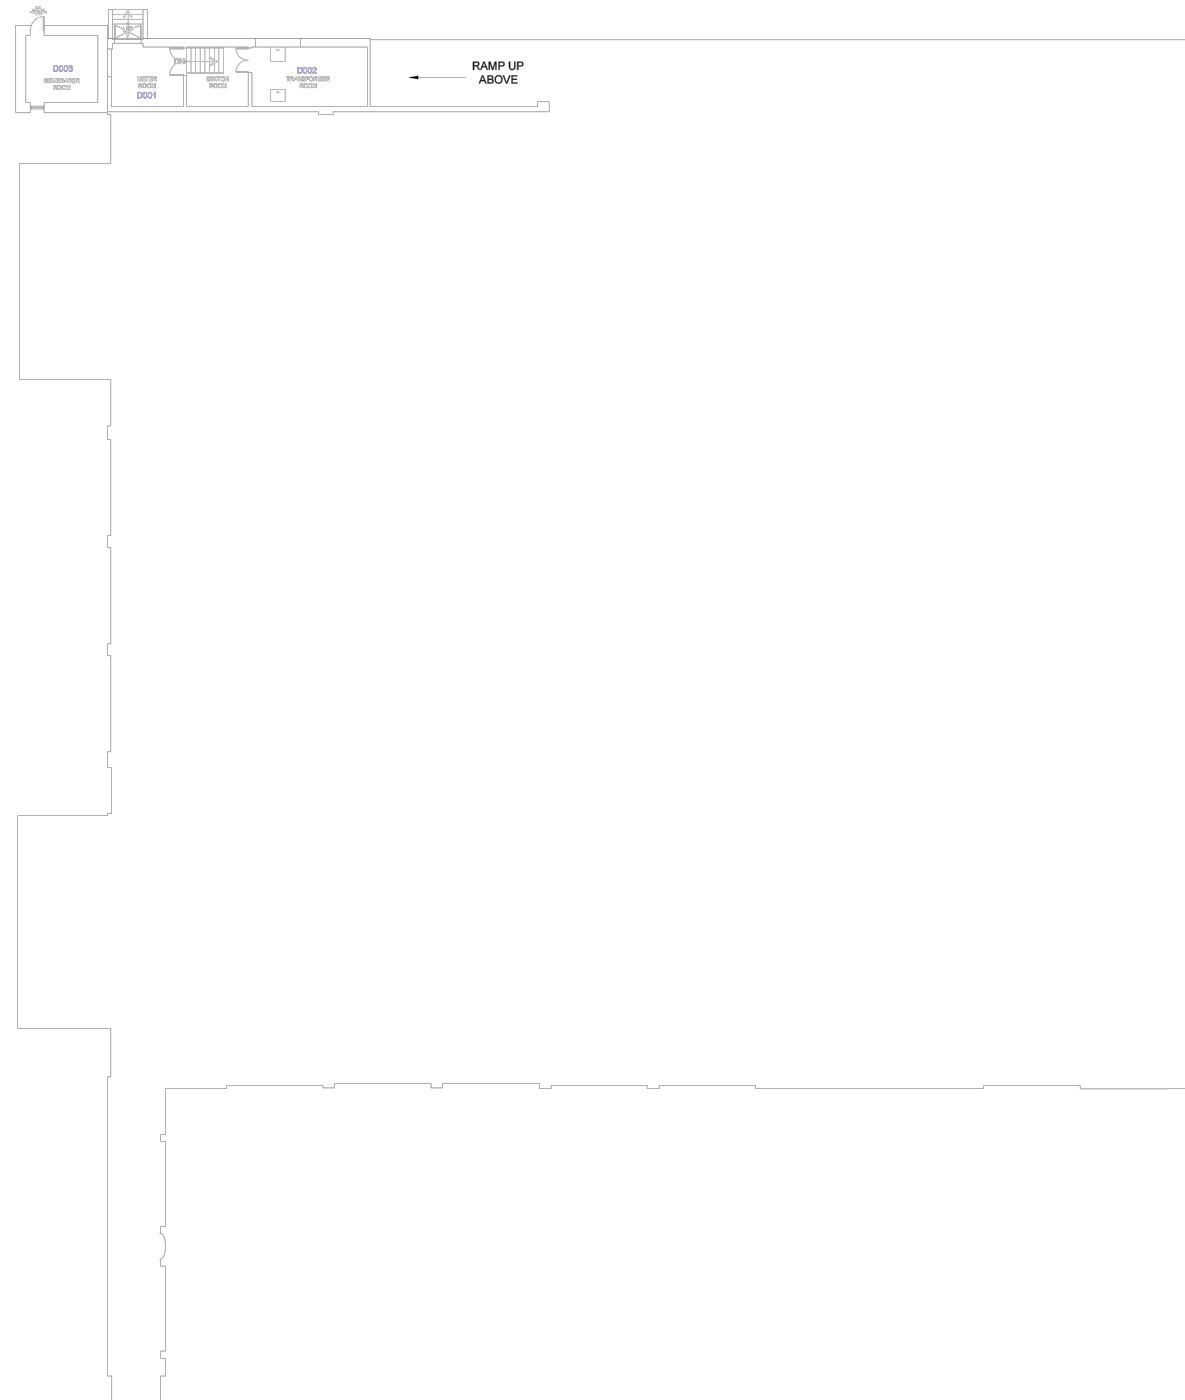
**cm3**  
 environmental  
 5710 AKINS ROAD, OTTAWA, ON  
 K2S 1B8

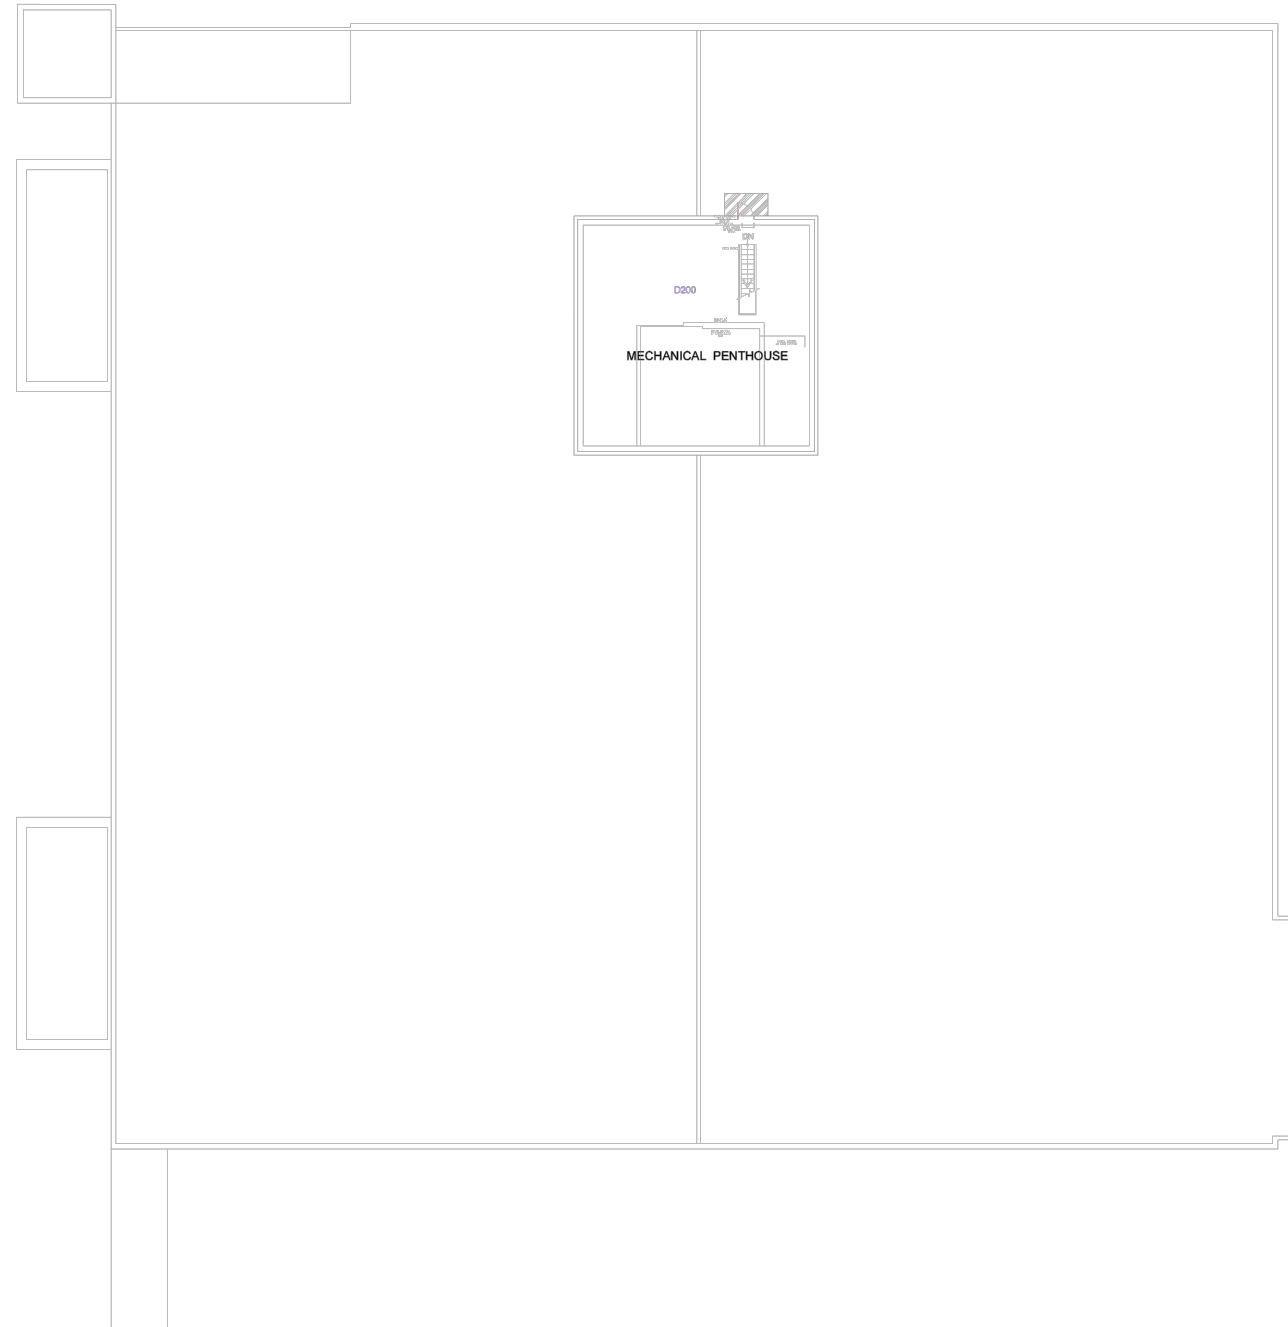
- LEGEND**
- ASBESTOS BULK SAMPLE LOCATION 2024
  - ▲ LEAD BULK SAMPLE LOCATION 2024
