DESIGNATED SUBSTANCES AND HAZARDOUS MATERIALS REPORT
Building B, Algonquin College Ottawa Campus
1385 Woodroffe Avenue, Ottawa, Ontario

March 2026

CM3 Project: TC1738

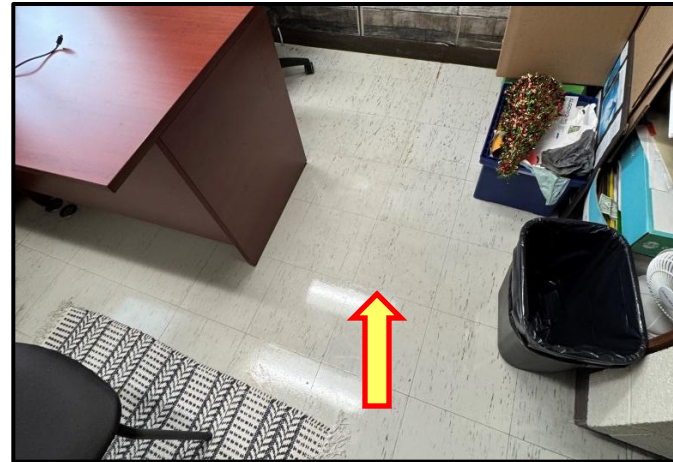
Photograph 2: View of asbestos-containing 12"x12" grey vinyl floor tiles.

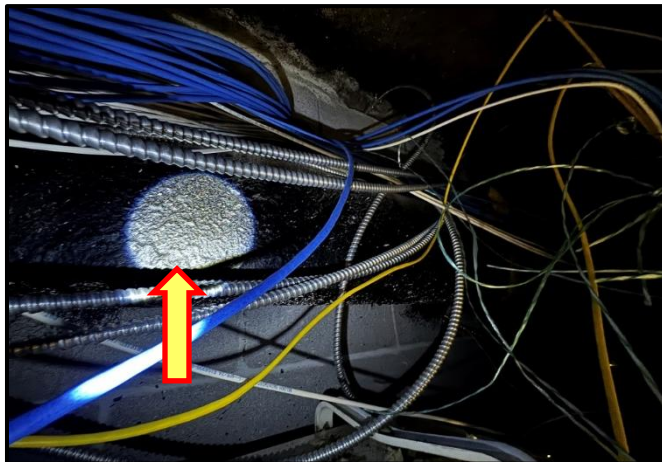
Photograph 3: View of asbestos-containing mastic observed on ductwork above ceiling spaces throughout the building.

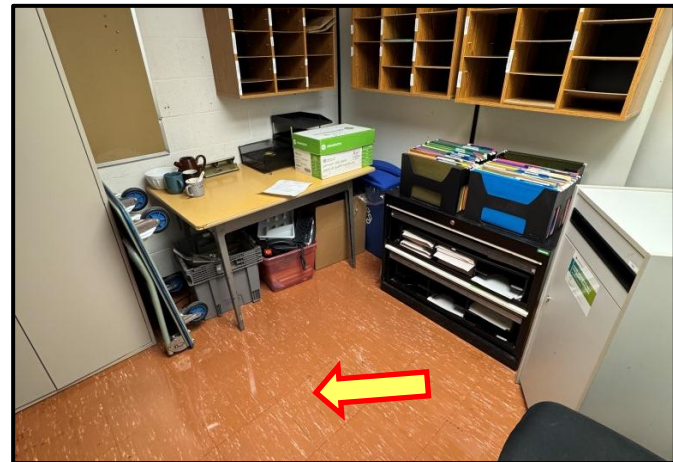
12"x12" red/orange vinyl floor tiles were observed to be in GOOD condition throughout the building at the time of the assessment.

Photograph 4: View of asbestos-containing 12"x12" red/orange vinyl floor tiles observed in Room B136S.

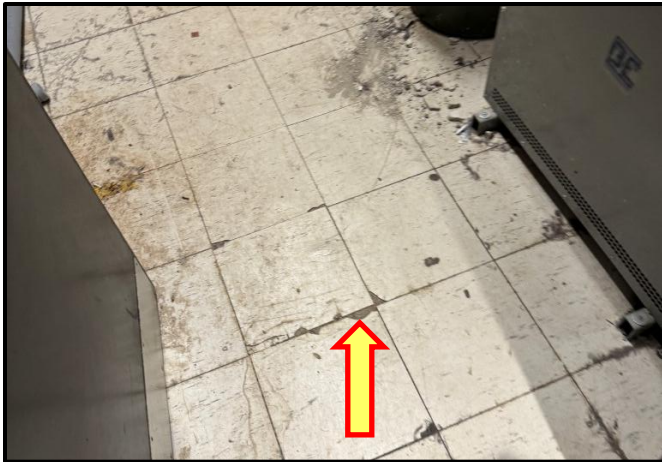
12"x12" grey vinyl floor tiles were observed to be in GOOD to POOR condition throughout the building during the assessment. Approximately 5 damaged tiles were observed in Room B362, and further tiles were observed to be missing/removed. Approximately 30m² of damaged/removed tiles were observed in Room B167.

Photograph 5: View of asbestos-containing 12"x12" Grey vinyl tiles in poor condition in Room B167.

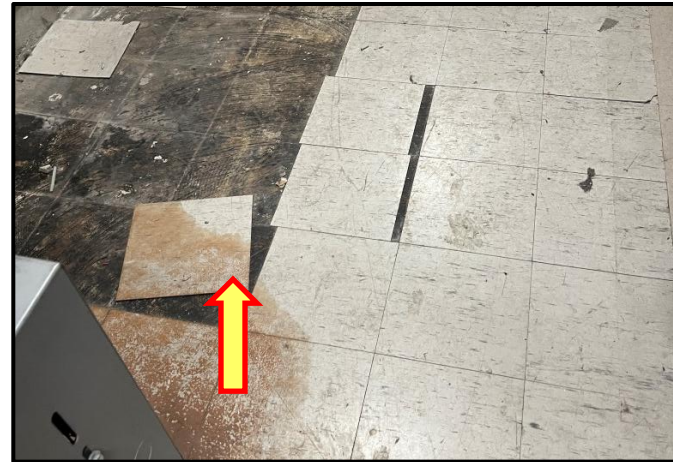
Photograph 6: View of asbestos-containing 12"x12" Grey vinyl floor tiles in poor in Room B362.

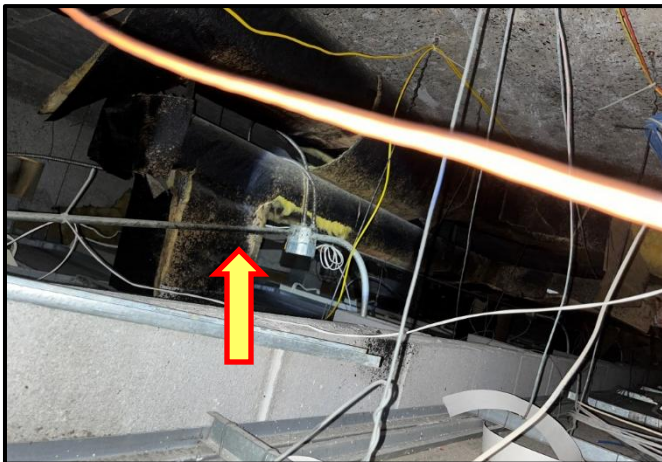
Photograph 7: View of asbestos-containing black tar in poor condition observed on ductwork in the ceiling space of Room B311A.

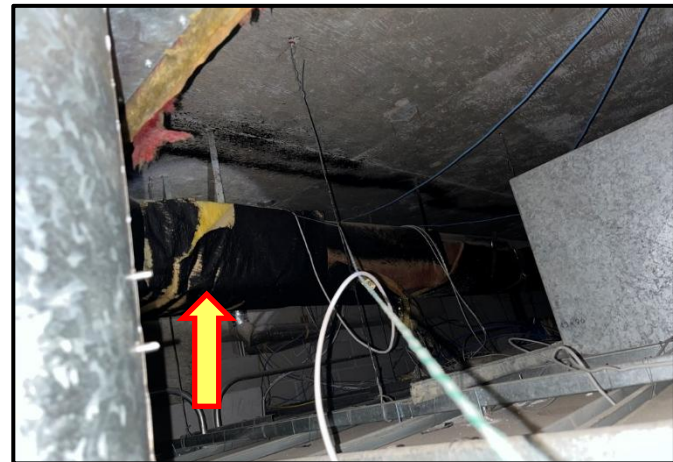
Photograph 8: View of asbestos-containing black tar in poor condition observed on ductwork in the ceiling space of Room B302.

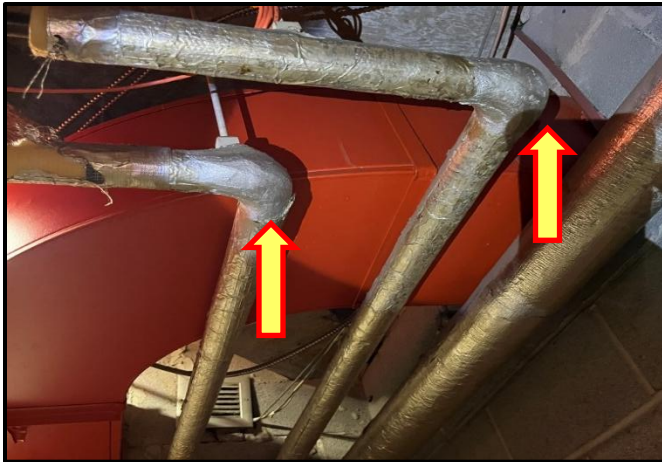
Photograph 9: View of asbestos-containing silver pipe elbow fittings observed in Room B301.

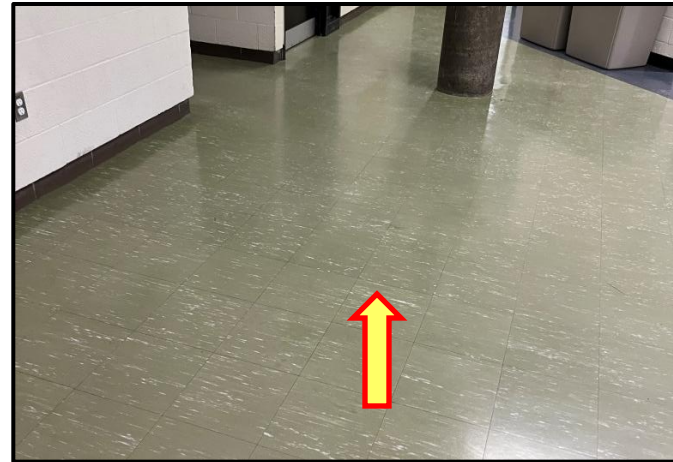
12"x12" green vinyl floor tiles were observed to be in GOOD condition throughout the building at the time of the assessment.

Photograph 10: View of asbestos-containing 12"x12" green vinyl floor tiles.

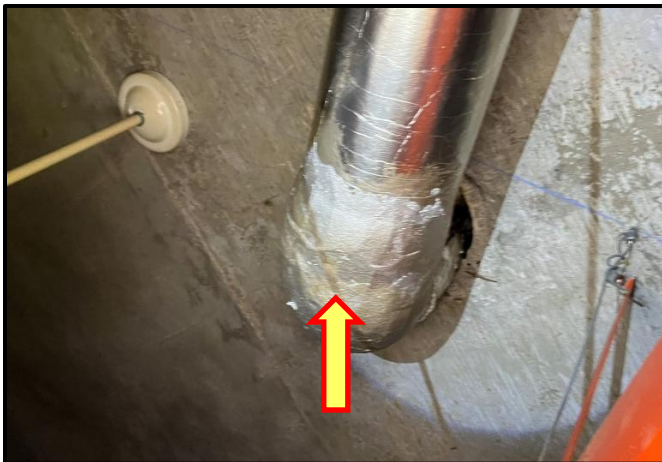
Photograph 11: View of asbestos-containing silver pipe elbow fitting observed in the ceiling space of Room B419.

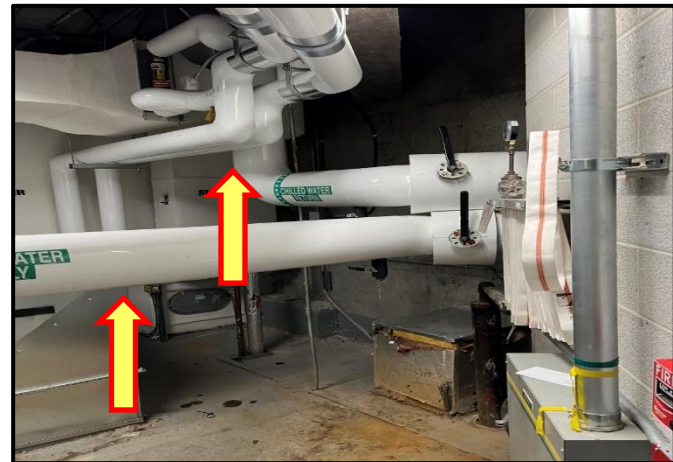
Photograph 12: View of non-asbestos fiberglass and PVC insulation observed on mechanical pipes within the mechanical penthouse.

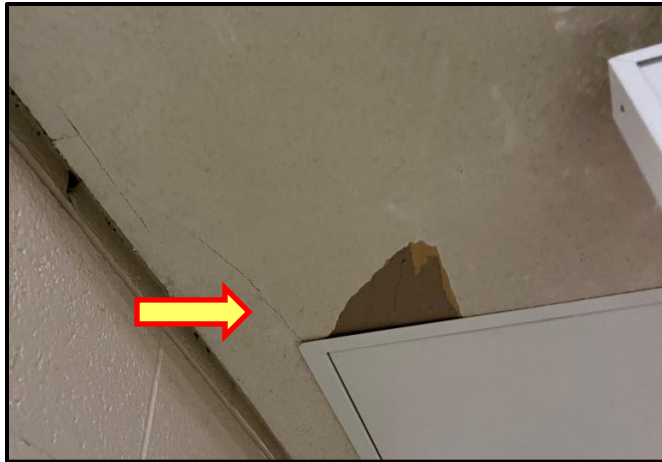
Ceiling stipple has previously been sampled throughout the building and confirmed through laboratory analysis to be an asbestos-containing material. Ceiling stipple is considered a non-friable asbestos-containing material and was observed to be in GOOD to POOR condition at the time of the assessment. Approximately 1m^2 of damaged ceiling stipple was observed in several locations throughout the building, including the first-floor corridor outside Room B115b, second-floor corridor between Room B234a and 234d, fourth-floor corridor outside Room B443, Room B210d and Room B191.

Photograph 13:View of asbestos-containing ceiling stipple observed in poor condition in the corridor outside Room B443.

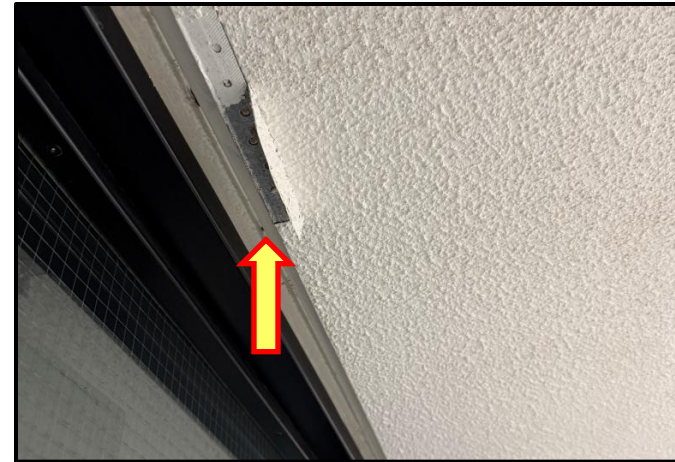
Photograph 14:View of damaged asbestos-containing ceiling stipple observed in the corridor outside Room B115B.

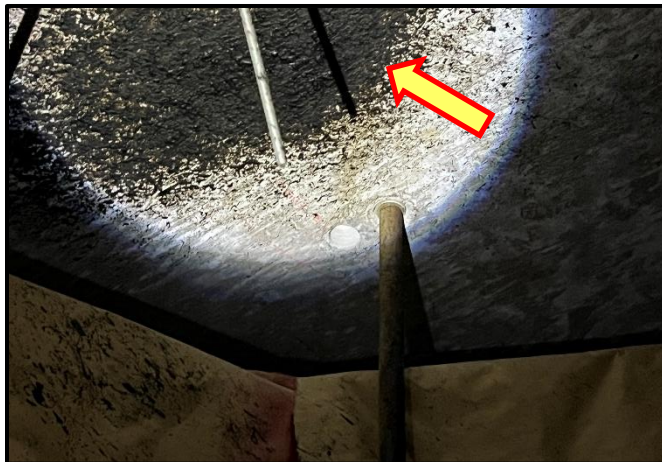
Photograph 15:View of excess asbestos-containing black tar observed on the concrete deck in the ceiling space of the corridor outside Room B419.

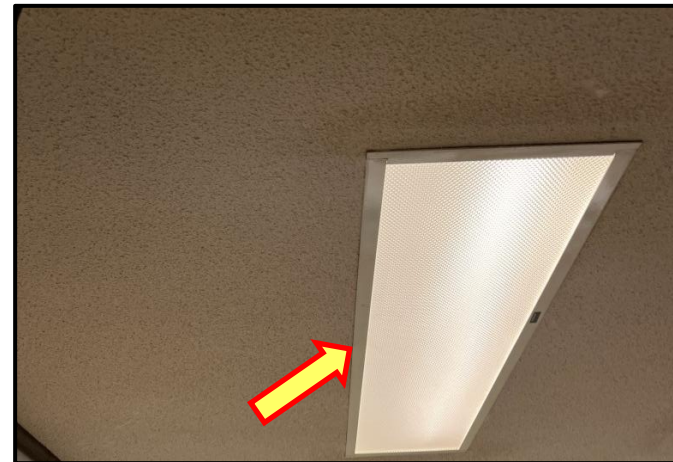
Mercury	<p>Mercury vapour is assumed to be present within fluorescent light tubes bulbs that are located in the subject building.</p> <p>Mercury may also be found in stable form in paints and adhesives.</p>	<p>If work on mercury containing materials is likely to produce mercury dust or fumes, for example during welding, torch cutting, grinding, sanding or sandblasting, then proper precautions should be followed.</p> <p>Prior to demolition, all fluorescent light tubes should be packaged and removed by a licensed contractor.</p>

Photograph 16:Typical view of mercury containing fluorescent lighting observed throughout the building.

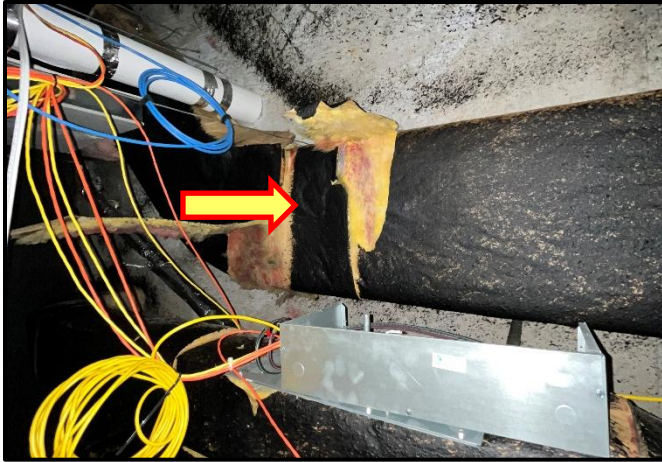
Photograph 17:View of asbestos-containing black tar on ductwork insulation observed in poor condition in the ceiling space of the corridor outside Room B414S.

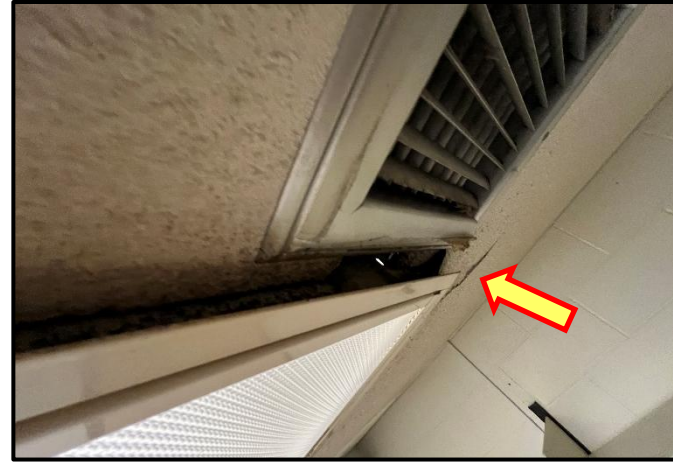
Photograph 18:View of asbestos-containing ceiling stipple observed in poor condition in the corridor outside Room B439.
