DESIGNATED SUBSTANCES AND HAZARDOUS MATERIALS REPORT
Building C, Algonquin College Ottawa Campus
215 Adjudjak Private, Ottawa, Ontario

DESIGNATED SUBSTANCES AND HAZARDOUS MATERIALS REPORT
Building C, Algonquin College Ottawa Campus
215 Adjidjak Private
Ottawa, Ontario

March, 2026

CM3 Project: TC1738

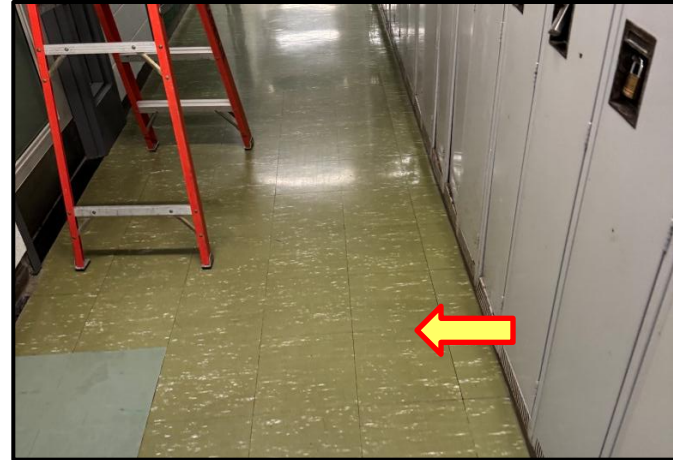
Photograph 2: View of asbestos-containing green 12"x12" vinyl floor tiles observed in the second-floor corridor.

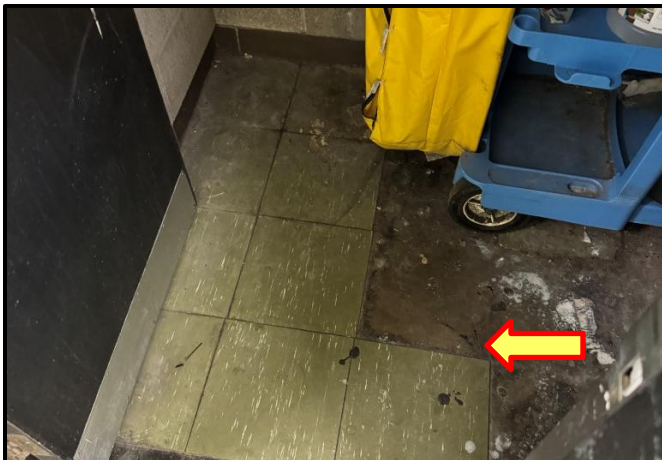
12"x12" Green vinyl floor tiles were observed to be in GOOD to POOR condition at the time of the assessment. Approximately 1 damaged tile was observed in Room C232 and several tiles observed to have been removed.

Photograph 3: View of damaged asbestos-containing green 12"x12" vinyl floor tiles observed in Room C232.

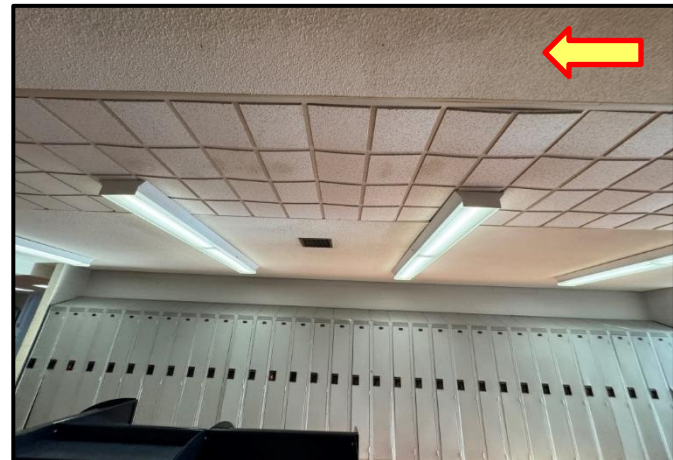
Ceiling stipple finishes throughout the building have previously been sampled and confirmed to contain asbestos. Ceiling stipple is considered a non-friable asbestos-containing material and was observed to be in GOOD condition at the time of the assessment.

Photograph 4: View of asbestos-containing ceiling stipple observed in the third-floor hallway.

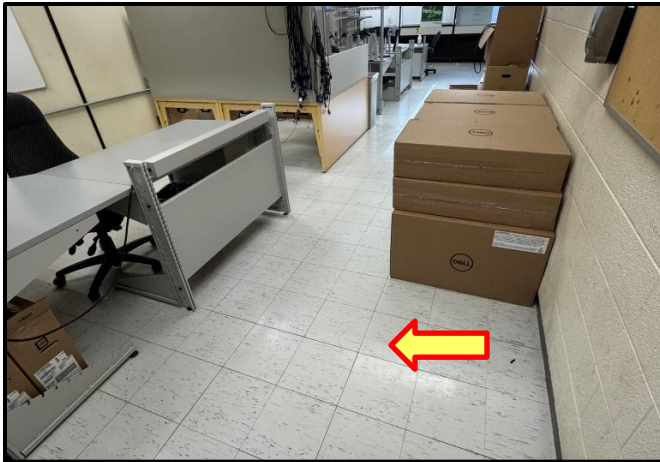
12"x12" Grey vinyl floor tiles with black streaks were observed to be in GOOD condition at the time of the assessment.

Photograph 5: View of the asbestos-containing grey 12"x12" vinyl floor tiles observed in Room C340.

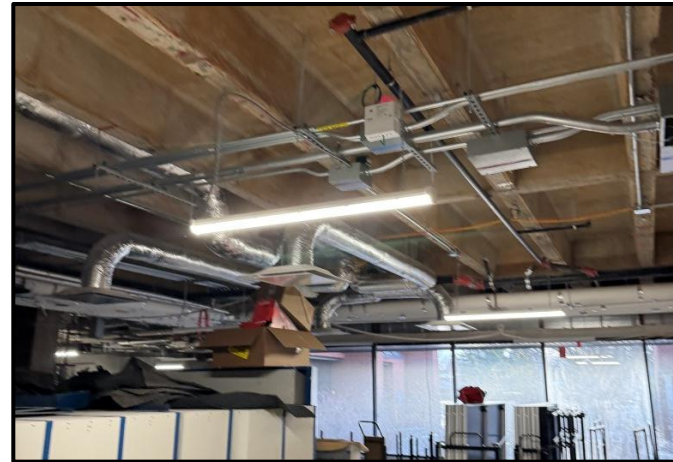
During the site assessment it was observed that the basement and large areas of the first, second and third floor had undergone renovation work in recent years. Therefore, the materials observed posed no concern with regards to asbestos content.

Photograph 6: View of Room C154 that is currently under construction and has been stripped back to base building materials.

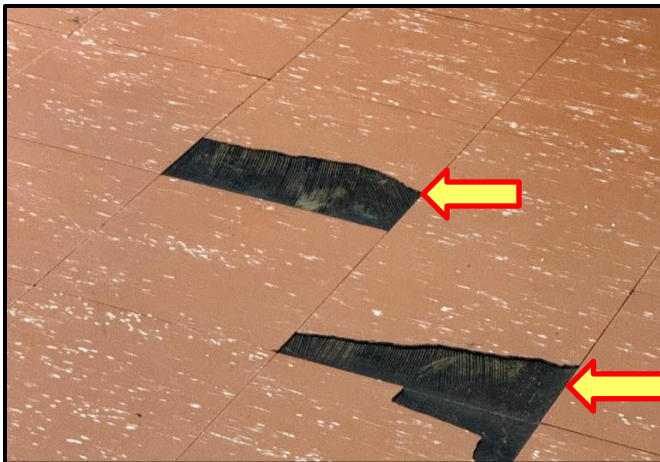
12"x12" Red vinyl floor tiles were observed in POOR condition in the corridor outside Room C346. Approximately 20+ tiles were observed to be damaged.

Photograph 7: View of asbestos-containing 12"x12" red vinyl floor tiles observed in poor condition in the corridor outside Room C346.

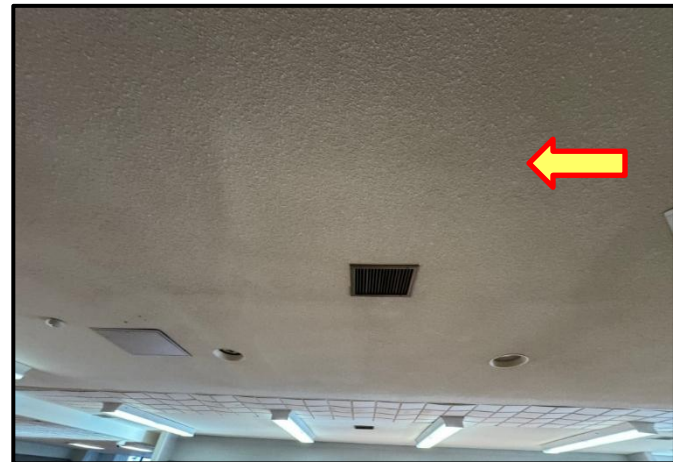
Photograph 8: View of asbestos-containing ceiling stipple observed in Room C348.

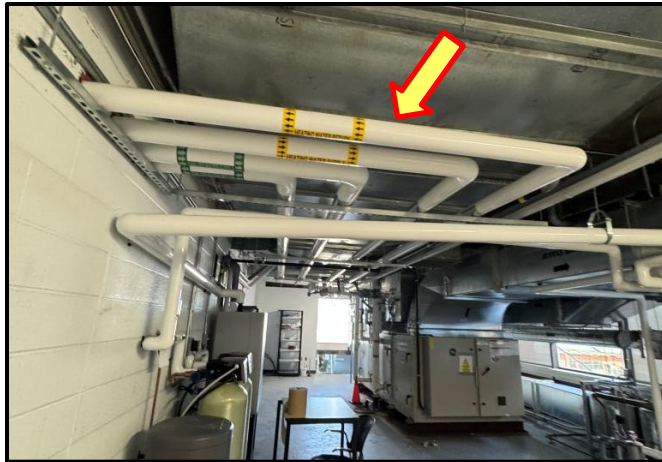
Photograph 9:View of the non-asbestos containing fiberglass and PVC pipe insulation observed in Room C341.

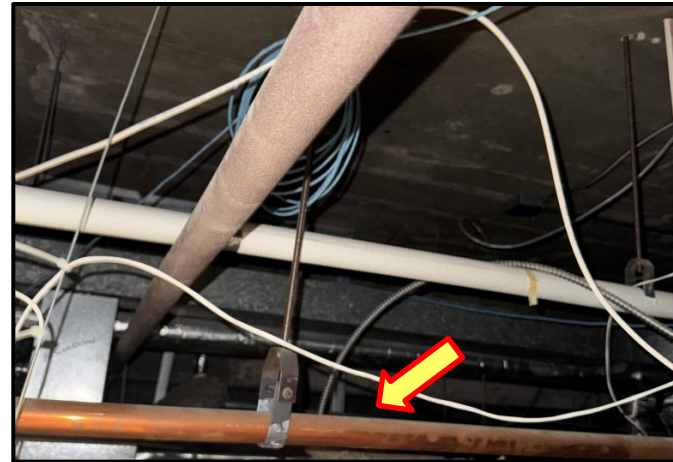
Photograph 10:View of potentially lead-containing copper piping observed throughout the building.

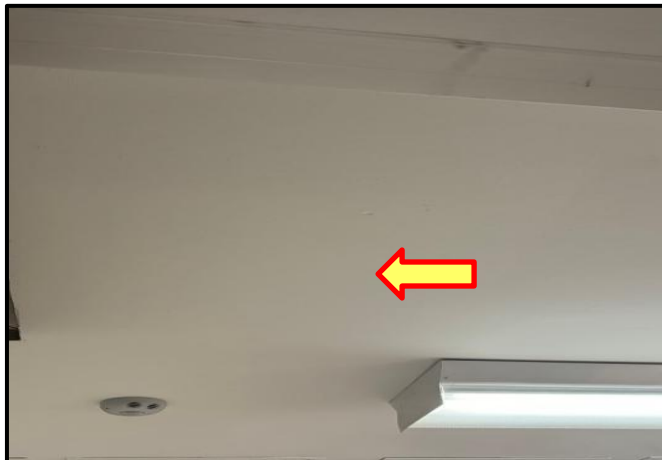
Drywall joint compound ceiling finishes throughout the building have previously been sampled and confirmed to contain asbestos. Drywall joint compound is considered a non-friable asbestos-containing material and was observed to be in GOOD condition at the time of the assessment.

Photograph 11:View of asbestos-containing drywall joint compound observed on the ceiling of Room C526.

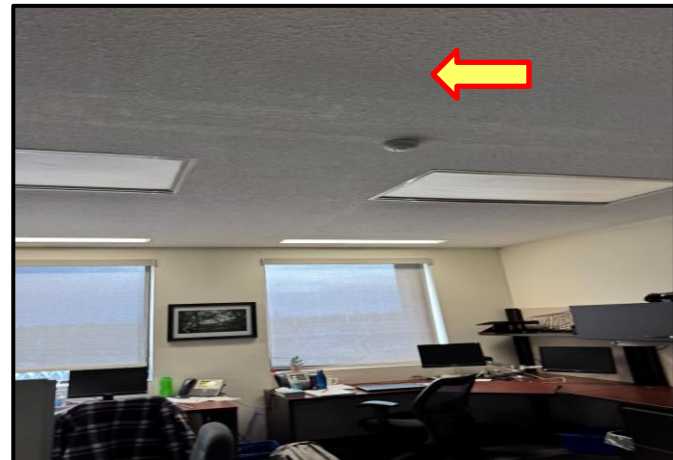
Photograph 12:View of asbestos-containing ceiling stipple observed in Room C530.

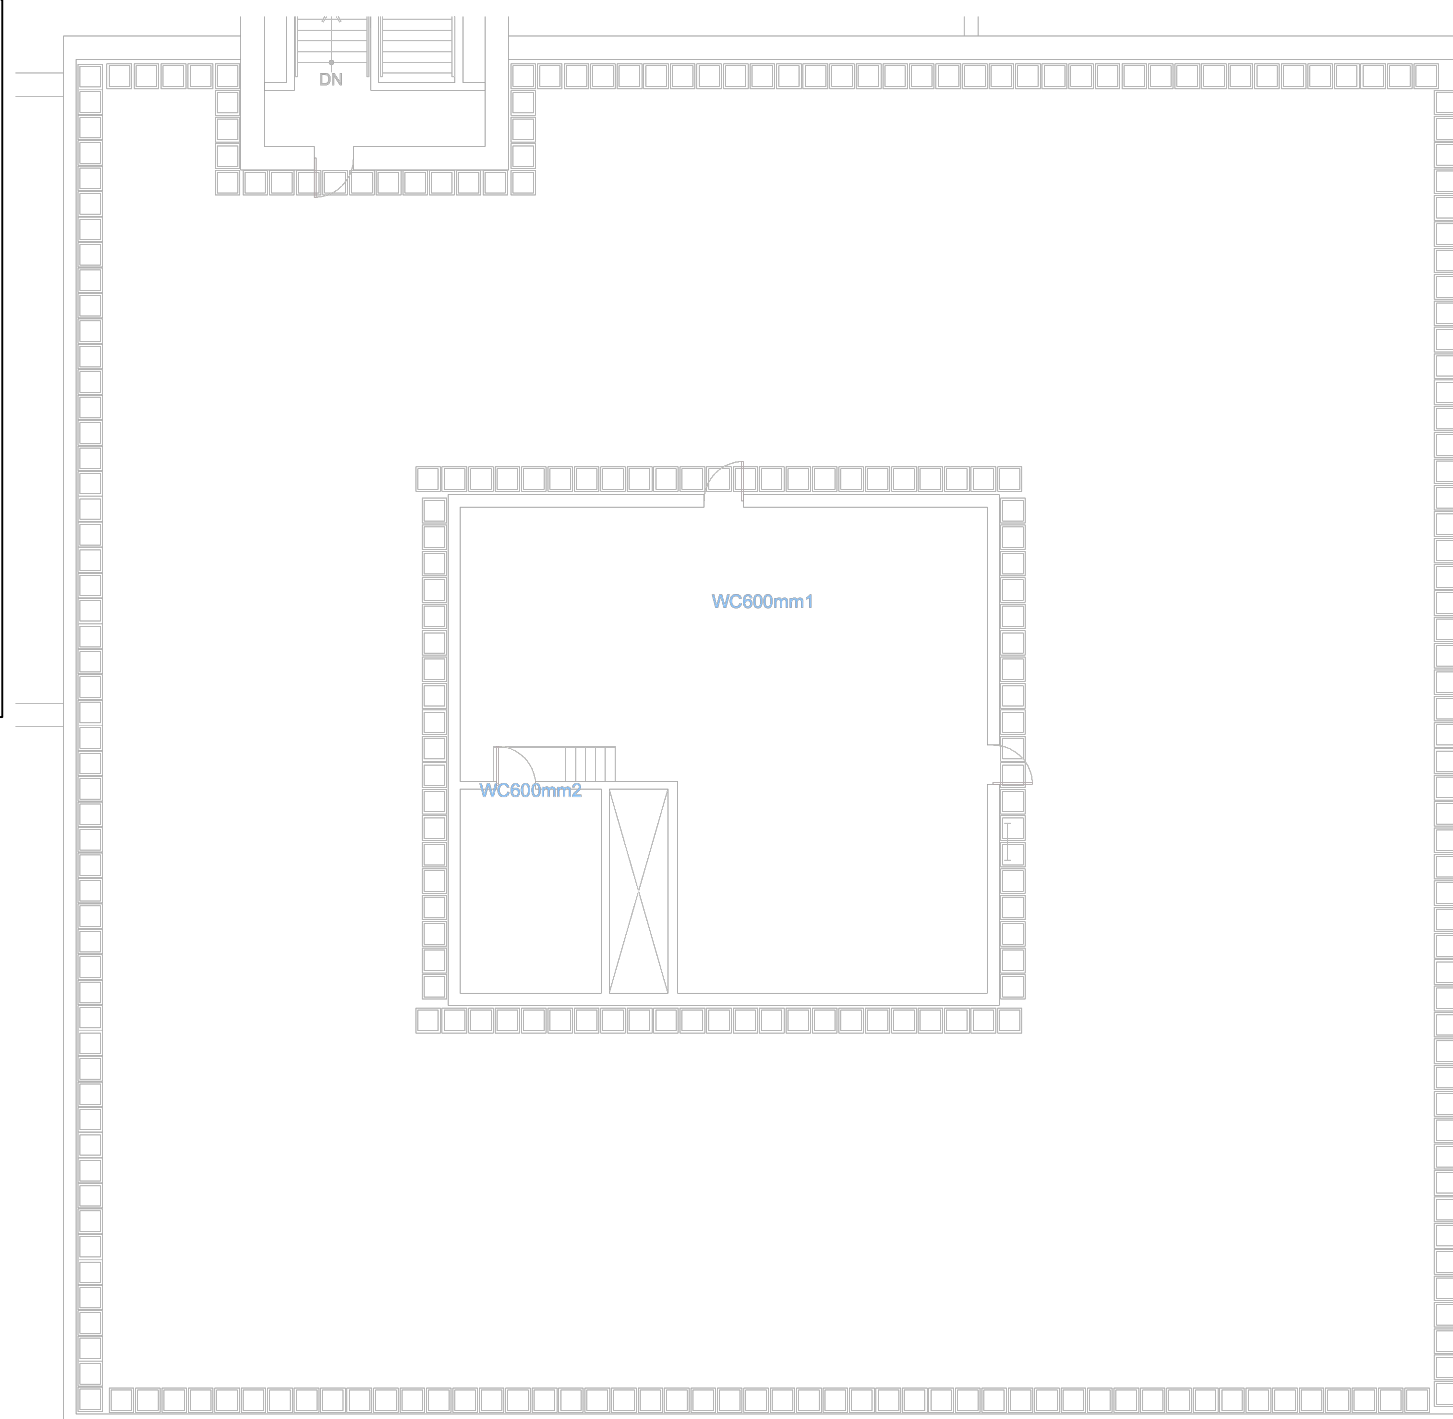
SIXTH FLOOR PLAN

NOTES:
 - NO ASBESTOS-CONTAINING MATERIAL WAS OBSERVED.
