DESIGNATED SUBSTANCES AND HAZARDOUS MATERIALS REPORT
Building F, Algonquin College Ottawa Campus
711 Wajashk Private, Ottawa, Ontario

March 2026

CM3 Project: TC1738

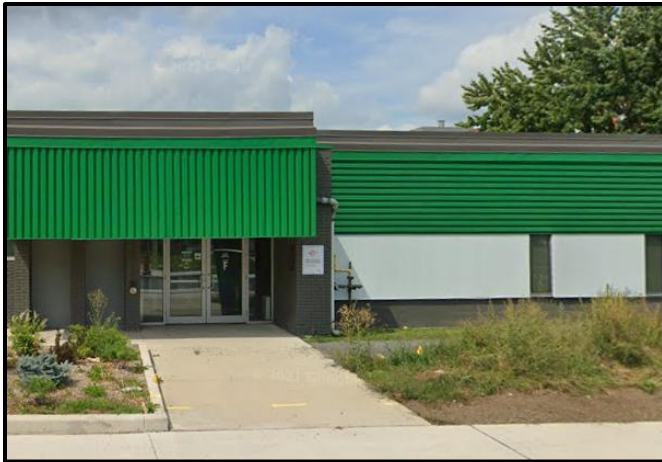
Photograph 1: Typical view of the exterior of the building.

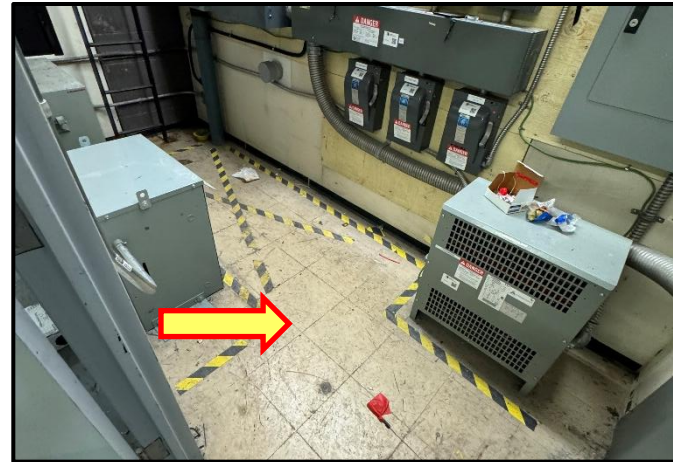
floor tiles are considered a non-friable asbestos containing material and was observed in POOR condition at the time of the assessment. Approximately 4 square meters of the asbestos-containing vinyl floor tiles were observed.

Photograph 2: View of the asbestos-containing 12"x12" beige vinyl floor tiles with white and black streaks observed in Room F113b.

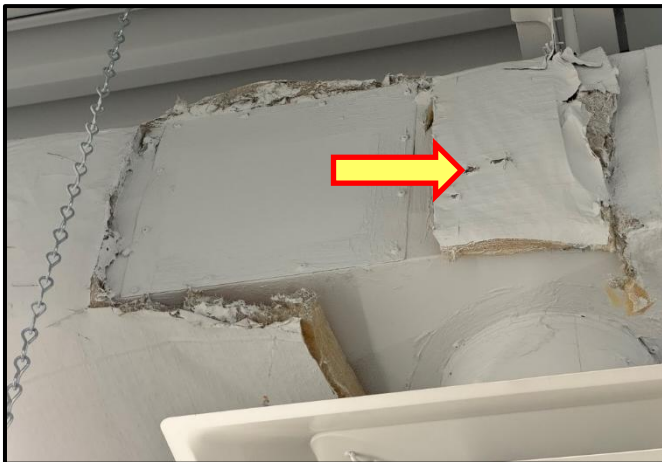
Photograph 3: Typical view of the non-asbestos fiberglass insulation observed on ductwork throughout the building.

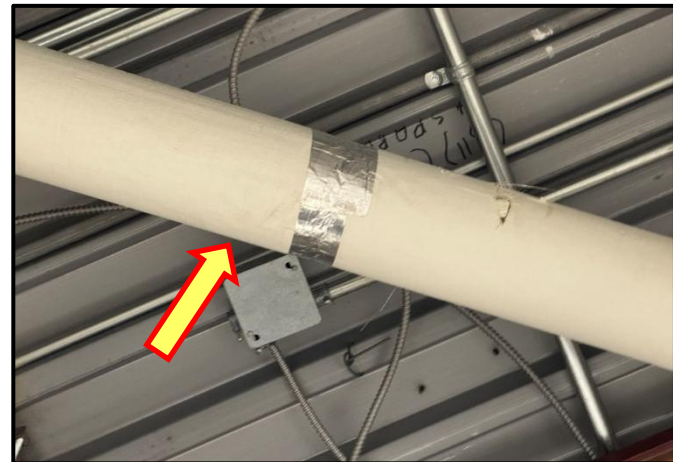
Photograph 4: Typical view of the non-asbestos fiberglass insulation observed on mechanical pipes throughout the building.

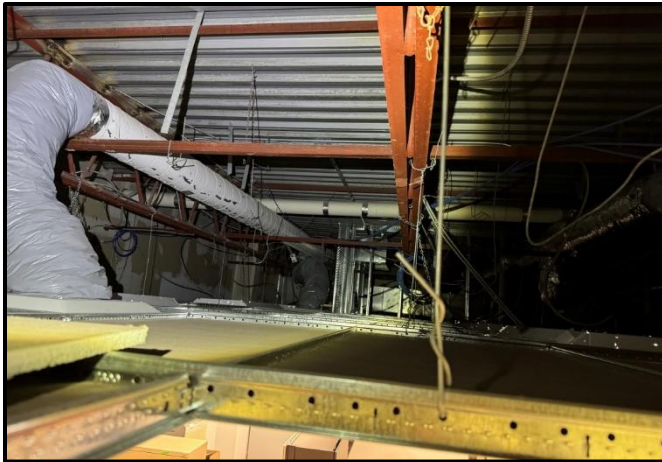
Photograph 5: Typical view of the ceiling spaces above the suspended grid system throughout the building.

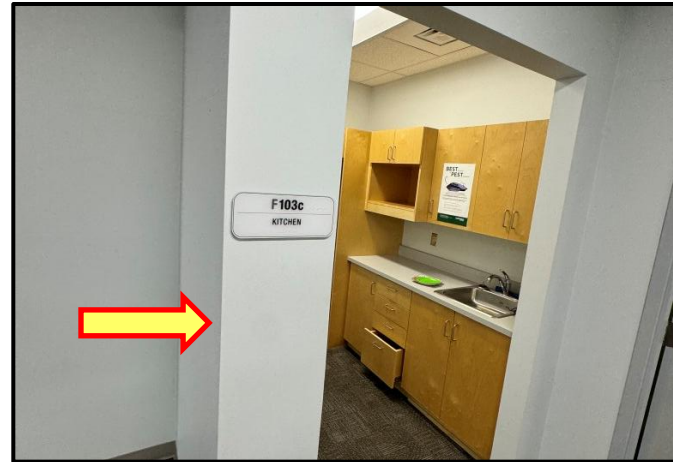
Photograph 6: View of non-asbestos containing drywall joint compound observed throughout the building.

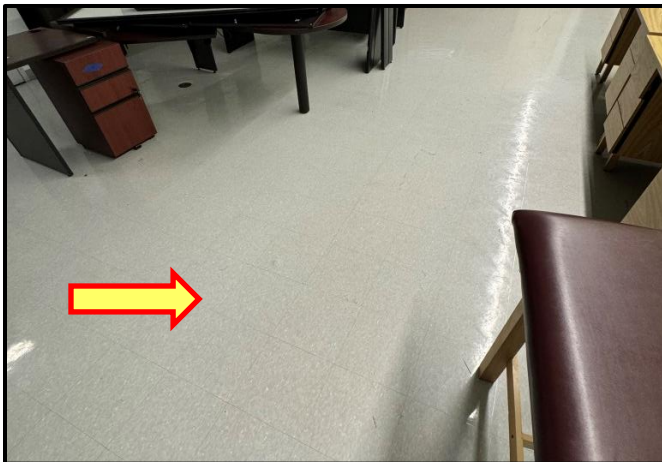
Photograph 7: View of the non-asbestos 12"x12" grey vinyl floor tiles with black and grey streaks observed in Room F102.

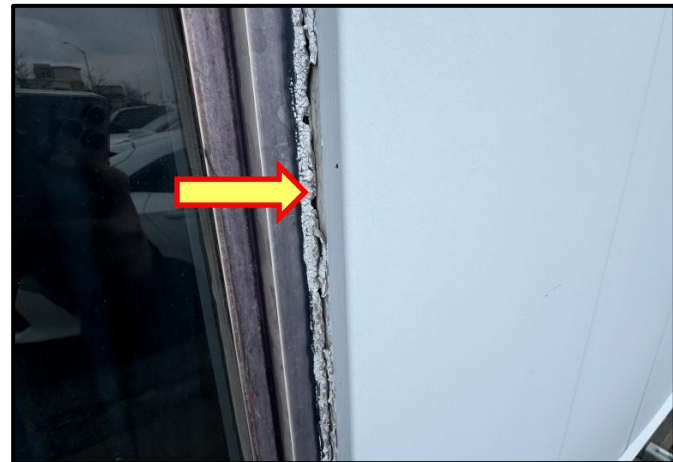
Three samples of caulking (ECLK-01A-C) were collected from around exterior windows and submitted for asbestos-content analysis. Analytical results indicate **10% Chrysotile asbestos** was detected in sample ECLK-01A in the brown layer of caulking. Caulking is considered a non-friable asbestos-containing material and was observed to be in GOOD to FAIR condition at the time of the assessment. Approximately 128 linear feet of caulking was observed to be present on exterior windows.

Photograph 8: View of asbestos-containing window caulking observed on exterior windows.
