CM3 File: TC1914

ANNUAL ASBESTOS CONTAINING MATERIALS REASSESSMENT – 2026
Building F, Ottawa Campus – 9558 Navaho Drive, Ottawa, Ontario

The site assessment was completed by CM3 on December 16, 2025, and represents the conditions at that time. No additional samples were collected as part of the re-assessment.

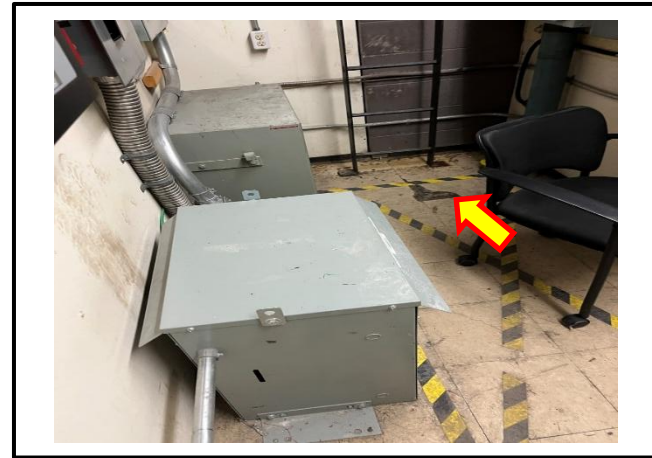
The majority of the ACMs identified throughout the buildings were observed to be in GOOD condition and can be managed in place at this time. The following ACMs were observed to be in deteriorating (FAIR) condition and require remedial action for compliance under O. Reg. 278/05:

- 12" x 12" Beige vinyl floor tiles with white and black streaks (3% Chrysotile asbestos)
 - Approximately 4 tiles were observed to be damaged/cracked in Electrical Room F113b.

Photograph 2: View of the damaged asbestos-containing beige vinyl floor tiles observed in Electrical Room F113b.

Table 2: Recommendations and Applicable Actions		
Action Level	ACM	Location/Description
Action 3 – ACM removal required for compliance	12"x12" Beige vinyl floor tiles with white and black streaks	Electrical Room F113b – Approximately 4 tiles were observed to be damaged/cracked.
Action 7 – Routine surveillance	All other ACMs in GOOD condition	See Appendix A .

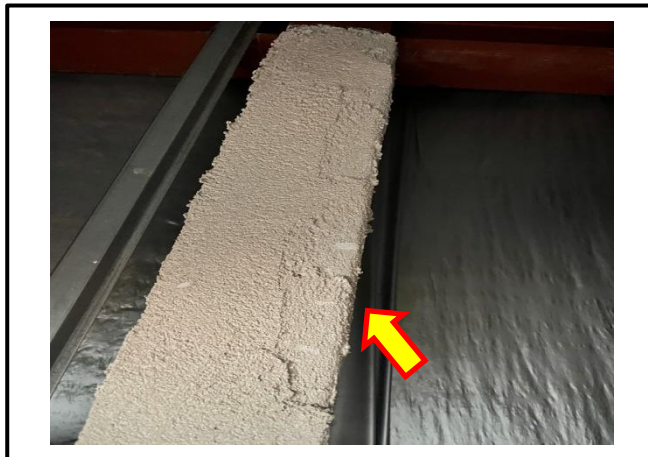
Photograph 3: View of the asbestos-containing textured plaster (Fireproofing) observed on structural beams throughout the building.

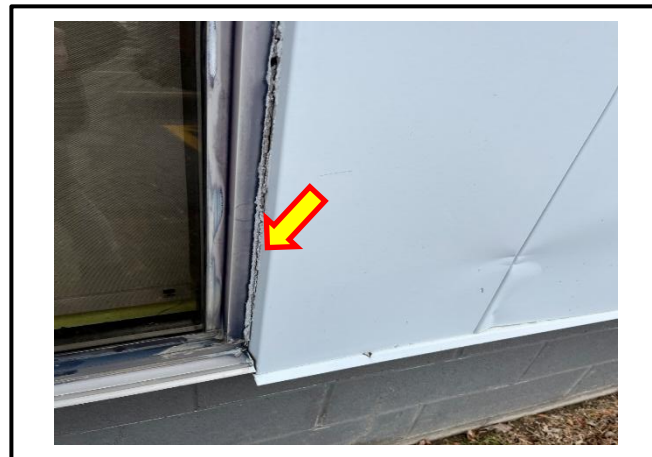
Photograph 4: View the asbestos-containing exterior window caulking observed on the exterior windows throughout the building.

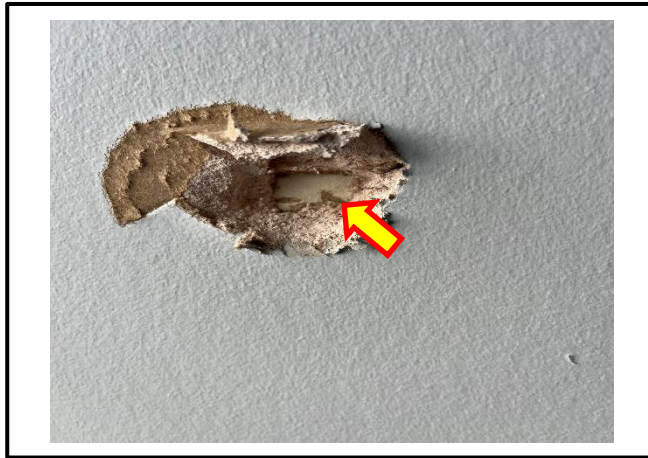
Photograph 5: View of the presumed asbestos-containing drywall observed under non-asbestos drywall throughout the building.

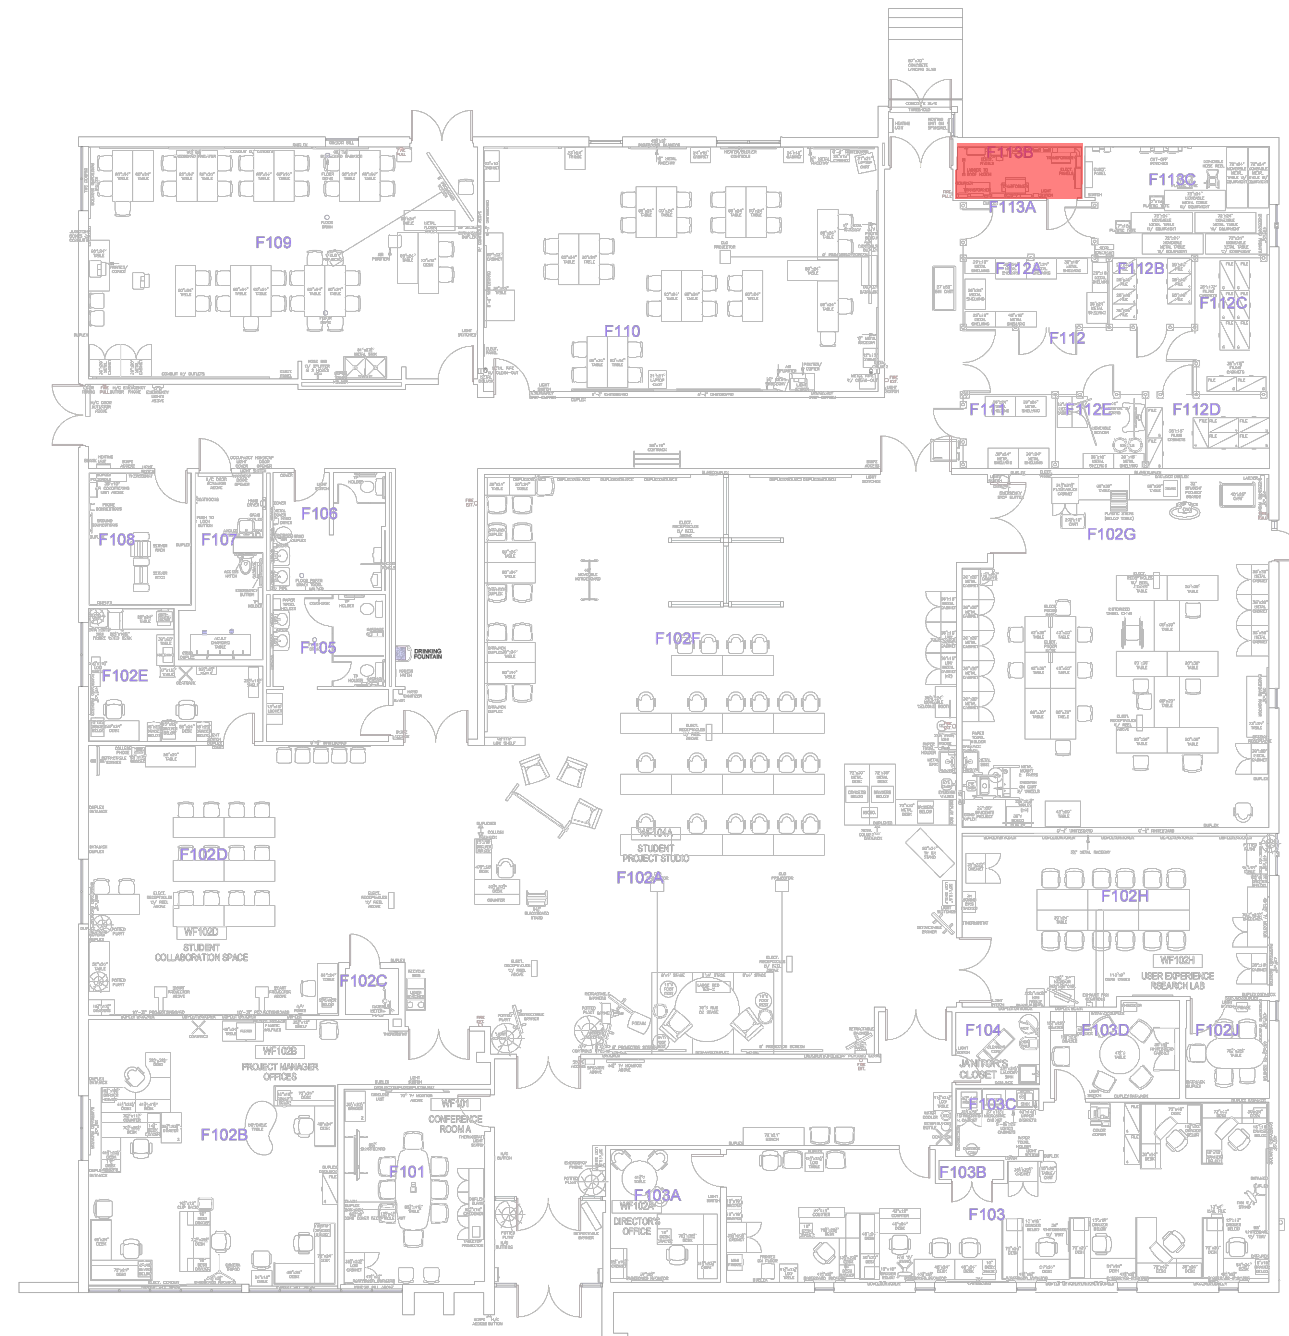
FIRST FLOOR PLAN

- ACM TEXTURED PLASTER PRESENT ON STRUCTURAL COLUMNS THROUGHOUT THE BUILDING.
- ACM EXTERIOR CAULKING PRESENT ON WINDOWS AND DOORS THROUGHOUT THE BUILDING.
- PRESUMED ACM DRYWALL JOINT COMPOUND PRESENT BEHIND NEW DRYWALL.
