March 31, 2026

CM3 File: TC1914

ANNUAL ASBESTOS CONTAINING MATERIALS REASSESSMENT – 2026
Building C, Ottawa Campus – 215 Adjidjak Private, Ottawa, Ontario

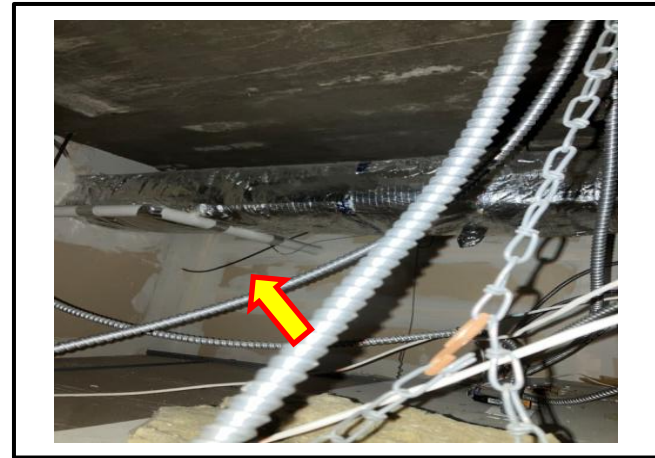
| ACM Inventory - Building C, Ottawa Campus – 215 Adjidjak Private, Ottawa, ON | | | | | | | | | | | |
|--|---|---|---|---|---|---|---|---|---|---|--|
| Clinic (C141) | Yes | Walls and Ceilings | Drywall Joint Compound | 1% Chrysotile | DJC-01A-E | Throughout | A | Good | NF | 7 | Routine Surveillance |

Photograph 2: View of the asbestos-containing drywall joint compound observed above the ceiling space in the first-floor clinic.

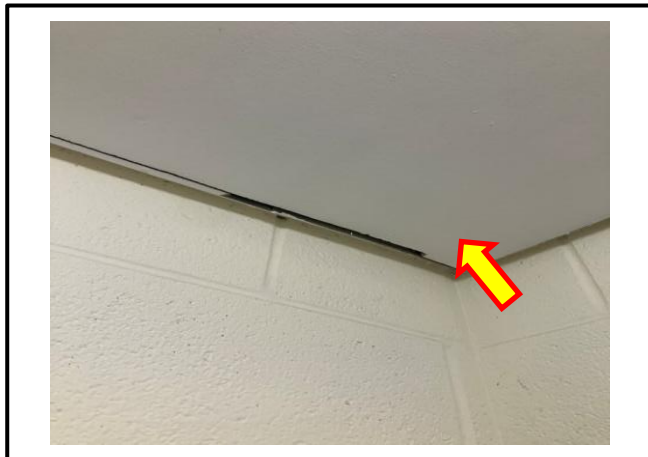
| ACM Inventory - Building C, Ottawa Campus – 215 Adjidjak Private, Ottawa, ON | | | | | | | | | | | |
|--|---|---|---|---|---|---|---|---|---|---|--|
| Clinic Vestibule | Yes | Ceilings | Joint Compound | 1% Chrysotile | JC-01A-C | 4m2 | C - Exposed | Good | NF | 7 | Routine Surveillance |

Photograph 3: View of the asbestos-containing joint compound observed on the gypsum board ceiling in the clinic vestibule.

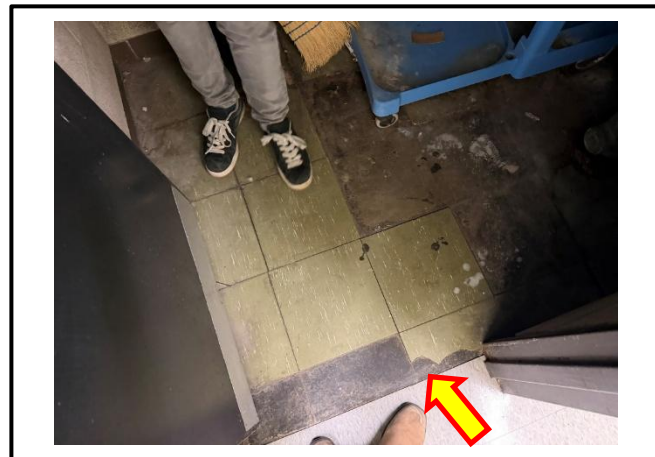
- 12"x12" vinyl floor tiles (Chrysotile)
 - Approximately less than 1m² of 12"x12" green vinyl floor tiles were observed in POOR condition in Room C232.

| ACM Inventory - Building C, Ottawa Campus – 215 Adjidjak Private, Ottawa, ON | | | | | | | | | | | |
|--|---|---|---|---|---|---|---|---|---|---|--|
| Room C232 | | | | | N/A | <1m2 | A | Poor | NF | 5/6 | Removal and / or repair of damaged vinyl floor tiles |

Photograph 4: View of damaged 12"x12" green vinyl floor tiles observed in Room C232.

| Table 2: Recommendations and Applicable Actions | | |
|---|---|---|
| | 12"x12" vinyl floor tile (Green) | Damaged vinyl floor tiles observed in Room C232. |

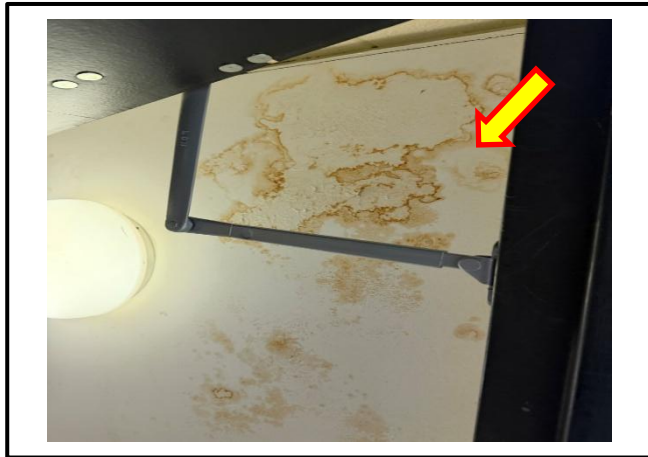
- Drywall joint compound (1-2% Chrysotile)
 - Drywall joint compound on the second floor observed in POOR condition in Room C231 and in the corridor opposite Room C215B.

| ACM Inventory - Building C, Ottawa Campus – 215 Adjidjak Private, Ottawa, ON | | | | | | | | | | | |
|--|---|---|---|---|---|---|---|---|---|---|--|
| Room C231 and in corridor opposite Room C215B | | | | | DJC-04A-C | Throughout | A | Poor | NF | 5/6 | Removal and / or repair or damaged drywall joint compound. Approximately less than 1m2 of damage in each location. |

Photograph 5: View of the damaged/moisture-stained drywall joint compound on the ceiling in Room C231.

| Table 2: Recommendations and Applicable Actions | | |
|---|---|---|
| Action 5 – Proactive ACM removal OR Action 6 – ACM repair required for compliance | Drywall joint compound | Damaged drywall joint compound observed in rooms and corridors throughout the building. |

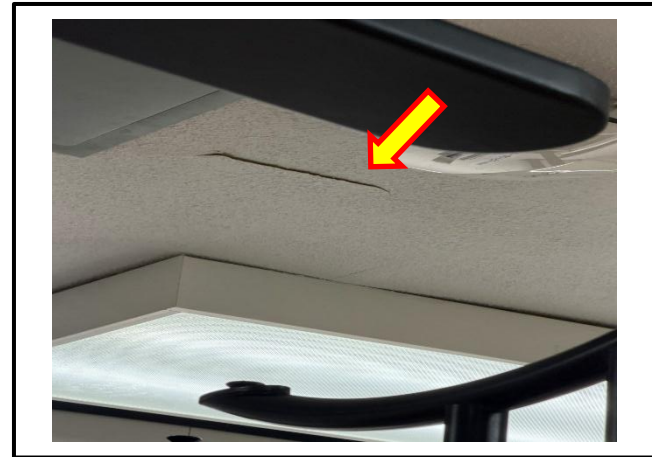
- Ceiling stipple on the second floor was observed in POOR condition in Rooms C215B, C215D and in the corridor outside Room C212C.
 - Ceiling stipple on the third floor was observed in POOR condition in Room C346.

| ACM Inventory - Building C, Ottawa Campus – 215 Adjidjak Private, Ottawa, ON | | | | | | | | | | | |
|--|---|---|---|---|---|---|---|---|---|---|--|
| Rooms C215B, C215D and Corridor outside Room C212C | | | | | N/A | N/A | C - Exposed | Poor | NF | 5/6 | Removal and / or repair of damaged ceiling stipple. Approximately less than 1m2 of damage in each location. |

Photograph 6: View of the damaged/delaminating asbestos-containing ceiling stipple observed in Room 215B.

| Table 2: Recommendations and Applicable Actions | | |
|---|---|---|
| | Ceiling stipple | Damaged ceiling stipple observed in rooms and corridors throughout the building. |

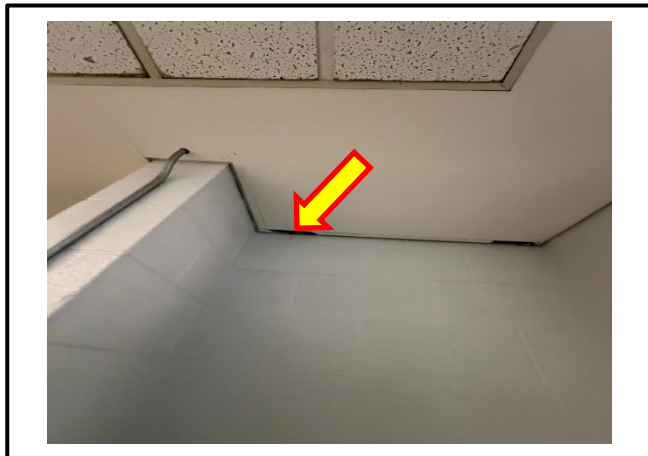
Photograph 7: View of the damaged asbestos-containing drywall joint compound observed

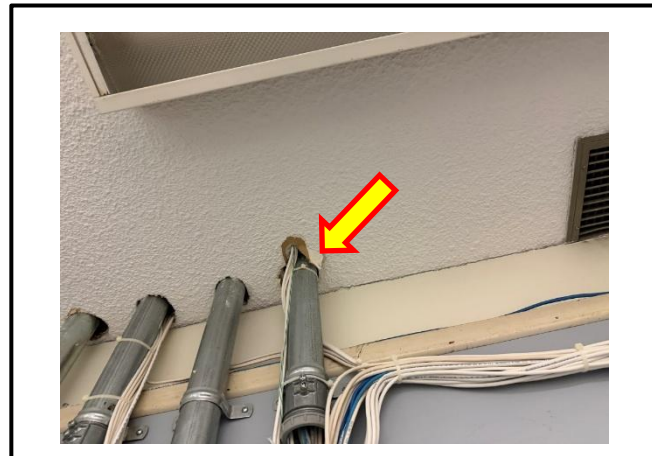
- Ceiling stipple on the fourth floor was observed in POOR condition in Rooms C430, C426B and in the corridor between Room C434 and the stairwell.
 - Ceiling stipple on the fifth floor was observed in POOR condition in Rooms C547, C546, C543, C545, C550, C534, C533, C531, C518, C507 and in sporadic locations throughout the corridors.

| ACM Inventory - Building C, Ottawa Campus – 215 Adjidjak Private, Ottawa, ON | | | | | | | | | | | |
|--|---|---|---|---|---|---|---|---|---|---|--|
| Room C430B, C426B and in Corridor between Room C434 and Stairwell | | | | | <1m2 | C - Exposed | Poor | NF | 5/6 | Removal and / or repair of damaged ceiling stipple. Approximately less than 1m2 of damage in each location. | |

Photograph 8: Typical view of the damaged asbestos-containing ceiling stipple observed throughout the fourth-floor corridor.

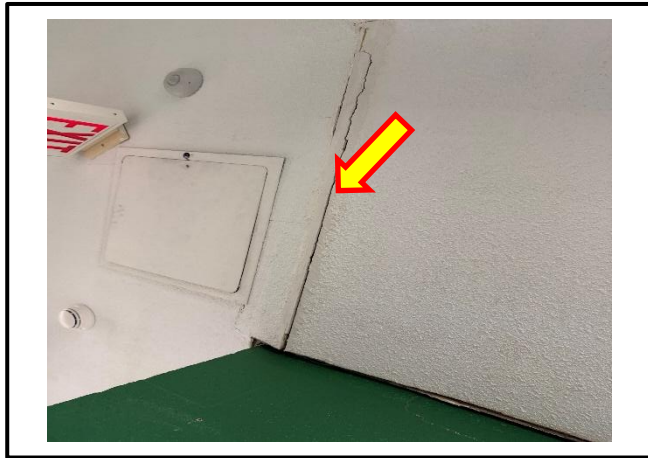
| ACM Inventory - Building C, Ottawa Campus – 215 Adjidjak Private, Ottawa, ON | | | | | | | | | | | |
|--|---|---|---|---|---|---|---|---|---|---|--|
| Room C547, C546, C543, C545, C550, C534, C533, C531, C518, C513, C507 and in sporadic locations throughout Corridors | | | | | <1m2 | C - Exposed | Poor | NF | 5/6 | Removal and / or repair of damaged ceiling stipple. Approximately less than 1m2 of damage in each location. | |

Photograph 9: Typical view of the damaged asbestos-containing ceiling stipple observed throughout the fifth-floor corridors.

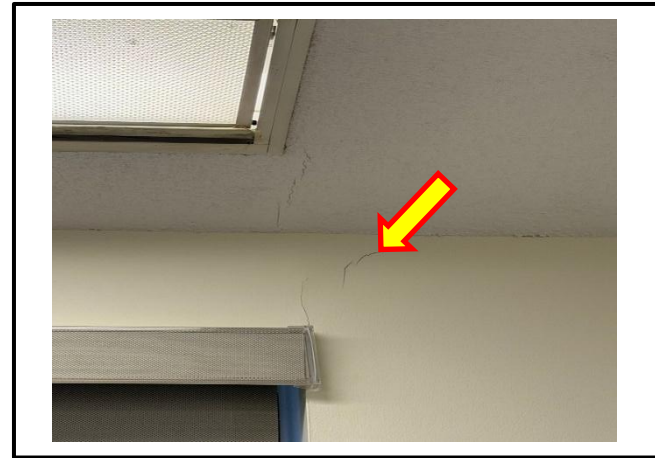
- Drywall joint compound on the fifth floor was observed in POOR condition in Rooms C505A, C530 and in the corridor between Rooms C535 and C548.
- Ceiling stipple (1-3% Chrysotile)

| ACM Inventory - Building C, Ottawa Campus – 215 Adjidjak Private, Ottawa, ON | | | | | | | | | | | |
|--|---|---|---|---|---|---|---|---|---|---|--|
| Room C505A, C530 and Corridor between Room C535 and C548 | | Walls | | | DJC-01A-E | <1m2 | A | Poor | NF | 5/6 | Removal and / or repair of damaged drywall joint compound. Approximately less than 1m2 of damage in each location. |

Photograph 10: View of the damaged asbestos-containing drywall joint compound observed in Room C530.
