March 31, 2026

CM3 File: TC1914

**ANNUAL ASBESTOS CONTAINING MATERIALS REASSESSMENT**  
**Building D, Ottawa Campus – 706 Wajashk Private, Ottawa, Ontario**

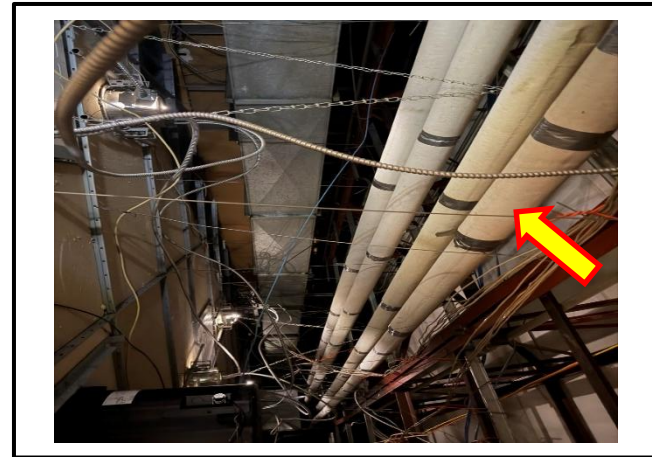
Photograph 2: View of the asbestos-containing airtell pipe insulation observed in the ceiling space of Room D101D.

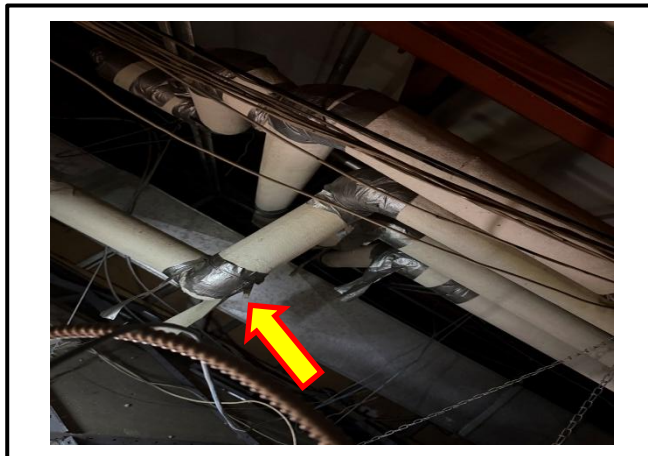
- Mechanical pipe insulation – Parging elbow fittings (55% chrysotile)
  - Approximately 8 fittings observed to be in POOR condition with damaged/exposed in the ceiling space of Room D101D. Applications of tape applied in attempt to encapsulate.
- Drywall joint compound (Chrysotile)
  - Drywall joint compound was observed in POOR condition in Rooms D101D, D106A, D106B, D108B, D114, D117, D119, the stairwell leading to the second-floor Mechanical Room and throughout the kitchen area. Damaged drywall was observed throughout the kitchen on corner beads and walls. Damaged drywall and debris was observed in the stairwell leading to the second floor Mechanical Room.
- 12"x12" vinyl floor tiles - Beige with black streaks (Chrysotile)
  - Approximately 8 tiles were observed damaged/cracked (POOR) in Room D117 and various tiles missing or removed.

Photograph 3: View of the damaged asbestos-containing paring cement elbows observed on mechanical pipes in the ceiling space of Room D101D.

Table 2: Recommendations and Applicable Actions		
Action 3 – ACM removal required for compliance	Mechanical pipe fitting insulation (parging cement elbows)	Ceiling space of Room D101D. Approximately 8 damaged/exposed fittings observed.
	Drywall joint compound	Rooms D101D, D106A, D106B, D108B, D114, D117, D119 and throughout kitchen area.
	12"x12" vinyl floor tiles (Beige with black streaks)	Approximately 8 damaged/cracked tiles observed in Room D117.
Action 7 – Routine surveillance	All other ACMs in GOOD condition	See <b>Appendix A</b> .

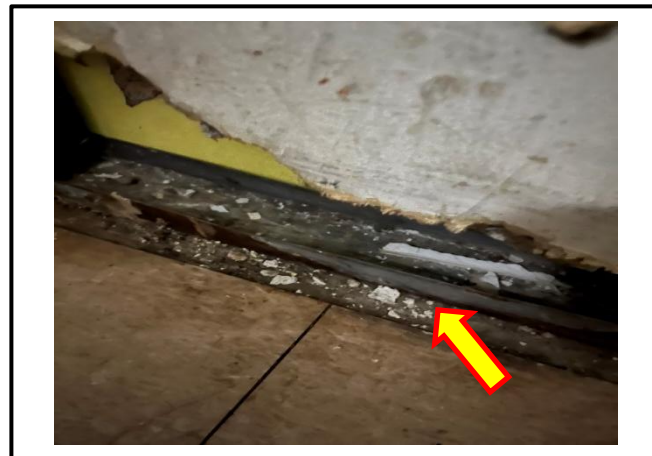
Photograph 4: View damaged asbestos –containing drywall and debris observed in the stairwell leading to the second-floor mechanical room.

Table 2: Recommendations and Applicable Actions		
Action Level	ACM	Location/Description
Action 1 – Immediate clean-up of debris that is likely to be disturbed	Drywall joint compound	Stairwell leading to the Mechanical room.

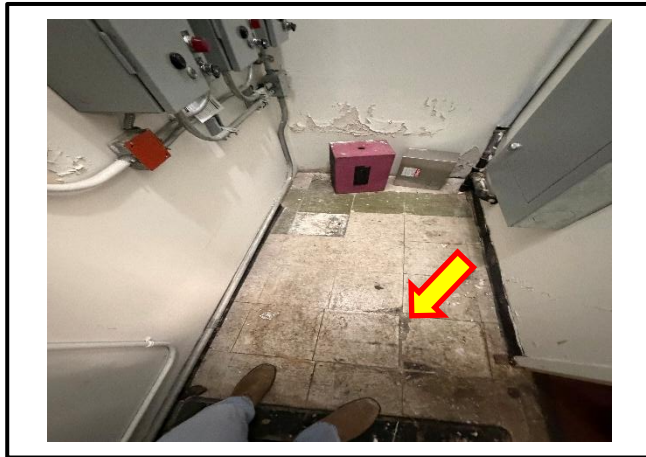
D117	Yes	Floors	12"x12" Vinyl Floor Tiles (Beige with black streaks)	Chrysotile	N/A	8m2	A	Poor	NF	3	Approxiamtely 8 damaged/cracked tiles were observed in Room D117. Remove and or repair damaged tiles.
D118A	Yes	Floors	12"x12" Vinyl Floor Tiles (Beige with black streaks)	Chrysotile	N/A	8m2	A	Good	NF	7	Routine Surveillance
Throughout	Suspect	Structural	Siporex	Presumed ACM	N/A	Throughout	C- Concealed	Good	NF	7	Routine Surveillance
Throughout	Yes	Walls	Covebase mastic	1% Chrysotile	CBM-01A-C	Throughout	A	Good	NF	7	Routine Surveillance
Throughout (Excluding D105)	Yes	Walls and Ceilings	Drywall Joint Compound	Chrysotile	N/A	Throughout	A	Good	NF	7	Routine Surveillance
Rooms D101D, D106A, D108B, D114, D117, D119 Stairwell leading to Mechanical Room, Kitchen Area	Yes	Walls and Ceilings	Drywall Joint Compound	Chrysotile	N/A	N/A	A	Poor	NF	1/3	Remove and or repair damaged drywall joint compound and cleanup debris.

Photograph 5: View of the damaged asbestos-containing 12"x12" beige vinyl floor tiles with black streaks observed in Room D117.

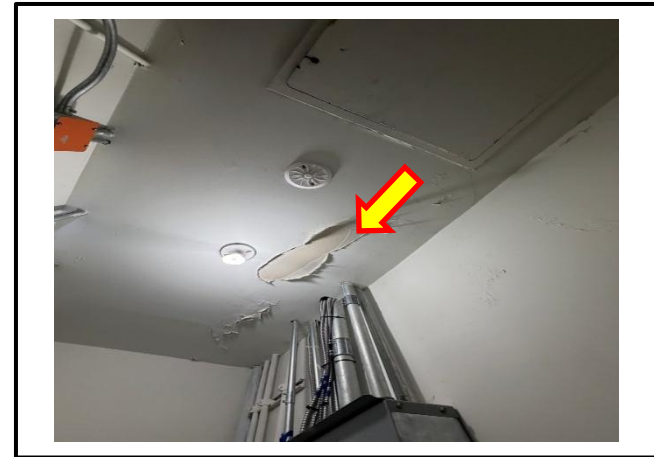
Photograph 6: View of the damaged asbestos-containing drywall joint compound on the ceiling of Room D117.

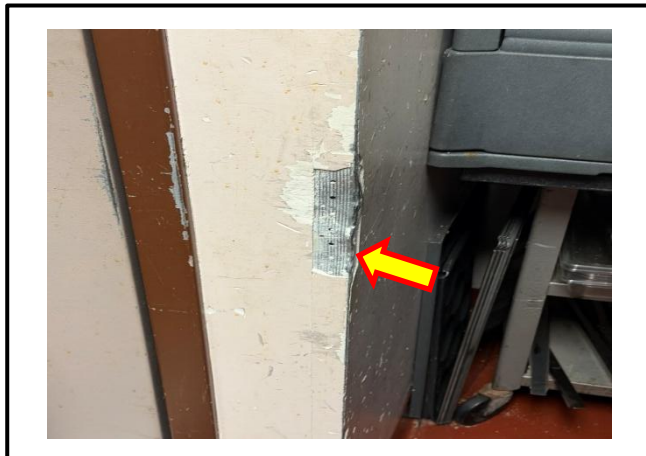
Photograph 7: Typical view of the damaged asbestos-containing drywall joint compound on walls and corner beads throughout Room D119.

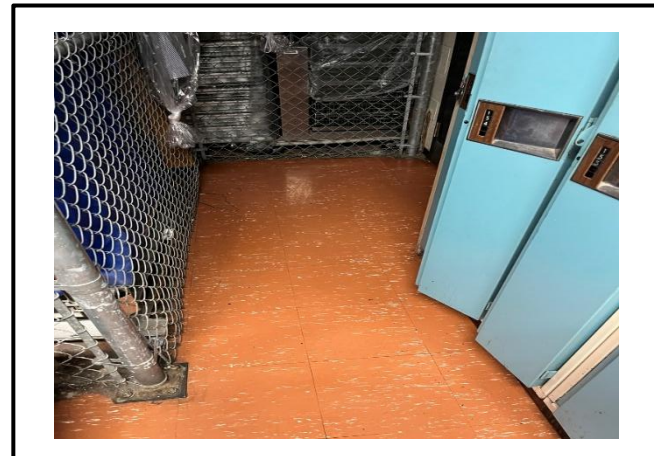
Photograph 8: Typical view of the asbestos-containing 12"x12" red vinyl floor tiles observed in Room D108.

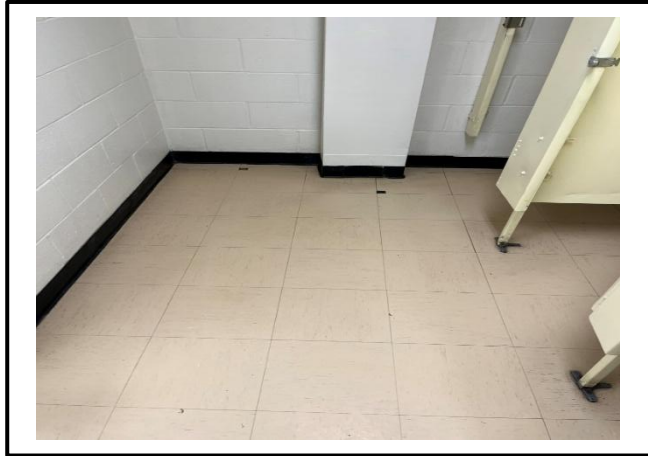
Photograph 9: View of the damaged asbestos-containing 12"x12" beige vinyl floor tiles with brown streaks observed in Room D108A.

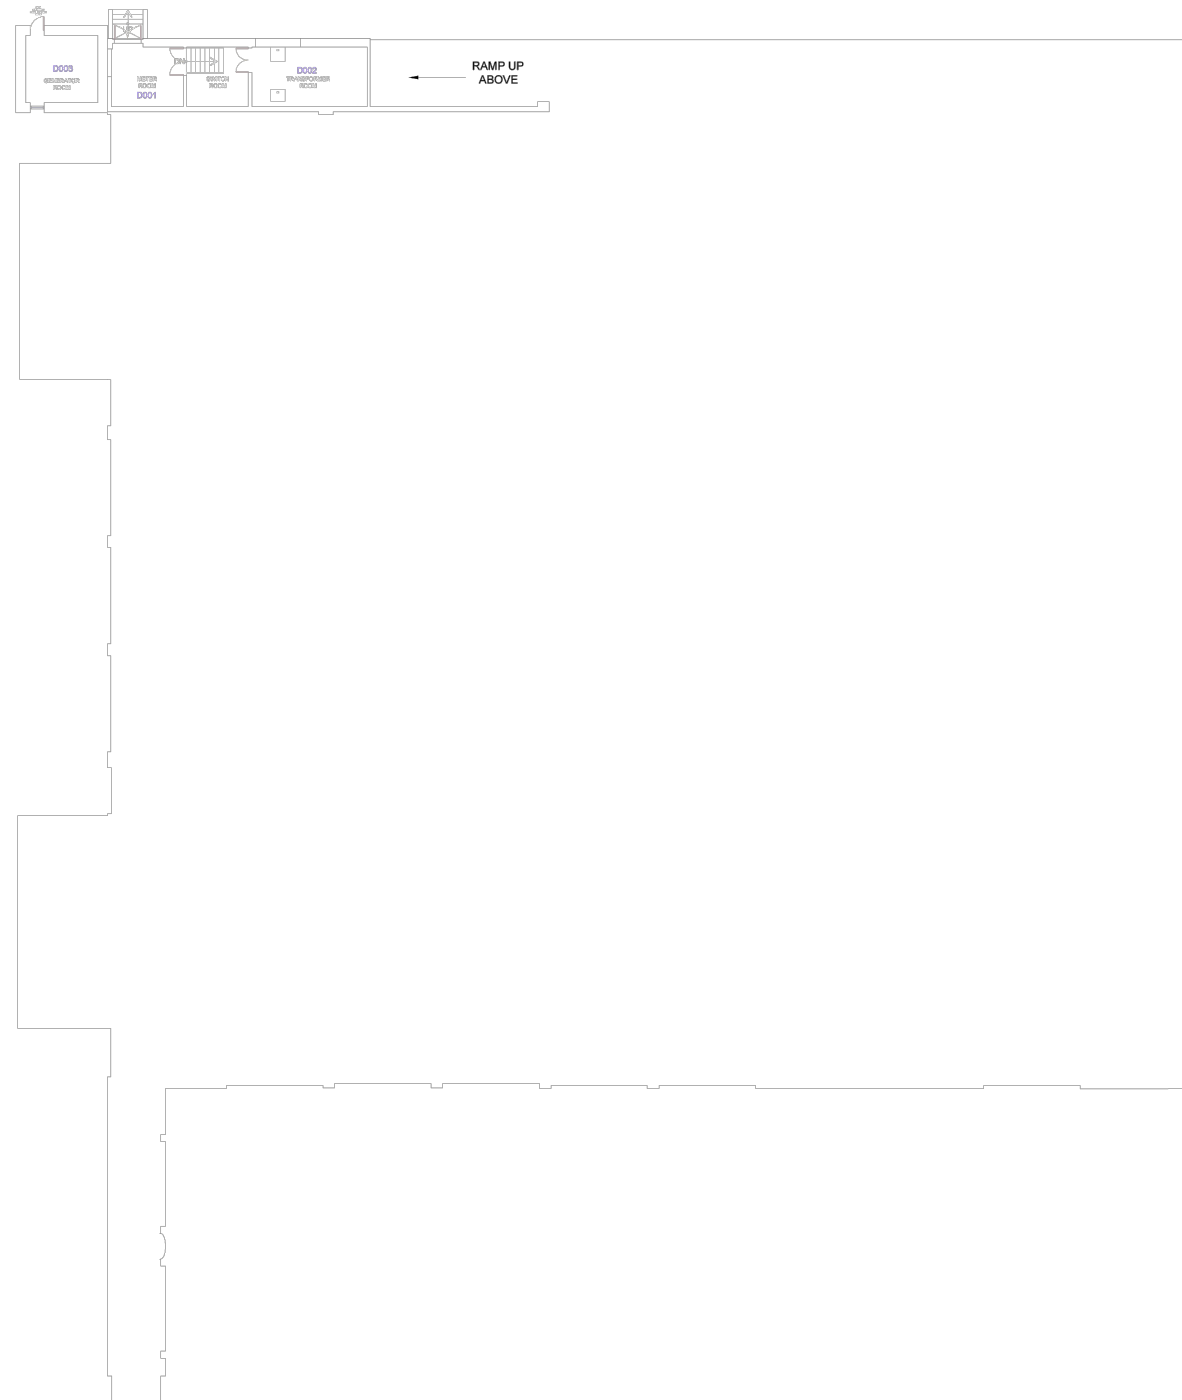
LOWER LEVEL FLOOR PLAN

NOTES:  
 - NO ASBESTOS-CONTAINING MATERIAL  
 WAS OBSERVED IN THE BASEMENT

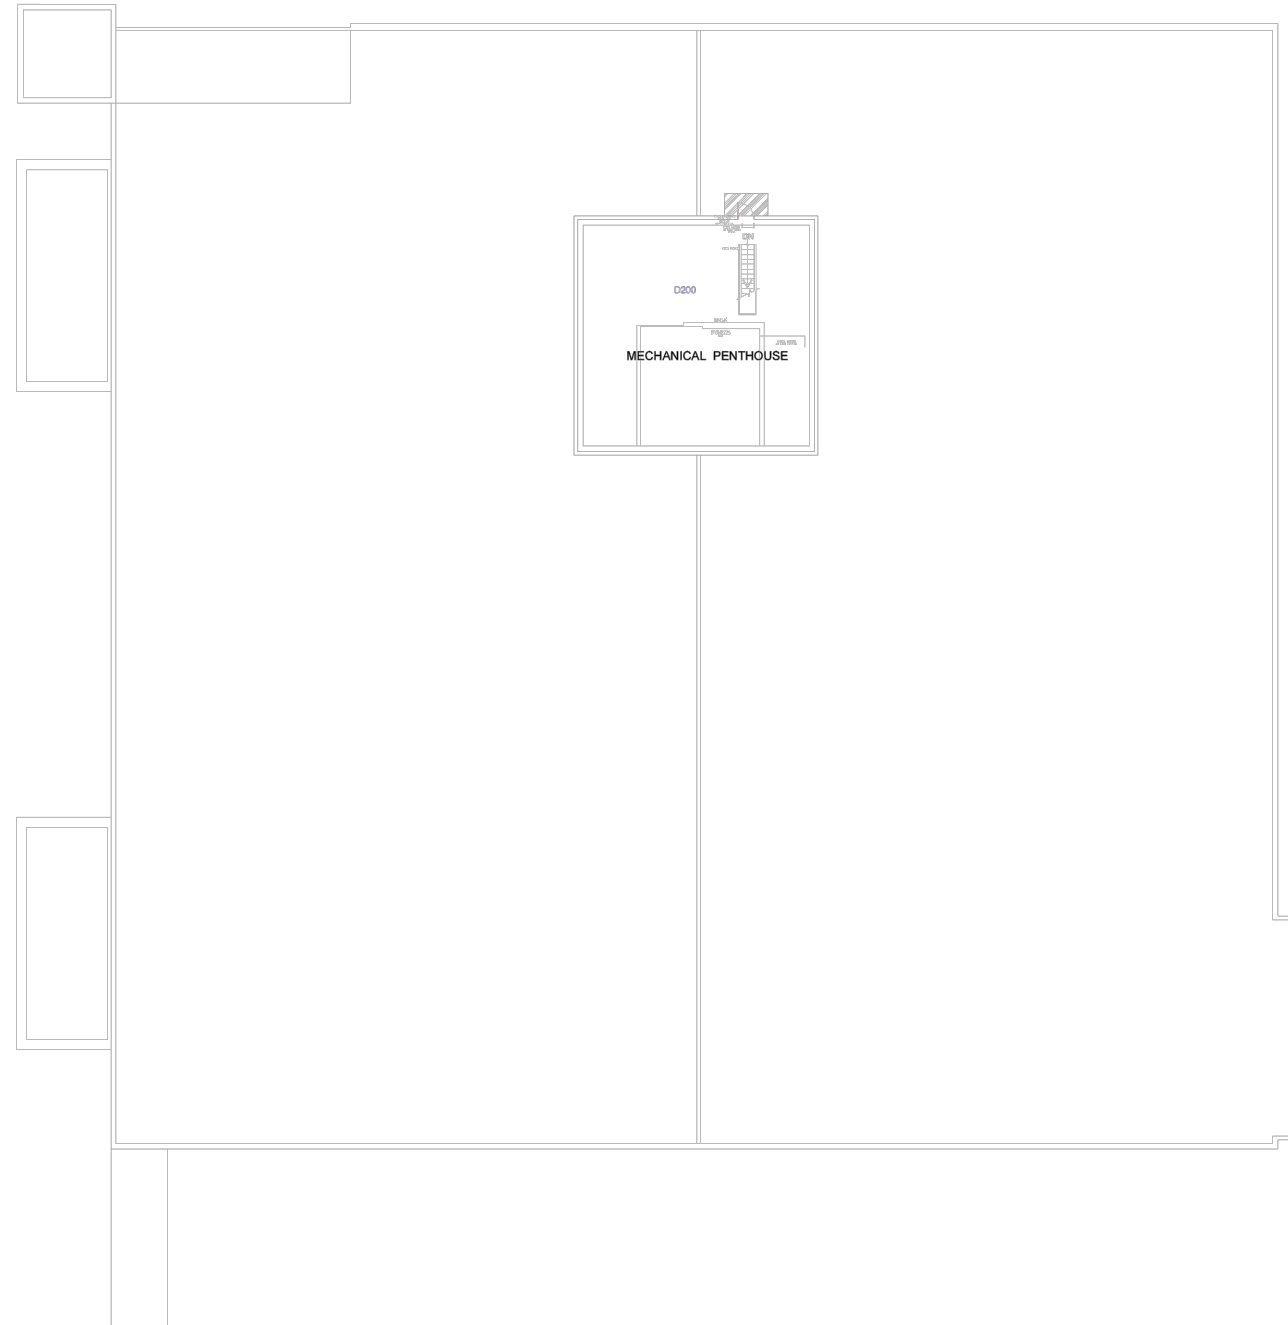
SECOND LEVEL FLOOR PLAN

**NOTES:**  
- NO ASBESTOS-CONTAINING MATERIAL  
WAS OBSERVED ON THE SECOND FLOOR
