April 2, 2026

CM3 File: TC1914

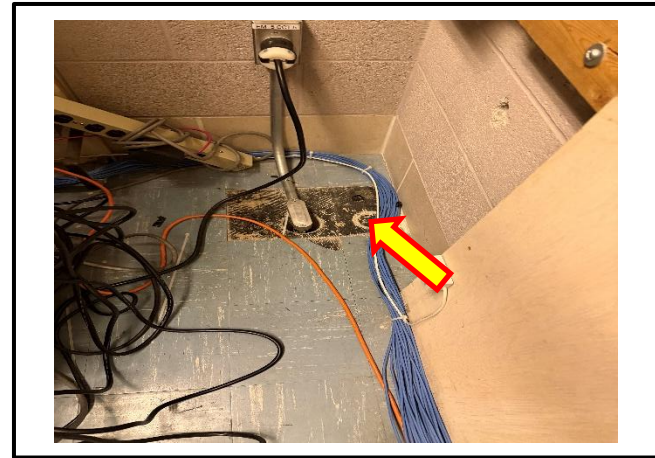
Photograph 2: View of the damaged asbestos-containing 9"x9" blue vinyl floor tiles and exposed asbestos-containing mastic observed in Room A1208A.

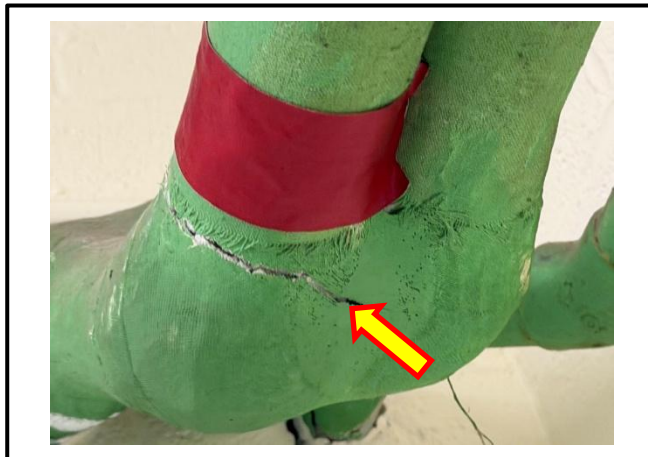
Photograph 3: View of the damaged asbestos-containing parging cement pipe elbow fitting observed in Room A1223B.

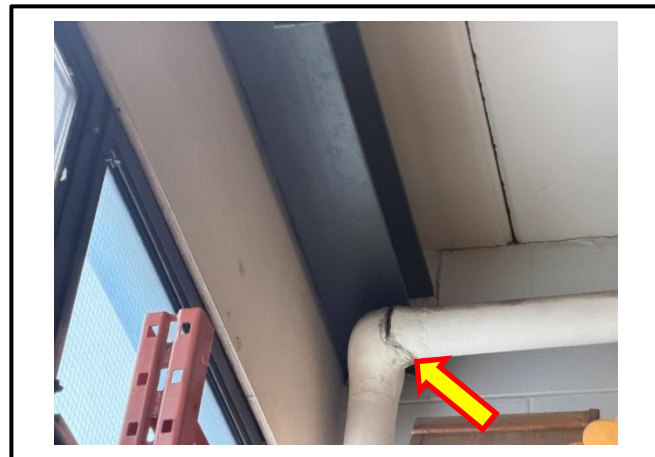
Photograph 4: View of the damaged asbestos-containing parging cement pipe elbow fitting observed in Room A1445.

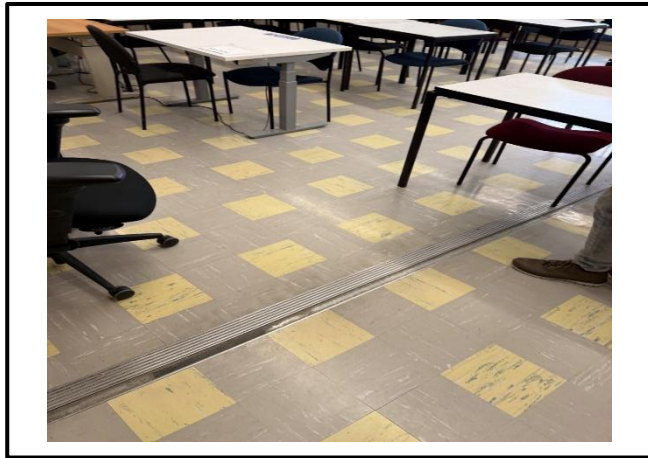
Photograph 5: View of asbestos-containing vinyl floor 9"x9" vinyl floor tiles observed in Room A2111.

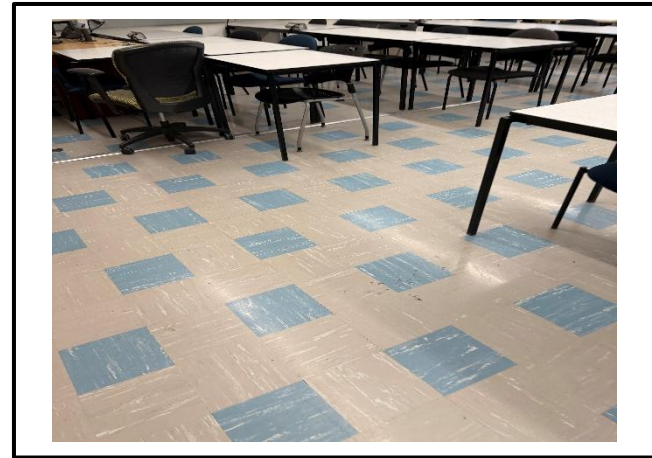
Photograph 6: View of asbestos-containing 9"x9" vinyl floor tiles observed in Room A2113.

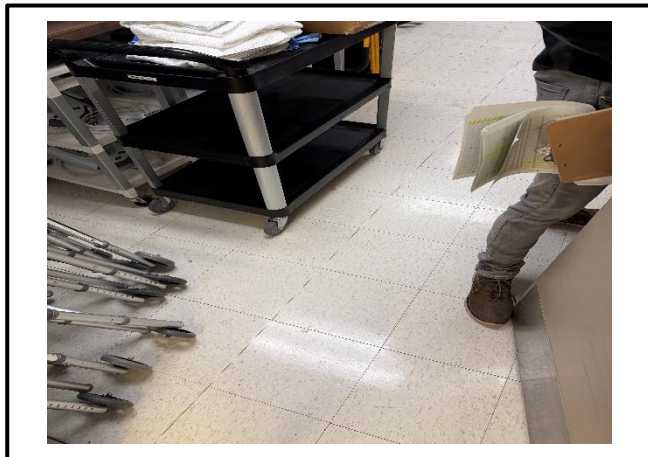
Photograph 7: View of the asbestos-containing 12"x12" white vinyl floor tiles with black and grey streaks observed in Room A2114.

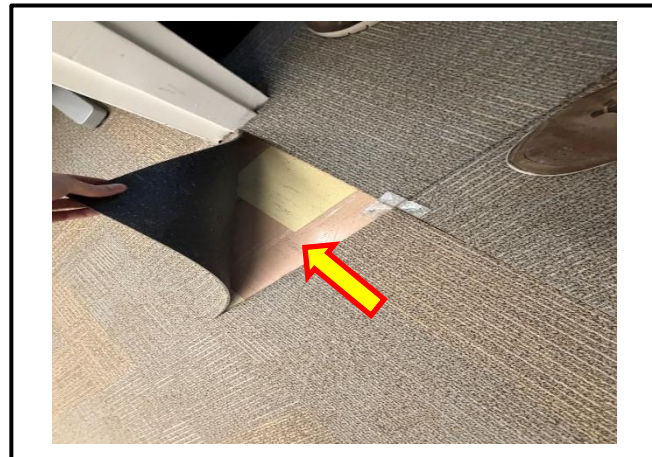
Photograph 8: View of the asbestos-containing 9"x9" vinyl floor tiles observed under carpet in Room A2127.
