April 6, 2026

CM3 File: TC1914

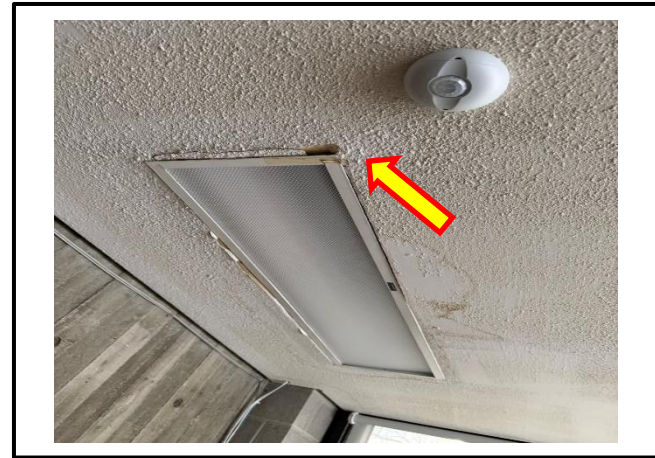
Photograph 2: View of the damaged asbestos-containing ceiling stipple observed around light fixtures in Room B146.

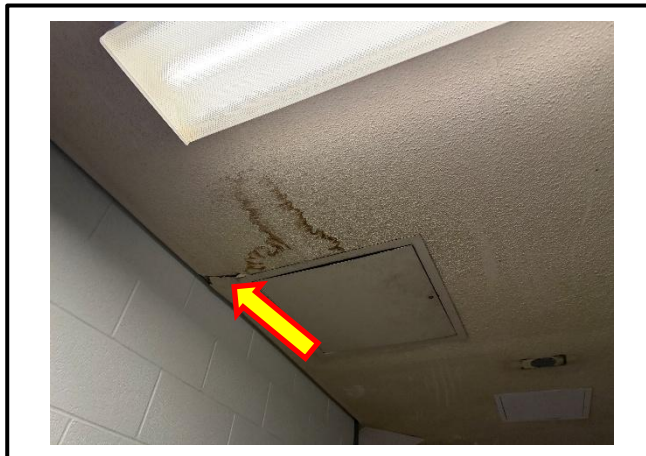
Photograph 3: View of damaged asbestos-containing ceiling stipple in the corridor outside Room B170.

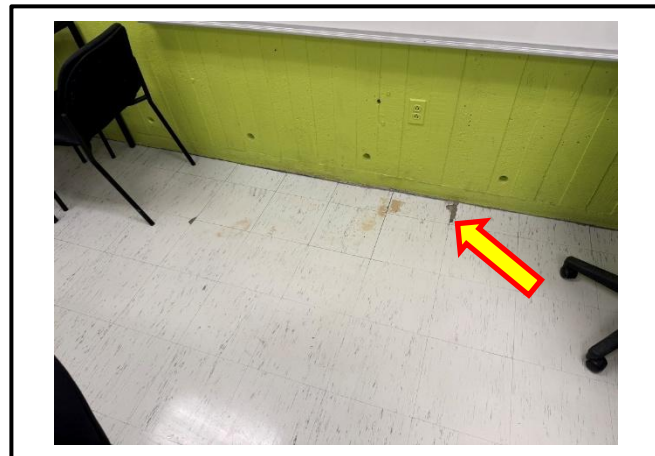
Photograph 4: View of the damaged asbestos-containing 12"x12" white/grey vinyl floor tiles observed in Room B133.

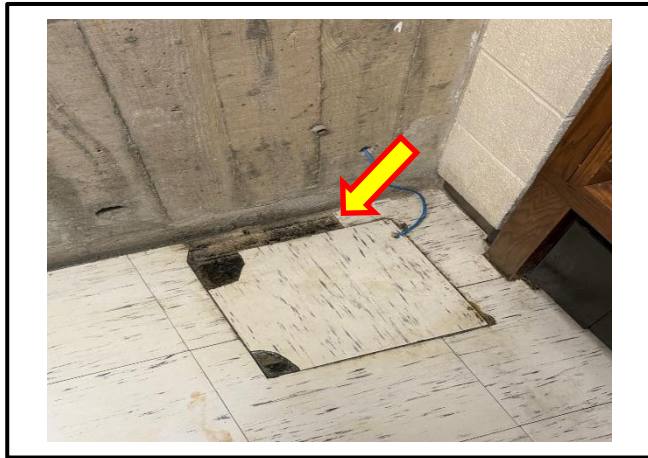
Photograph 5: View of the damaged asbestos-containing 12"x12" grey vinyl floor tiles observed in Room B137A.

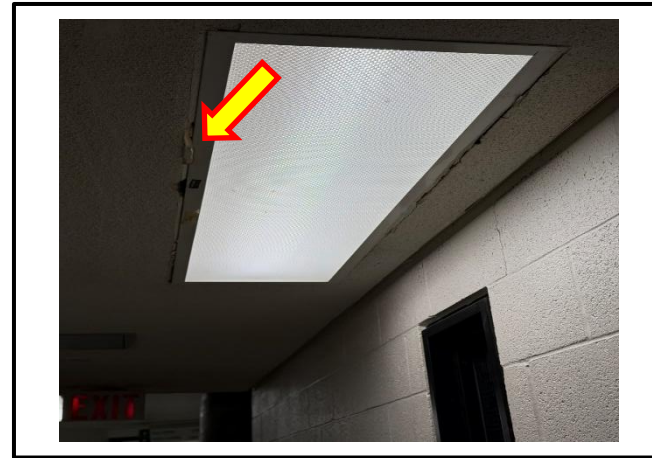
Photograph 6: View of the damaged asbestos-containing ceiling stipple observed on light fixtures throughout the second-floor.

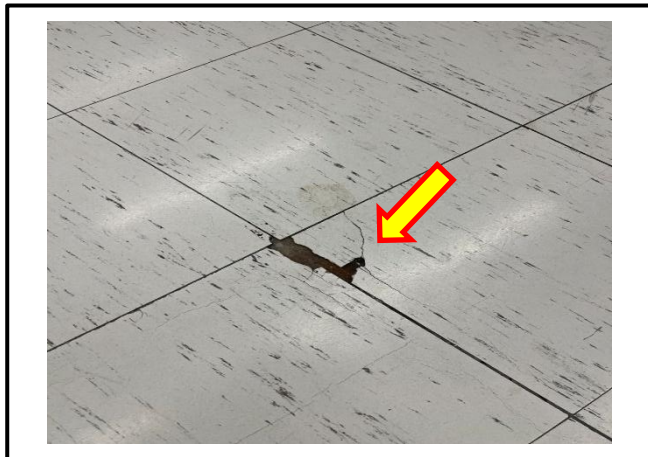
Photograph 7: View of the damaged asbestos-containing 12"x12" grey vinyl floor tiles observed in Room B261.

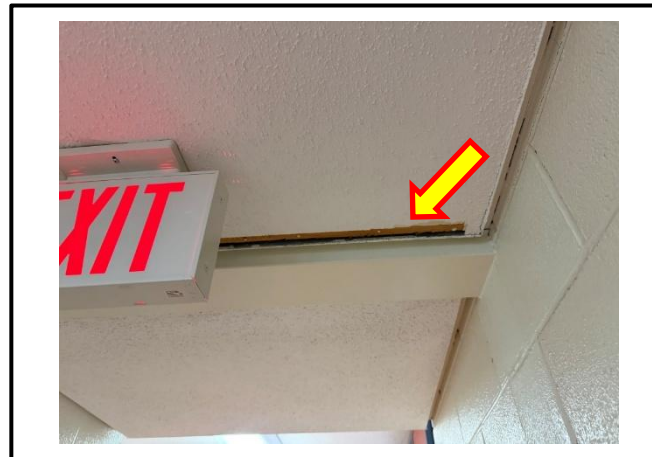
Photograph 8: Typical view of the damaged asbestos-containing ceiling stipple observed in the third-floor corridors.

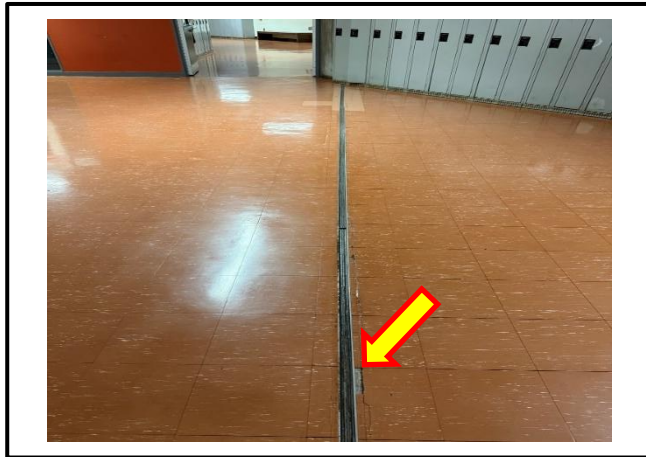
Photograph 9: View of the damaged asbestos-containing 12"x12" red/orange vinyl floor tiles observed in the third-floor corridor outside Room B355.

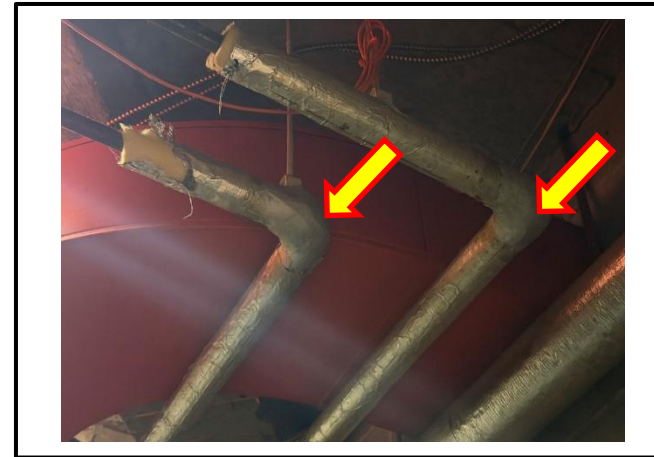
Photograph 10: View of the asbestos-containing parging cement elbows on mechanical pipes in Room B301.

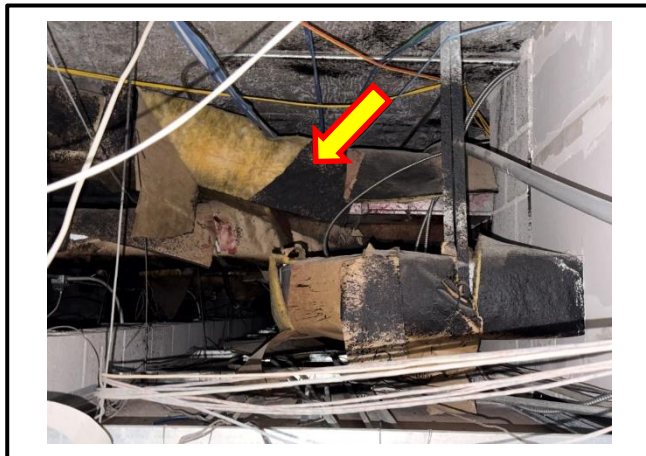
Photograph 11: View of the damaged asbestos-containing black tar on ductwork in the ceiling space in the corridor outside Room B311A.

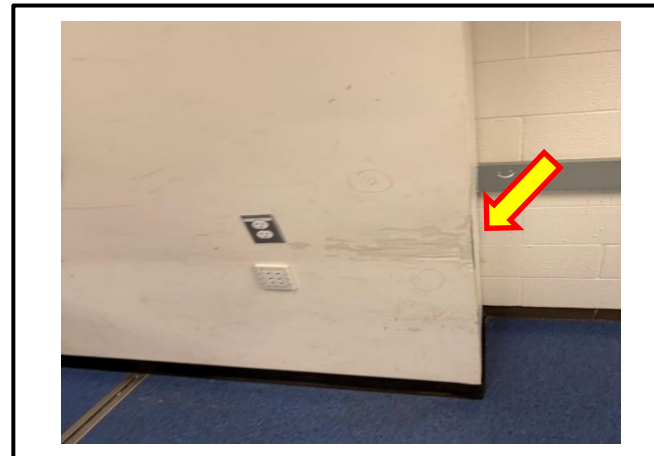
Photograph 12: View of the damaged asbestos-containing drywall joint compound observed in Room B383.

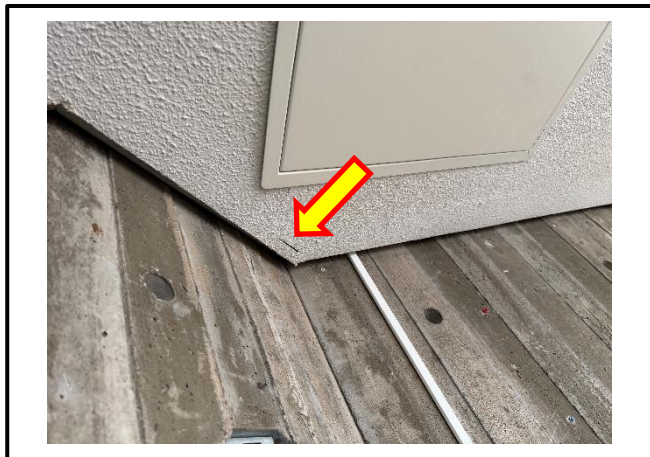
Photograph 13: View of the damaged asbestos-containing ceiling stipple observed in Room B414.
