DESIGNATED SUBSTANCES AND HAZARDOUS MATERIALS REPORT
Building CA, Algonquin College Ottawa Campus
1408 Woodroffe Avenue, Ottawa, Ontario

December, 2025

CM3 Project: TC1738

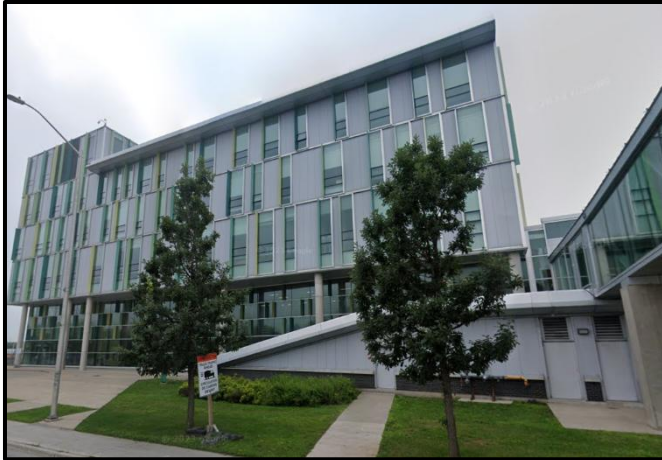
Photograph 1: Typical view of the exterior of the building.

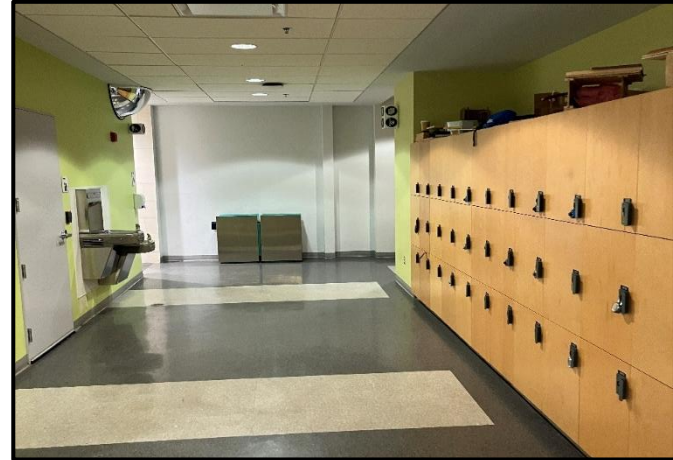
Photograph 2: Typical view of corridors within the building.

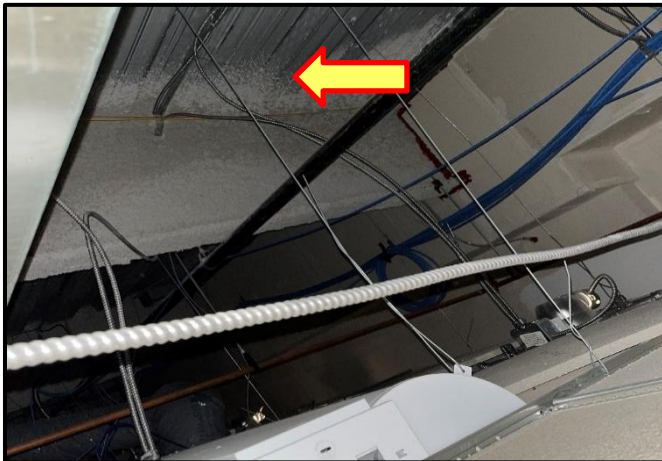
The ceilings throughout the building were observed to consist of drywall, various acoustic ceiling tiles and steel deck. Applications of sprayed fireproofing were observed in ceiling spaces throughout the building. There are no concerns with regards to asbestos-containing ceiling finishes.

Photograph 3: View of non-asbestos containing sprayed fireproofing observed in ceiling spaces throughout.

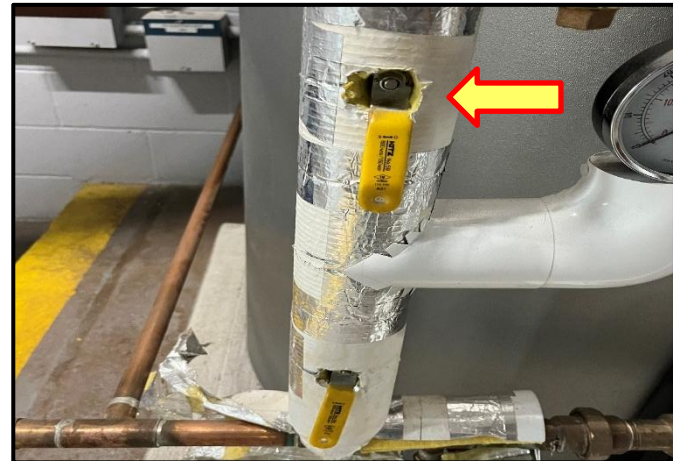
Mechanical pipes throughout the building were observed to be either uninsulated or insulated with non-asbestos applications of fibreglass and PVC. Ductwork throughout the building was observed to be either uninsulated or insulated with non-asbestos applications of fibreglass. Applications of mastic were also observed on ductwork throughout the building. Given the age of construction there are no concerns with regards to asbestos-containing insulating materials; therefore, no samples were collected as part of the assessment.

Photograph 4: View of non-asbestos containing fiberglass insulation observed on mechanical pipe fittings throughout.

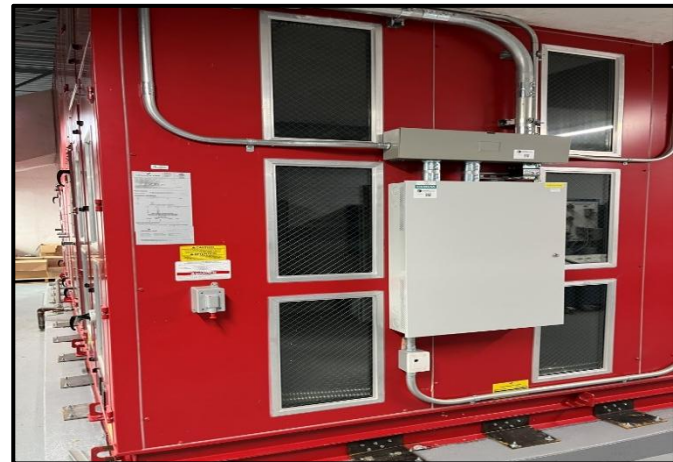
Photograph 8: View of air handling unit observed in the sixth-floor mechanical penthouse.

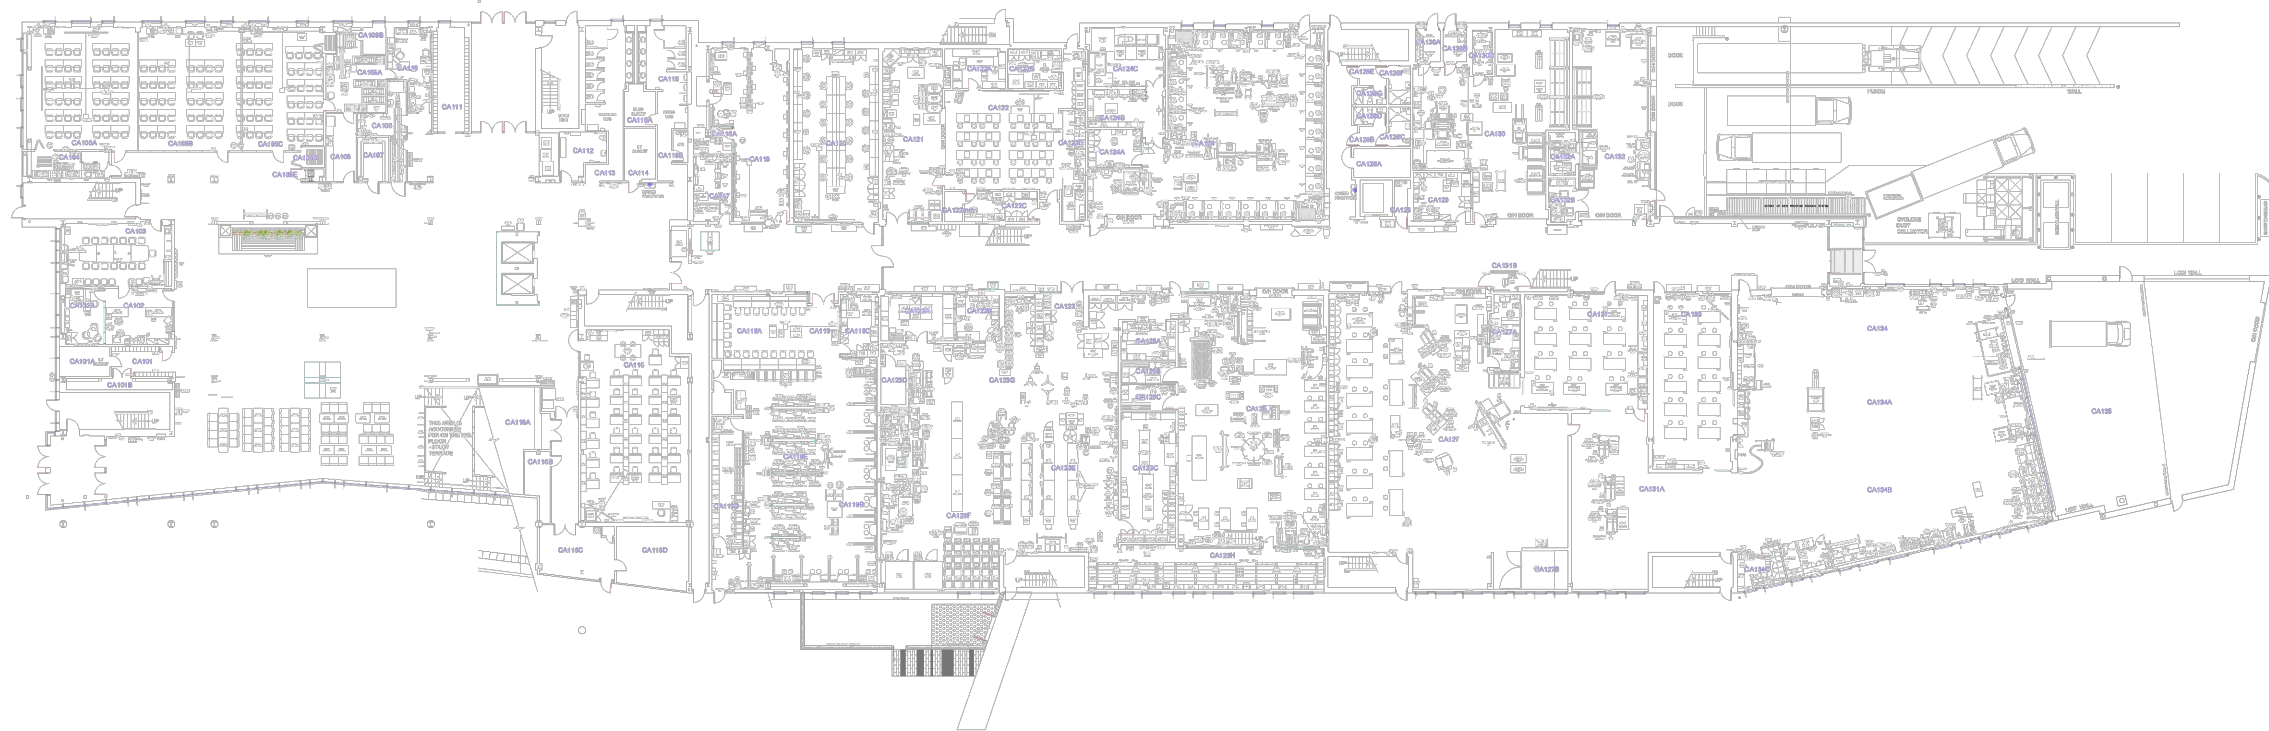
BUILDING CA - 1st. FLOOR PLAN
NOT TO SCALE

NOTES:
- GIVEN THE AGE OF CONSTRUCTION THERE ARE NO CONCERNS WITH REGARDS TO ASBESTOS - CONTAINING MATERIALS.
- GIVEN THE AGE OF CONSTRUCTION THERE ARE NO CONCERNS WITH REGARDS TO LEAD-CONTAINING PAINTS.

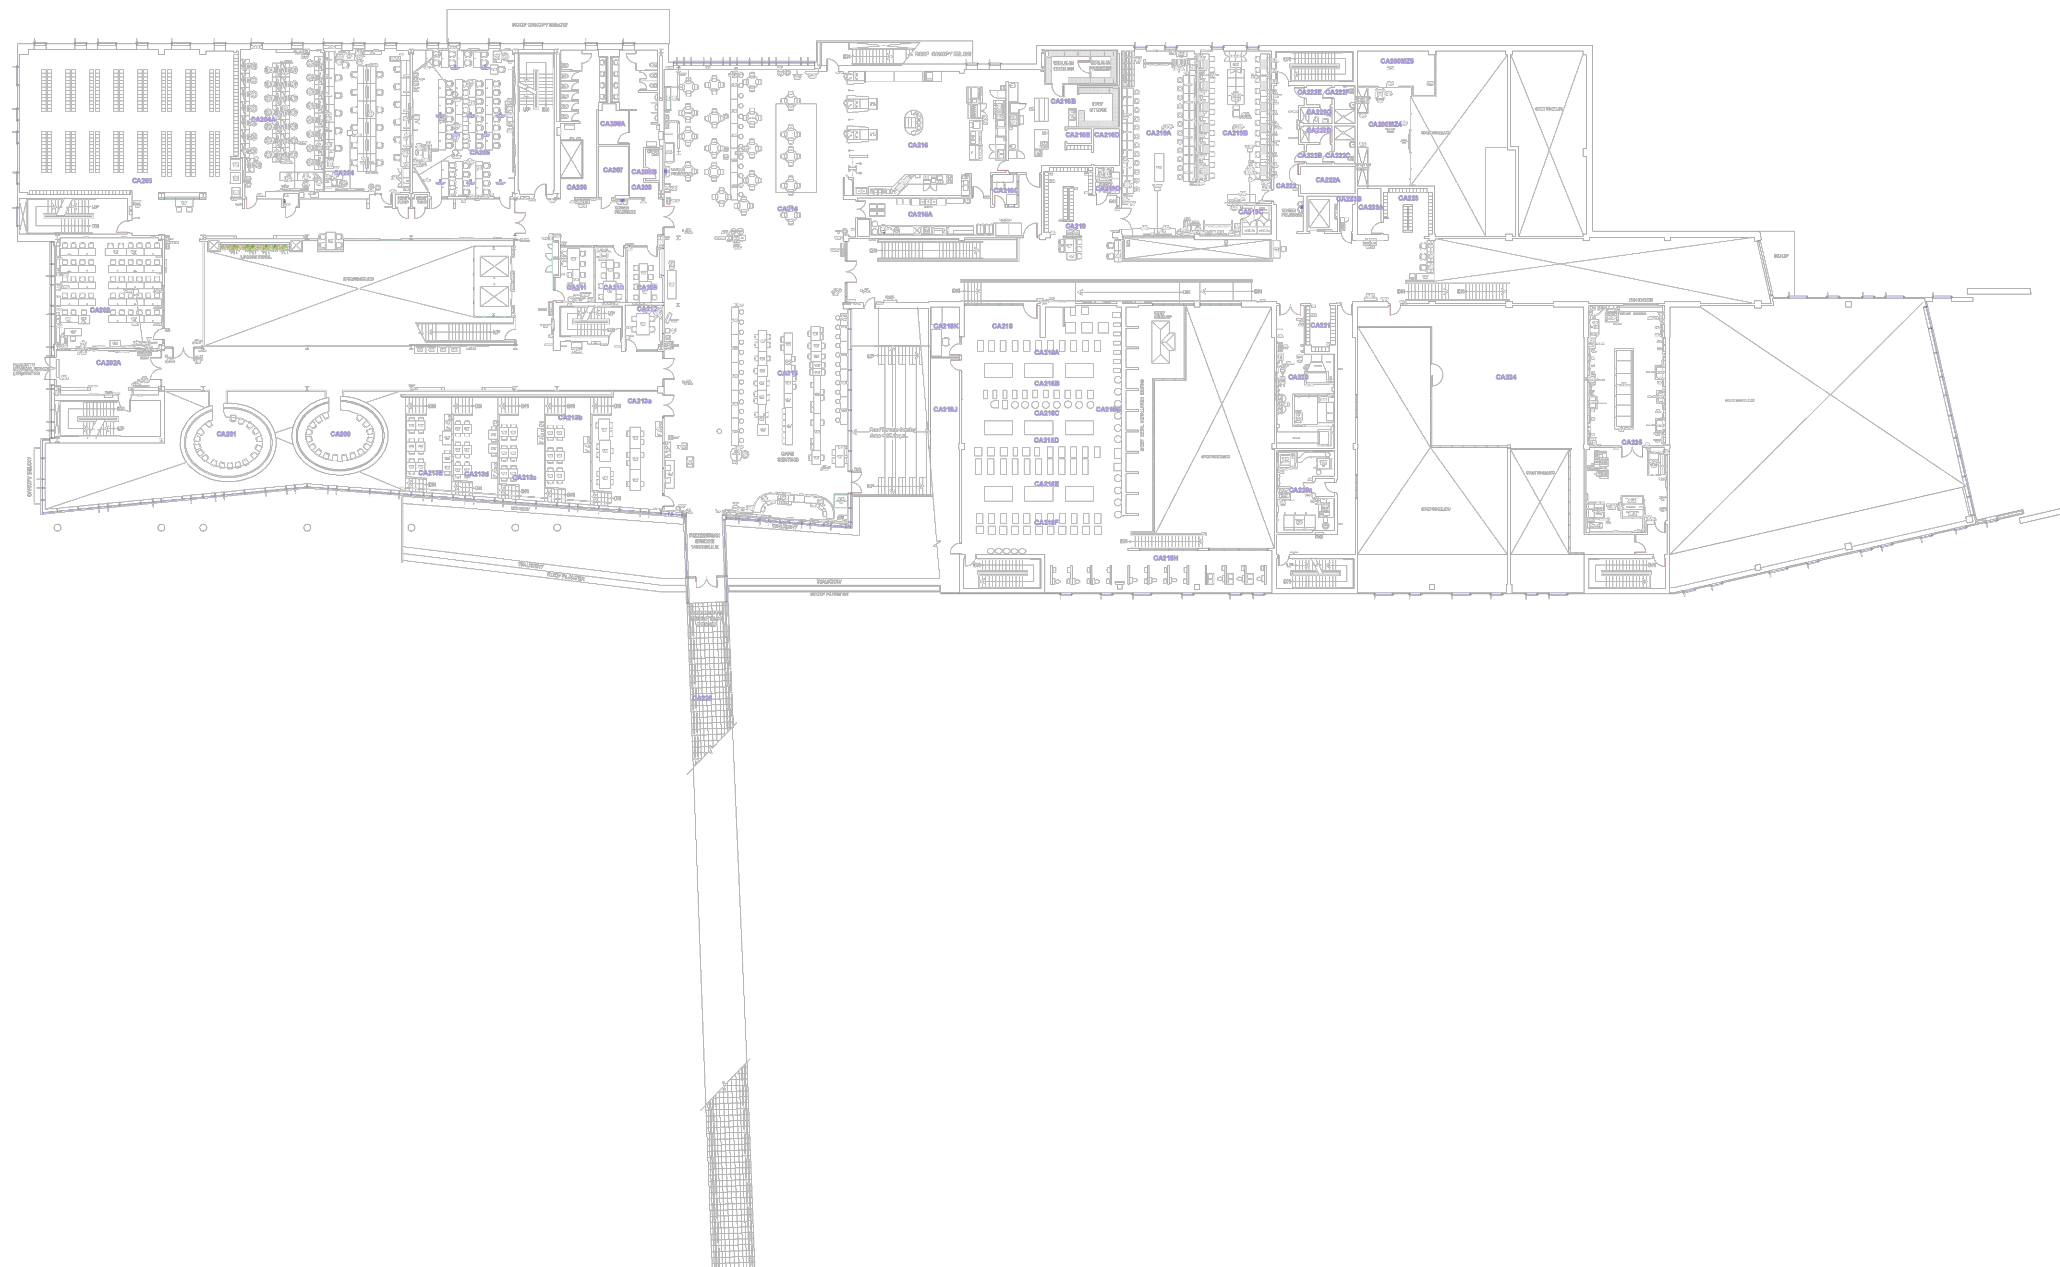
BUILDING CA - 2nd. FLOOR PLAN
 NOT TO SCALE

NOTES:
 - GIVEN THE AGE OF CONSTRUCTION THERE ARE NO CONCERNS WITH REGARDS TO ASBESTOS - CONTAINING MATERIALS.
 - GIVEN THE AGE OF CONSTRUCTION THERE ARE NO CONCERNS WITH REGARDS TO LEAD-CONTAINING PAINTS.

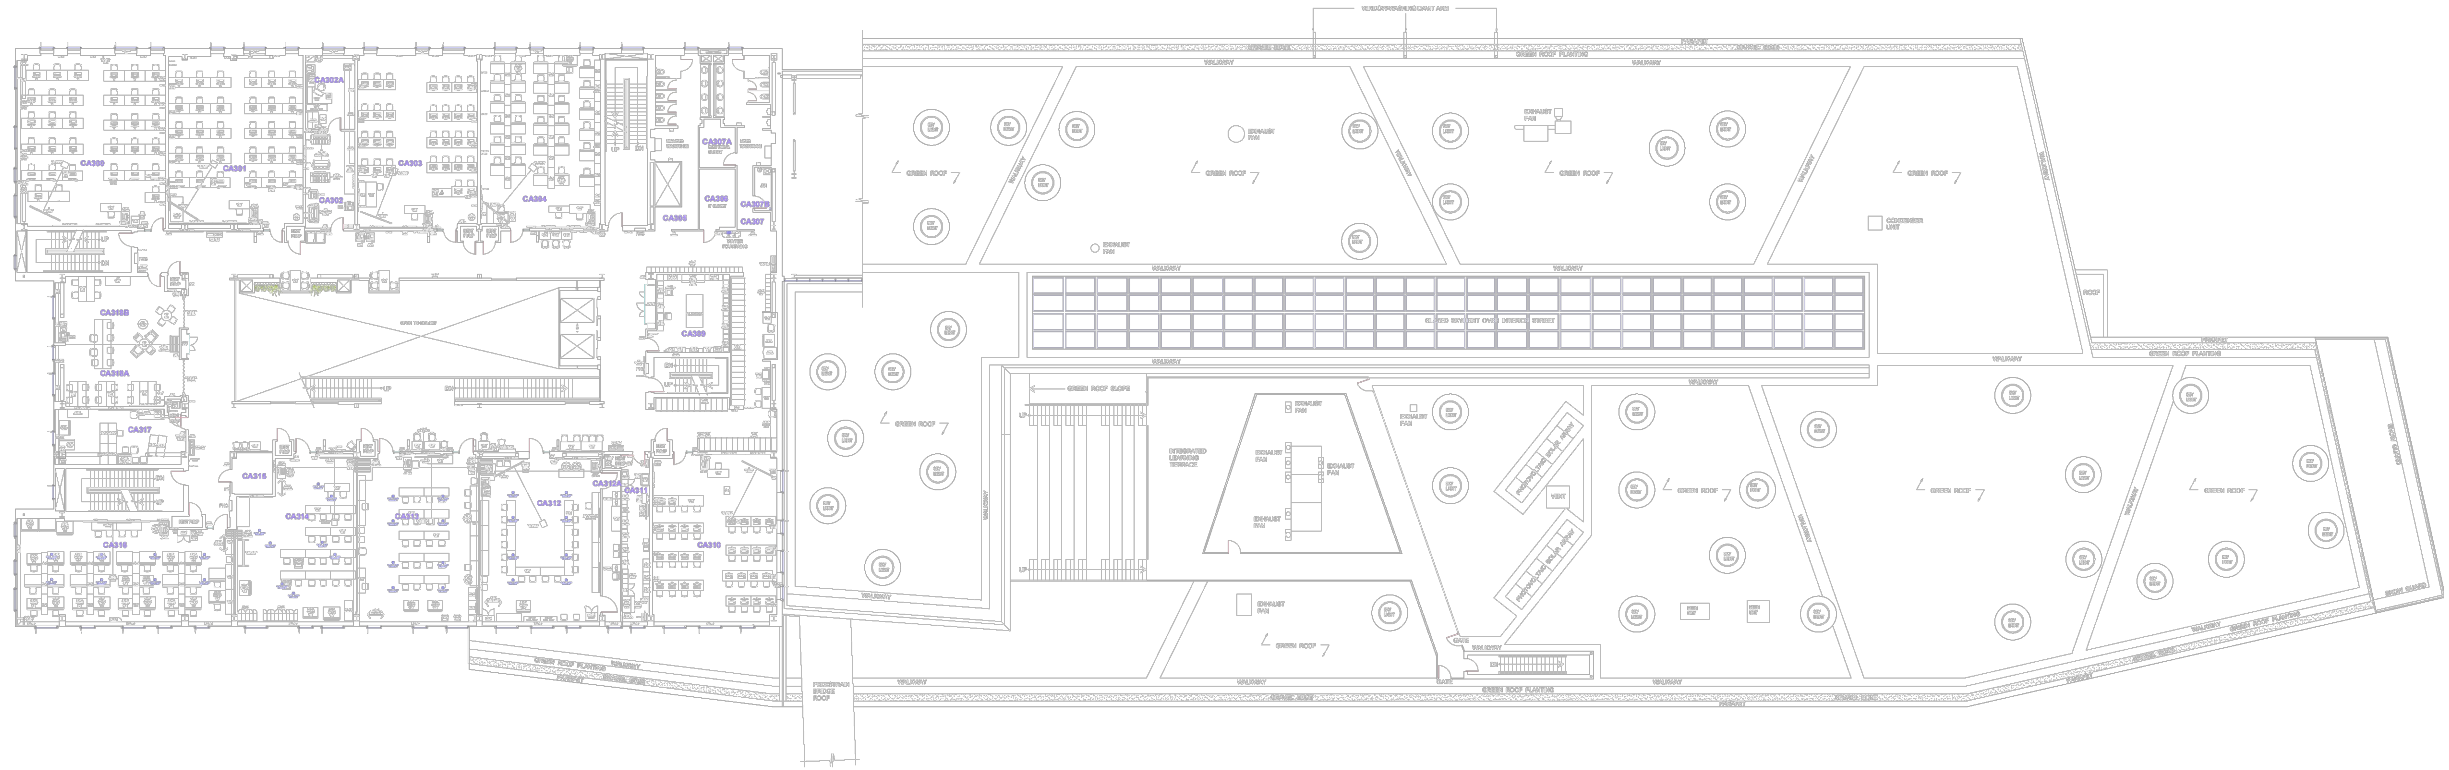
BUILDING CA - 3rd. FLOOR PLAN
 NOT TO SCALE

NOTES:
 - GIVEN THE AGE OF CONSTRUCTION THERE ARE NO CONCERNS WITH REGARDS TO ASBESTOS - CONTAINING MATERIALS.
 - GIVEN THE AGE OF CONSTRUCTION THERE ARE NO CONCERNS WITH REGARDS TO LEAD-CONTAINING PAINTS.

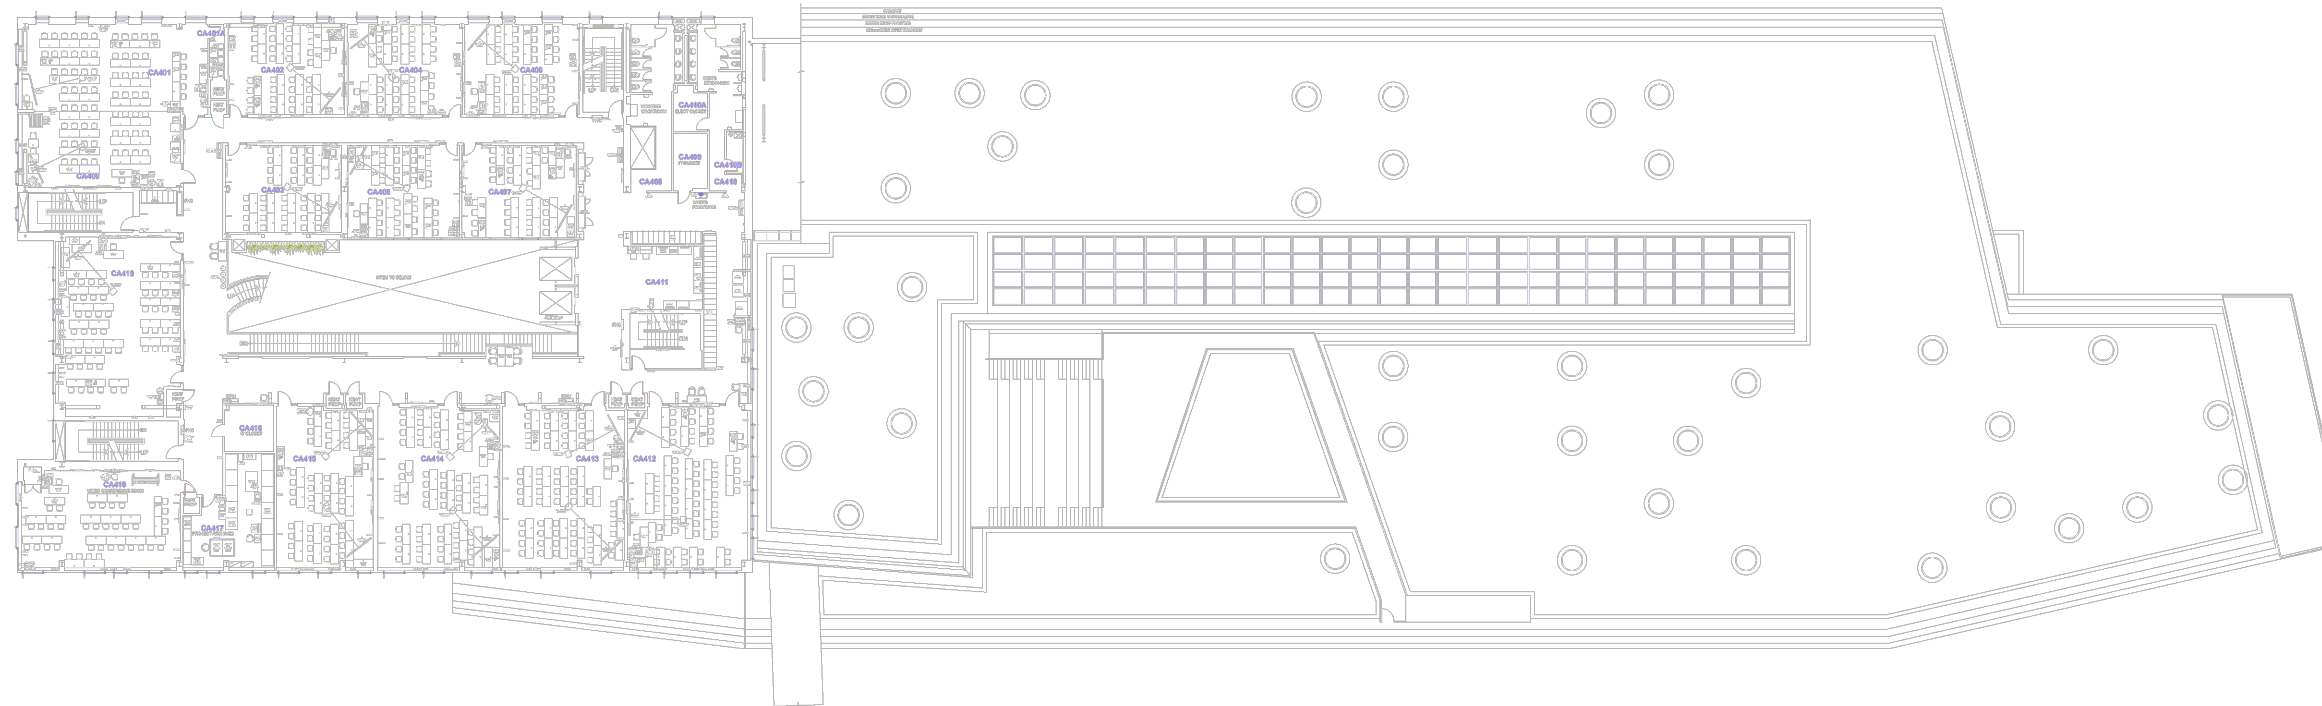
BUILDING CA - 4th. FLOOR PLAN
 NOT TO SCALE

NOTES:
 - GIVEN THE AGE OF CONSTRUCTION THERE ARE NO CONCERNS WITH REGARDS TO ASBESTOS - CONTAINING MATERIALS.
 - GIVEN THE AGE OF CONSTRUCTION THERE ARE NO CONCERNS WITH REGARDS TO LEAD-CONTAINING PAINTS.

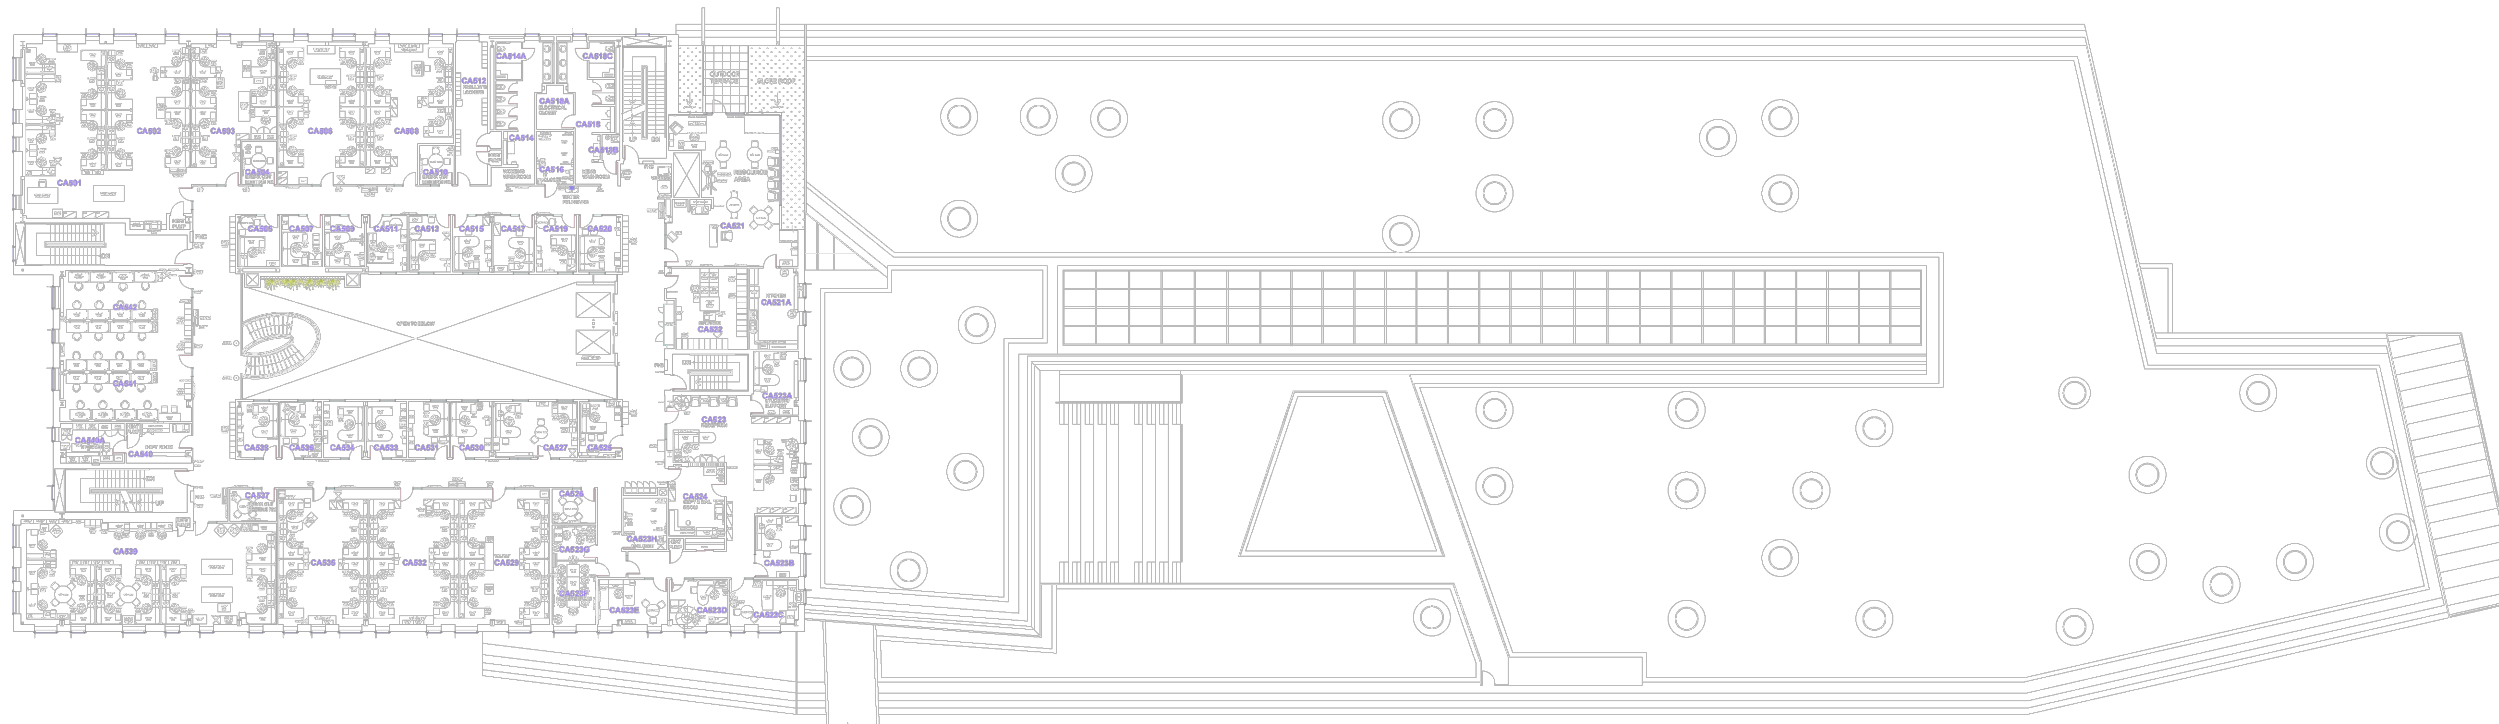
BUILDING CA - 5th. FLOOR PLAN
 NOT TO SCALE

NOTES:
 - GIVEN THE AGE OF CONSTRUCTION THERE ARE NO CONCERNS WITH REGARDS TO ASBESTOS - CONTAINING MATERIALS.
 - GIVEN THE AGE OF CONSTRUCTION THERE ARE NO CONCERNS WITH REGARDS TO LEAD-CONTAINING PAINTS.

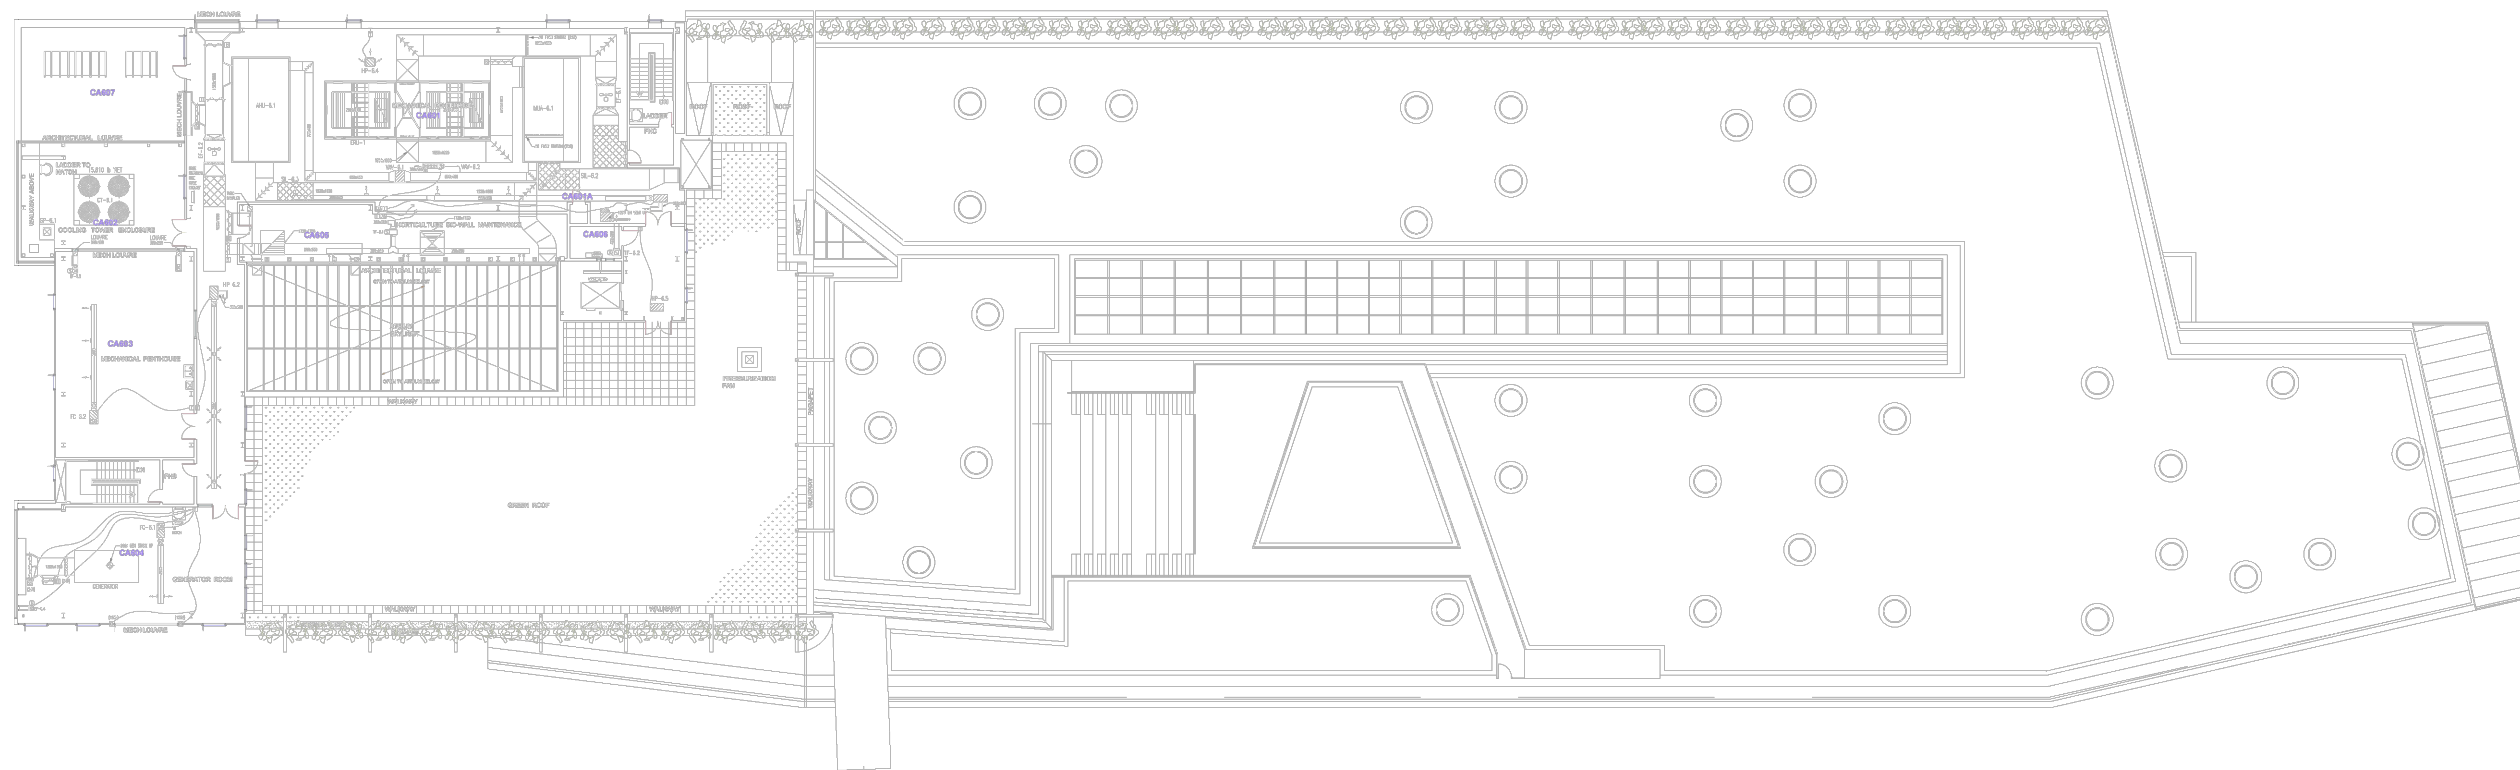
BUILDING CA - 6th. FLOOR PLAN
NOT TO SCALE

NOTES:
- GIVEN THE AGE OF CONSTRUCTION THERE ARE NO CONCERNS WITH REGARDS TO ASBESTOS - CONTAINING MATERIALS.
- GIVEN THE AGE OF CONSTRUCTION THERE ARE NO CONCERNS WITH REGARDS TO LEAD-CONTAINING PAINTS.
