**DESIGNATED SUBSTANCES AND HAZARDOUS MATERIALS REPORT**  
**Building X, Algonquin College Ottawa Campus**  
**525 Wabisheshi Private, Ottawa, Ontario**

**February 4, 2026**

**CM3 Project: TC1738**

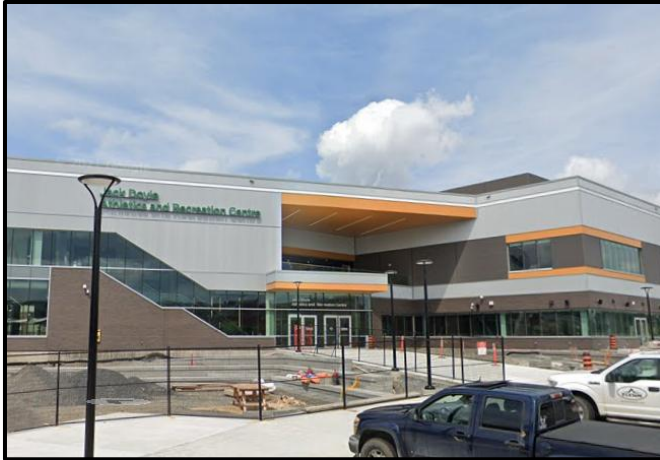
The exterior of the facility was observed to consist of brick masonry, metal siding and a concrete foundation. No suspect asbestos-containing exterior finishes were observed during the assessment; therefore, no samples were collected.

Photograph 1: Typical view of the exterior of the building.

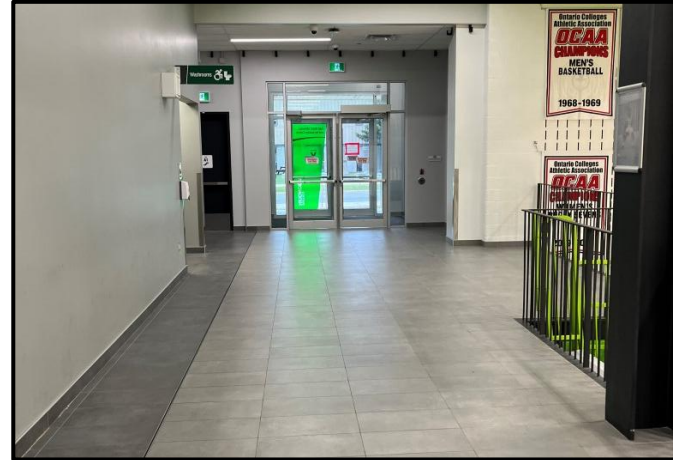
Photograph 2: Typical view of corridors observed throughout the building.

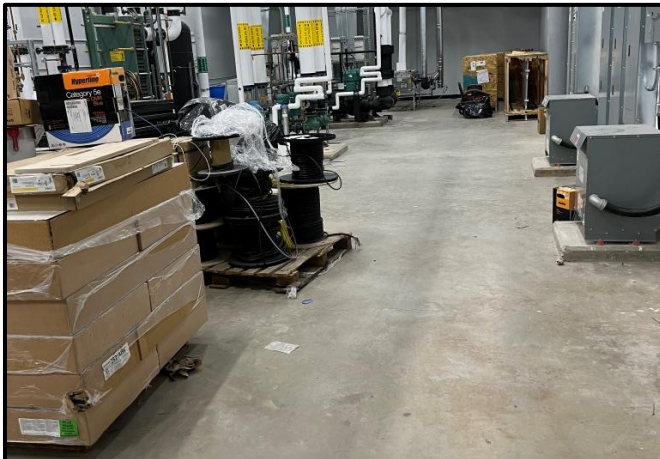
Photograph 3: View of Mechanical Room observed within the building.

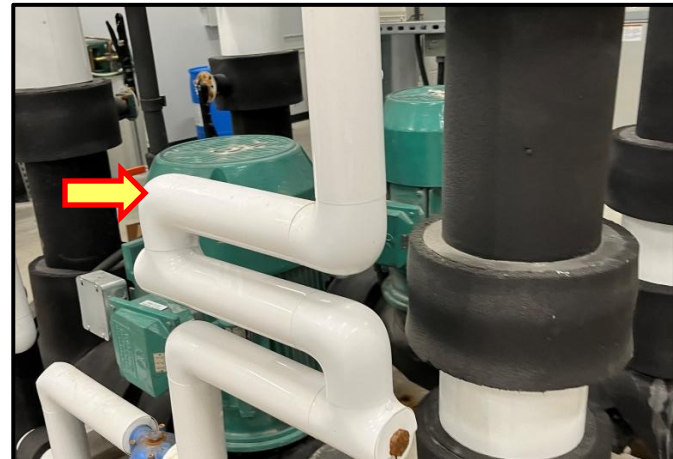
Mechanical pipes throughout the building were observed to be either uninsulated or insulated with non-asbestos applications of fibreglass and PVC. Applications of sprayed fireproofing were observed in ceiling spaces throughout the building.

Photograph 4: View of non-asbestos containing fiberglass insulation with PVC cover on mechanical pipes observed.

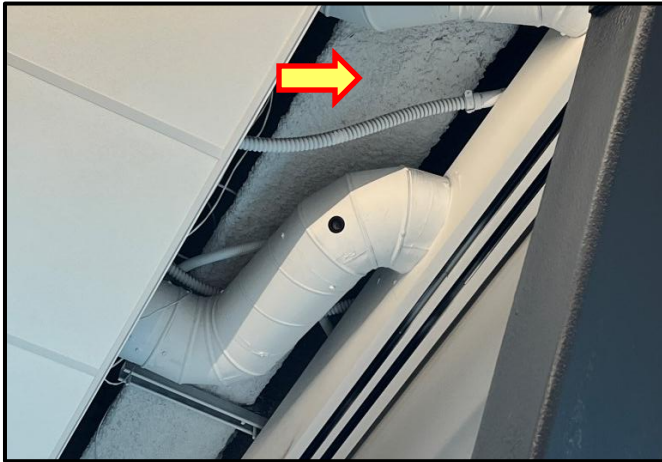
No suspect asbestos-containing insulating materials were observed during the assessment; therefore, no samples were collected.

Photograph 5: View of non-asbestos containing sprayed on fireproofing observed in ceiling spaces throughout.

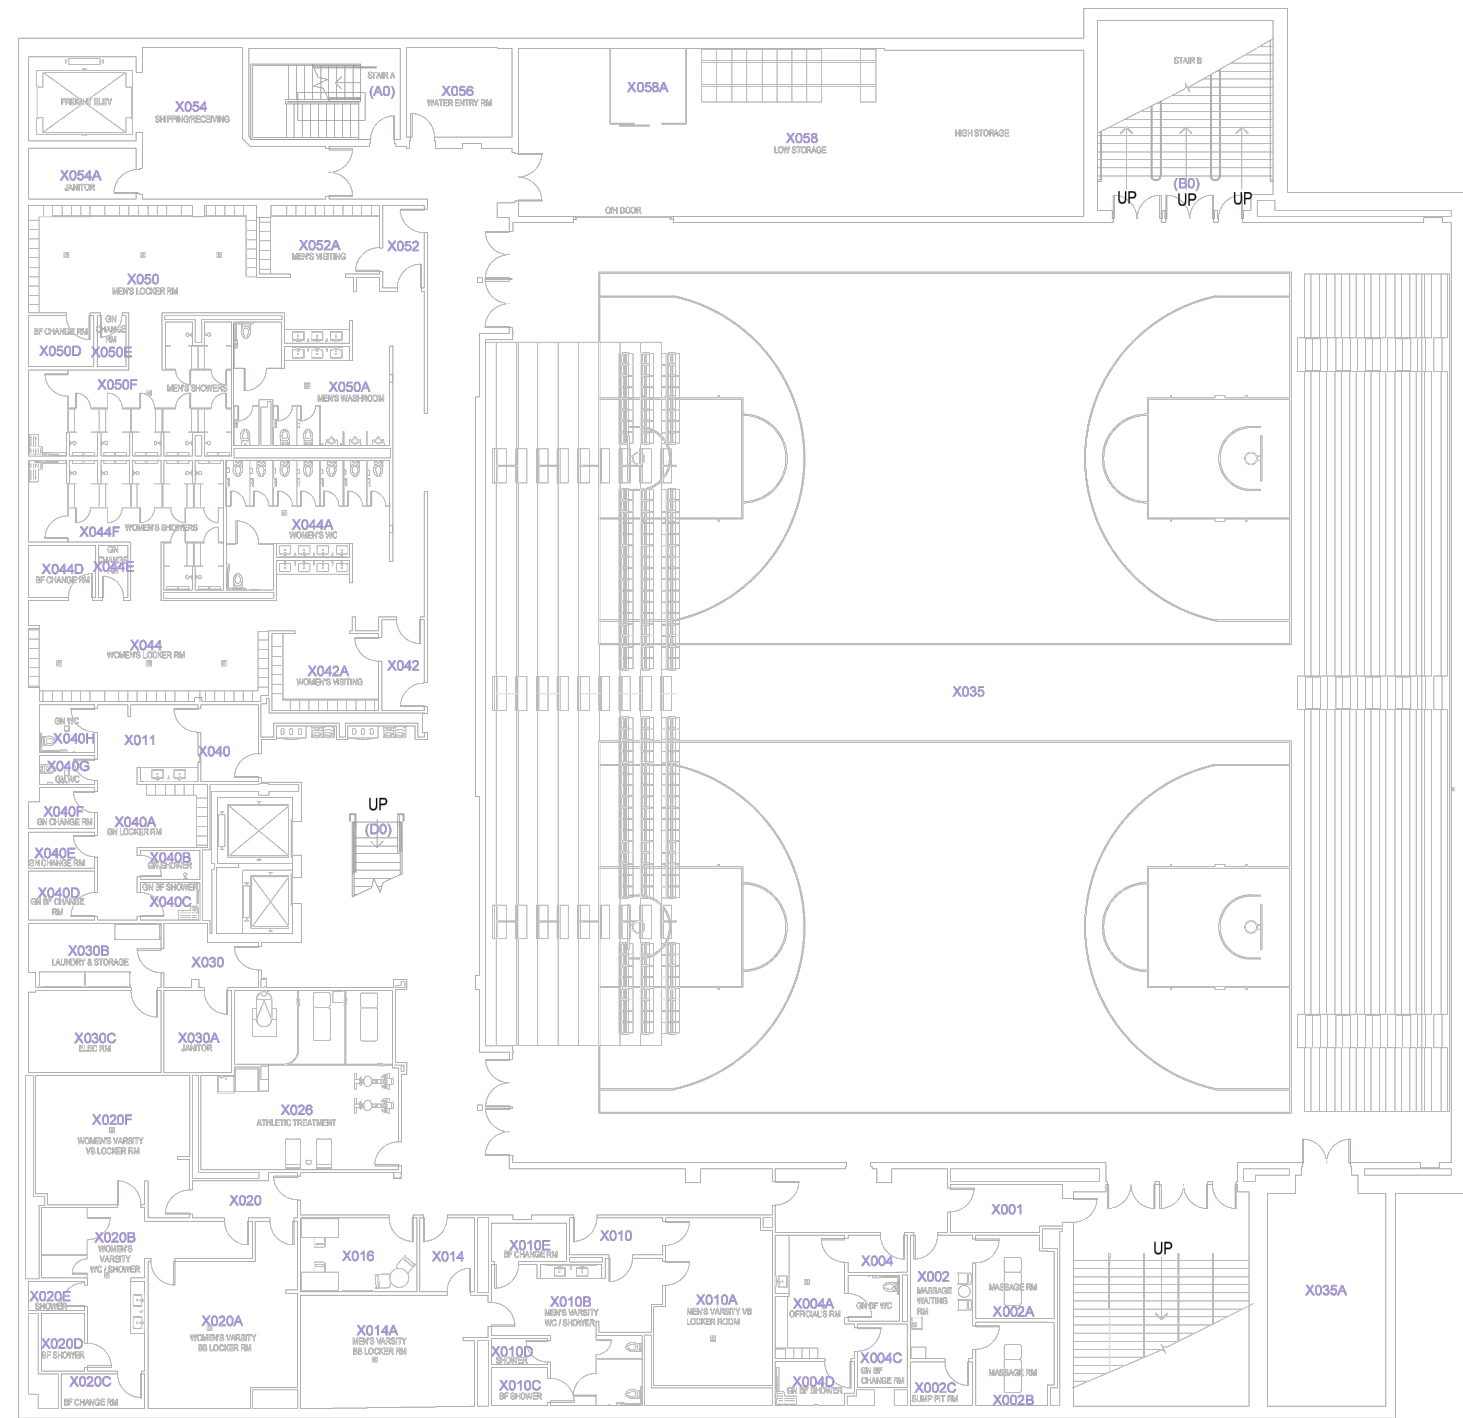
**BUILDING X - LOWER LEVEL FLOOR PLAN**  
NOT TO SCALE

**NOTES:**  
- GIVEN THE AGE OF CONSTRUCTION THERE ARE NO CONCERNS WITH REGARDS TO ASBESTOS - CONTAINING MATERIALS.  
- GIVEN THE AGE OF CONSTRUCTION THERE ARE NO CONCERNS WITH REGARDS TO LEAD CONTAINING PAINTS.

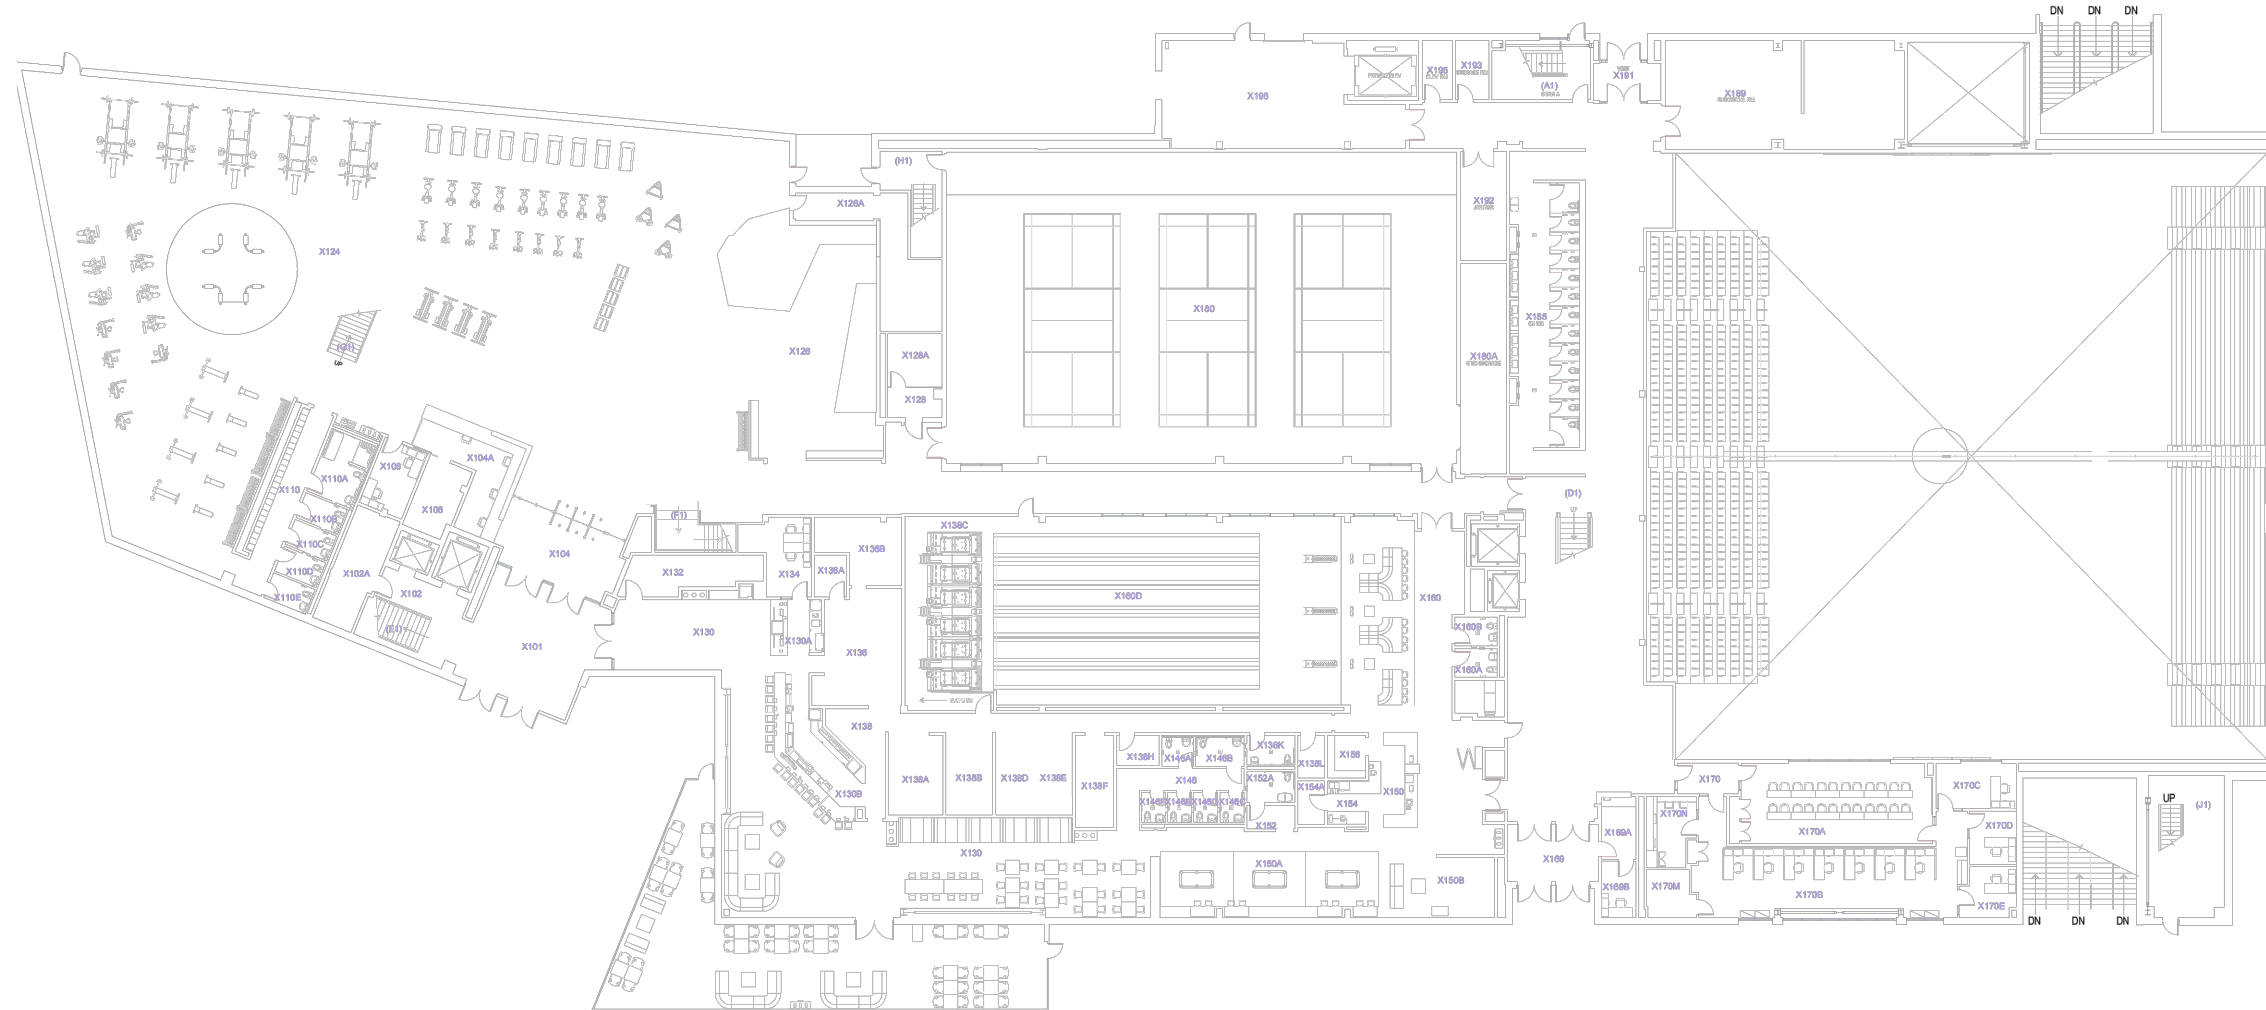
**BUILDING X - 1st. FLOOR PLAN**  
 NOT TO SCALE

**NOTES:**  
 - GIVEN THE AGE OF CONSTRUCTION THERE ARE NO CONCERNS WITH REGARDS TO ASBESTOS - CONTAINING MATERIALS.  
 - GIVEN THE AGE OF CONSTRUCTION THERE ARE NO CONCERNS WITH REGARDS TO LEAD CONTAINING PAINTS.

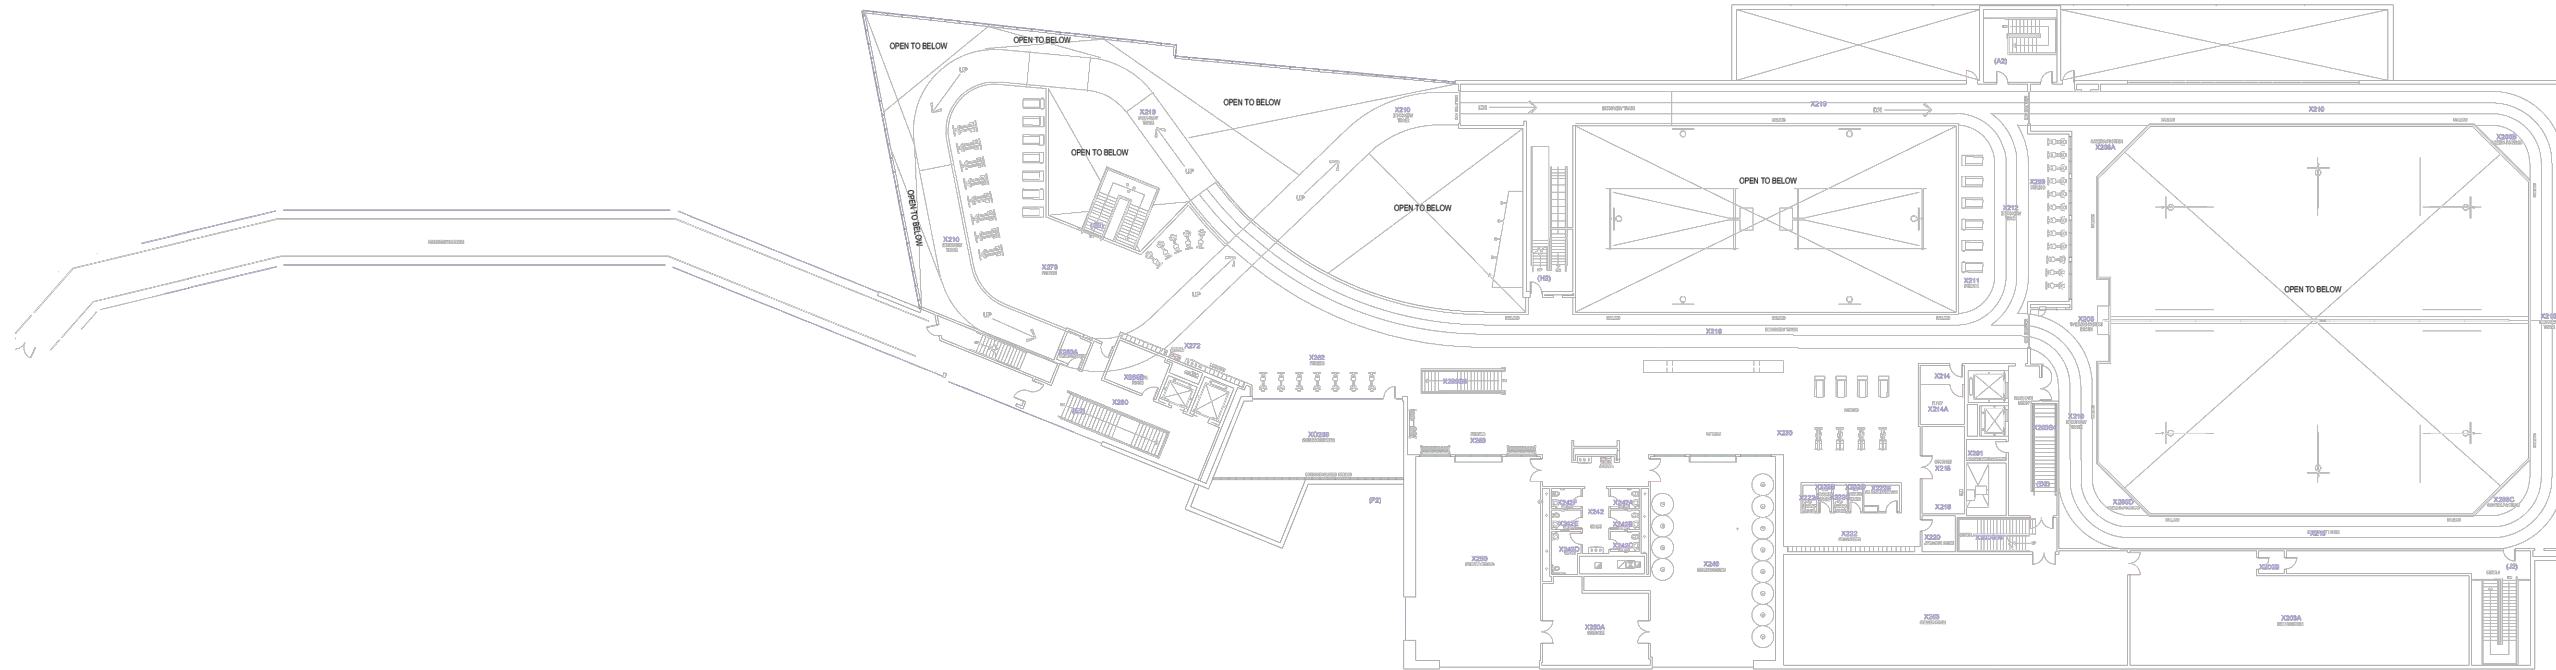
**BUILDING X - 2nd. FLOOR PLAN**  
NOT TO SCALE

**NOTES:**  
- GIVEN THE AGE OF CONSTRUCTION THERE ARE NO CONCERNS WITH REGARDS TO ASBESTOS - CONTAINING MATERIALS.  
- GIVEN THE AGE OF CONSTRUCTION THERE ARE NO CONCERNS WITH REGARDS TO LEAD CONTAINING PAINTS.

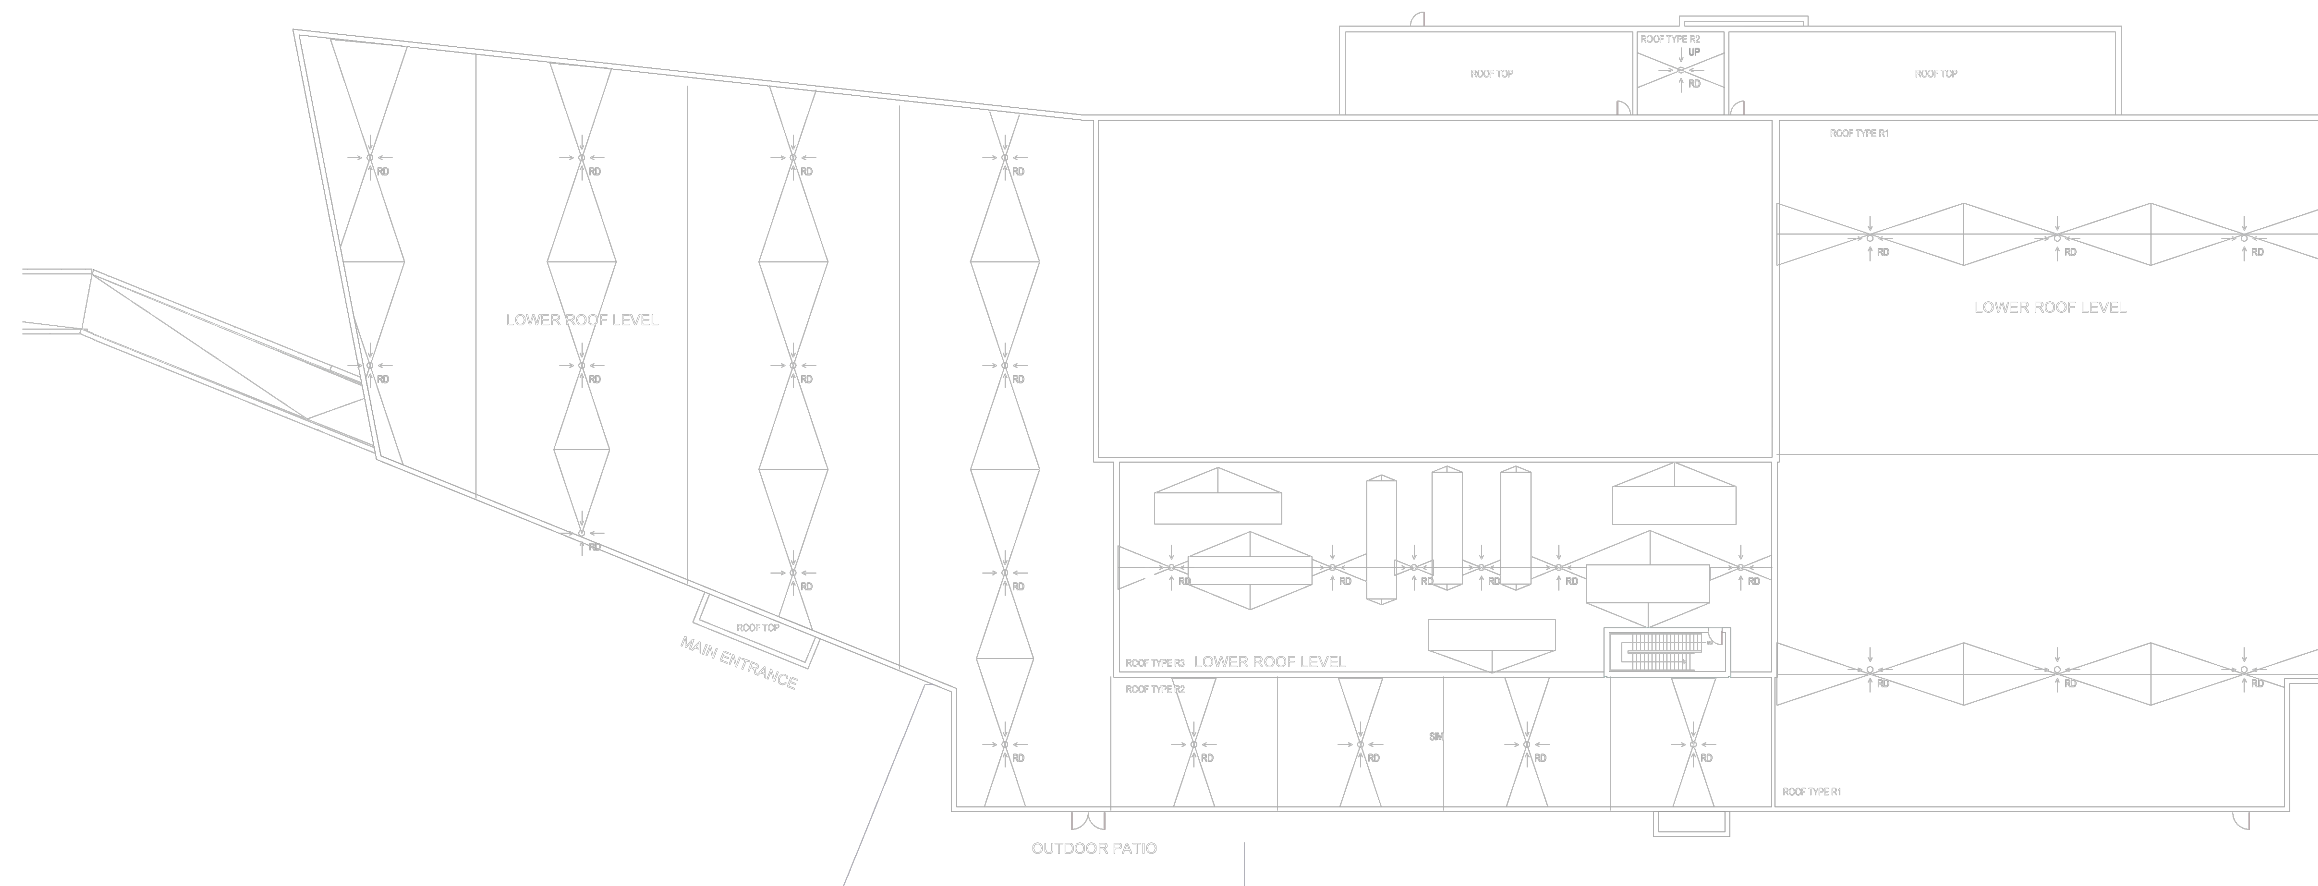
**BUILDING X - 3rd. FLOOR ROOF PLAN**  
 NOT TO SCALE

**NOTES:**  
 - GIVEN THE AGE OF CONSTRUCTION THERE ARE NO CONCERNS WITH REGARDS TO ASBESTOS - CONTAINING MATERIALS.  
 - GIVEN THE AGE OF CONSTRUCTION THERE ARE NO CONCERNS WITH REGARDS TO LEAD CONTAINING PAINTS.
