**DESIGNATED SUBSTANCES AND HAZARDOUS MATERIALS REPORT**  
**Building V, Algonquin College Ottawa Campus**  
**550 Wabisheshi Private, Ottawa, Ontario**

**February, 2026**

**CM3 Project: TC1738**

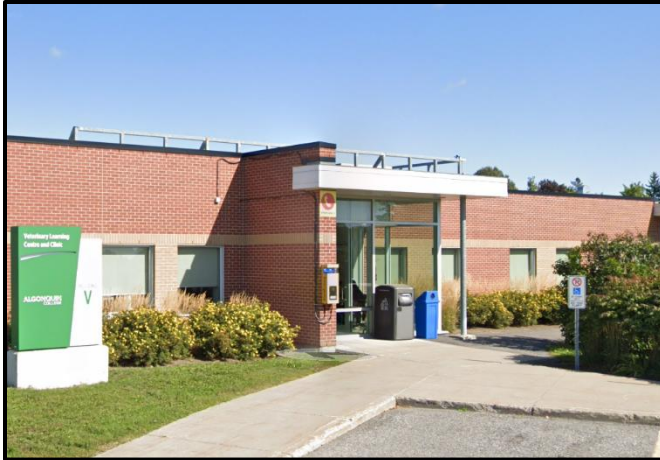
The exterior finishes of the building were observed to consist of brick masonry and a poured concrete foundation. The building features a flat roof system. There are no concerns with regards to asbestos-containing exterior finishes; therefore, no samples were collected as part of the assessment.

Photograph 1: Typical view of the exterior of the building.

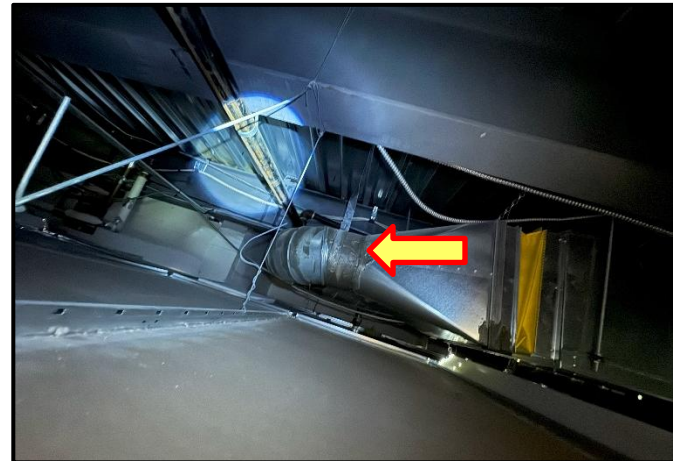
Mechanical pipes throughout the building were observed to be uninsulated or insulated with non-asbestos applications of fibreglass insulation and PVC. Ductwork was observed to be uninsulated or insulated with non-asbestos applications of fibreglass insulation. Applications of mastic were observed on ductwork throughout the building. There are no concerns with regards to asbestos-containing insulating materials; therefore, no samples were collected.

Photograph 4: View of non-asbestos mastic observed on ductwork throughout the building.

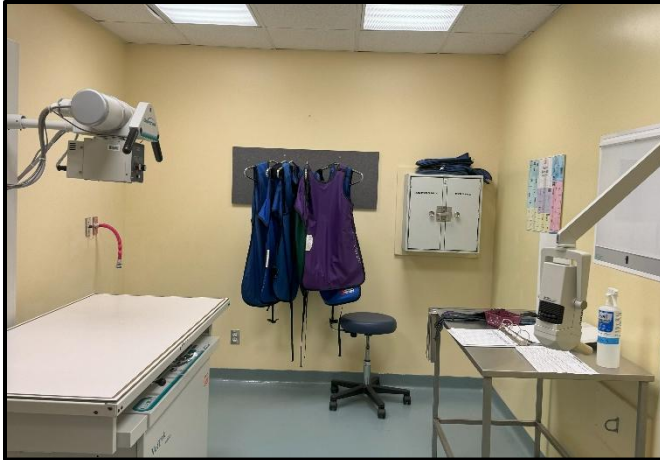
Photograph 5:View of the X-ray facility located in Room V115b.

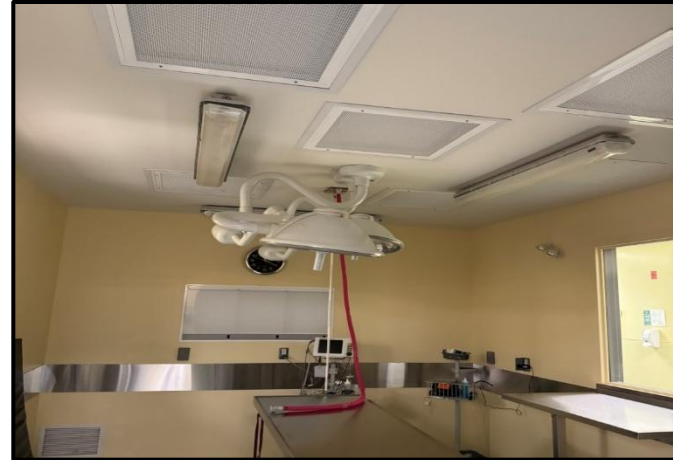
Photograph 6:View of the surgery facility located in Room V115e.
