DESIGNATED SUBSTANCES AND HAZARDOUS MATERIALS REPORT
Algonquin College Pembroke Campus
1 College Way, Pembroke, Ontario

February 4, 2026

CM3 Project: TC1738

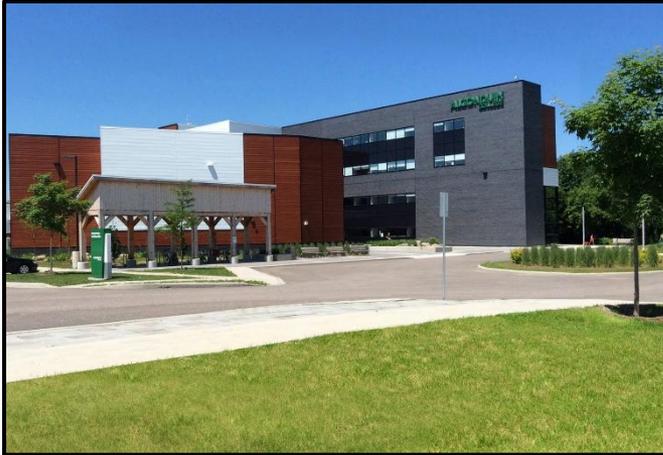
The exterior of the facility was observed to consist of brick masonry, corrugated sheet metal, vinyl siding and a concrete foundation. No suspect asbestos-containing exterior finishes were observed; therefore, no samples were collected.

Photograph 1: Typical view of the exterior of the building.

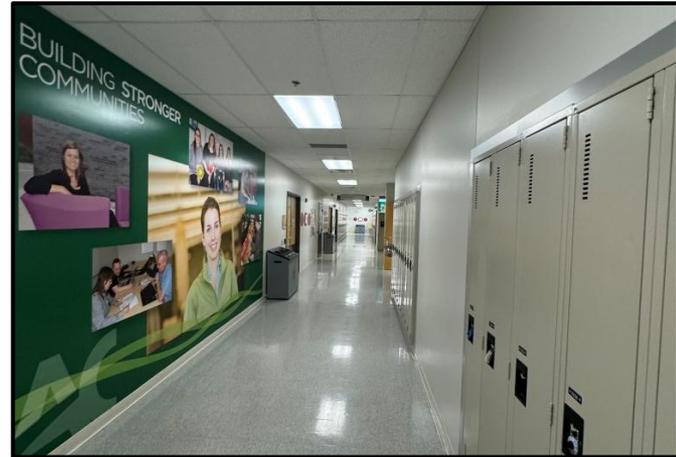
Photograph 2: Typical view of corridors observed throughout the building.

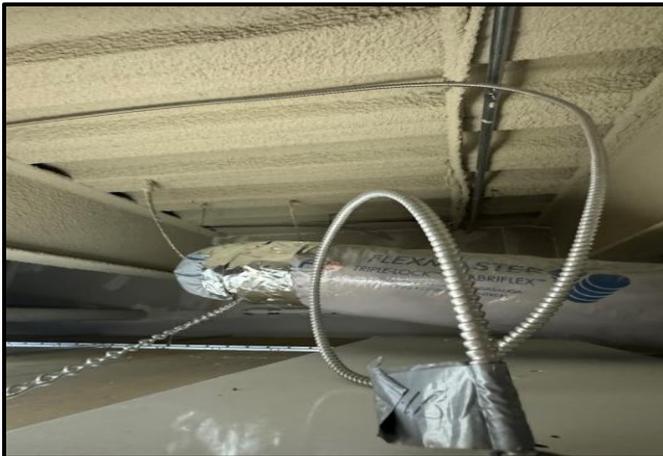
Photograph 3: View of non-asbestos containing sprayed fireproofing observed in ceiling spaces throughout the building.

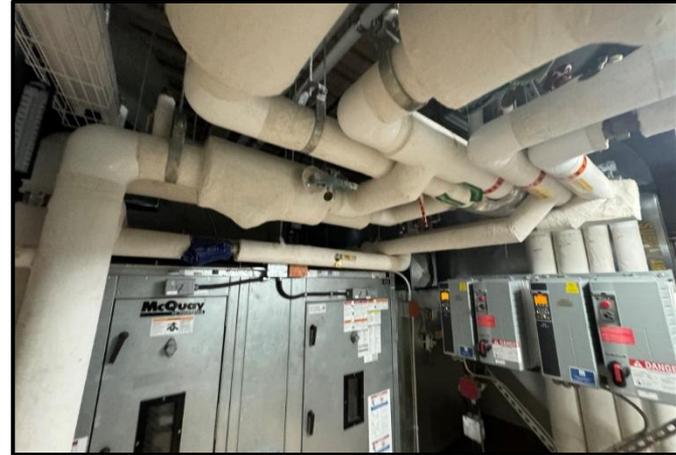
Photograph 6: View of non-asbestos containing applications of fiberglass insulation on mechanical pipes with PVC elbow fittings located in Room 212.
