DESIGNATED SUBSTANCES AND HAZARDOUS MATERIALS REPORT
Building T, Algonquin College Ottawa Campus
505 Wabisheshi Private, Ottawa, Ontario

December, 2025

CM3 Project: TC1738

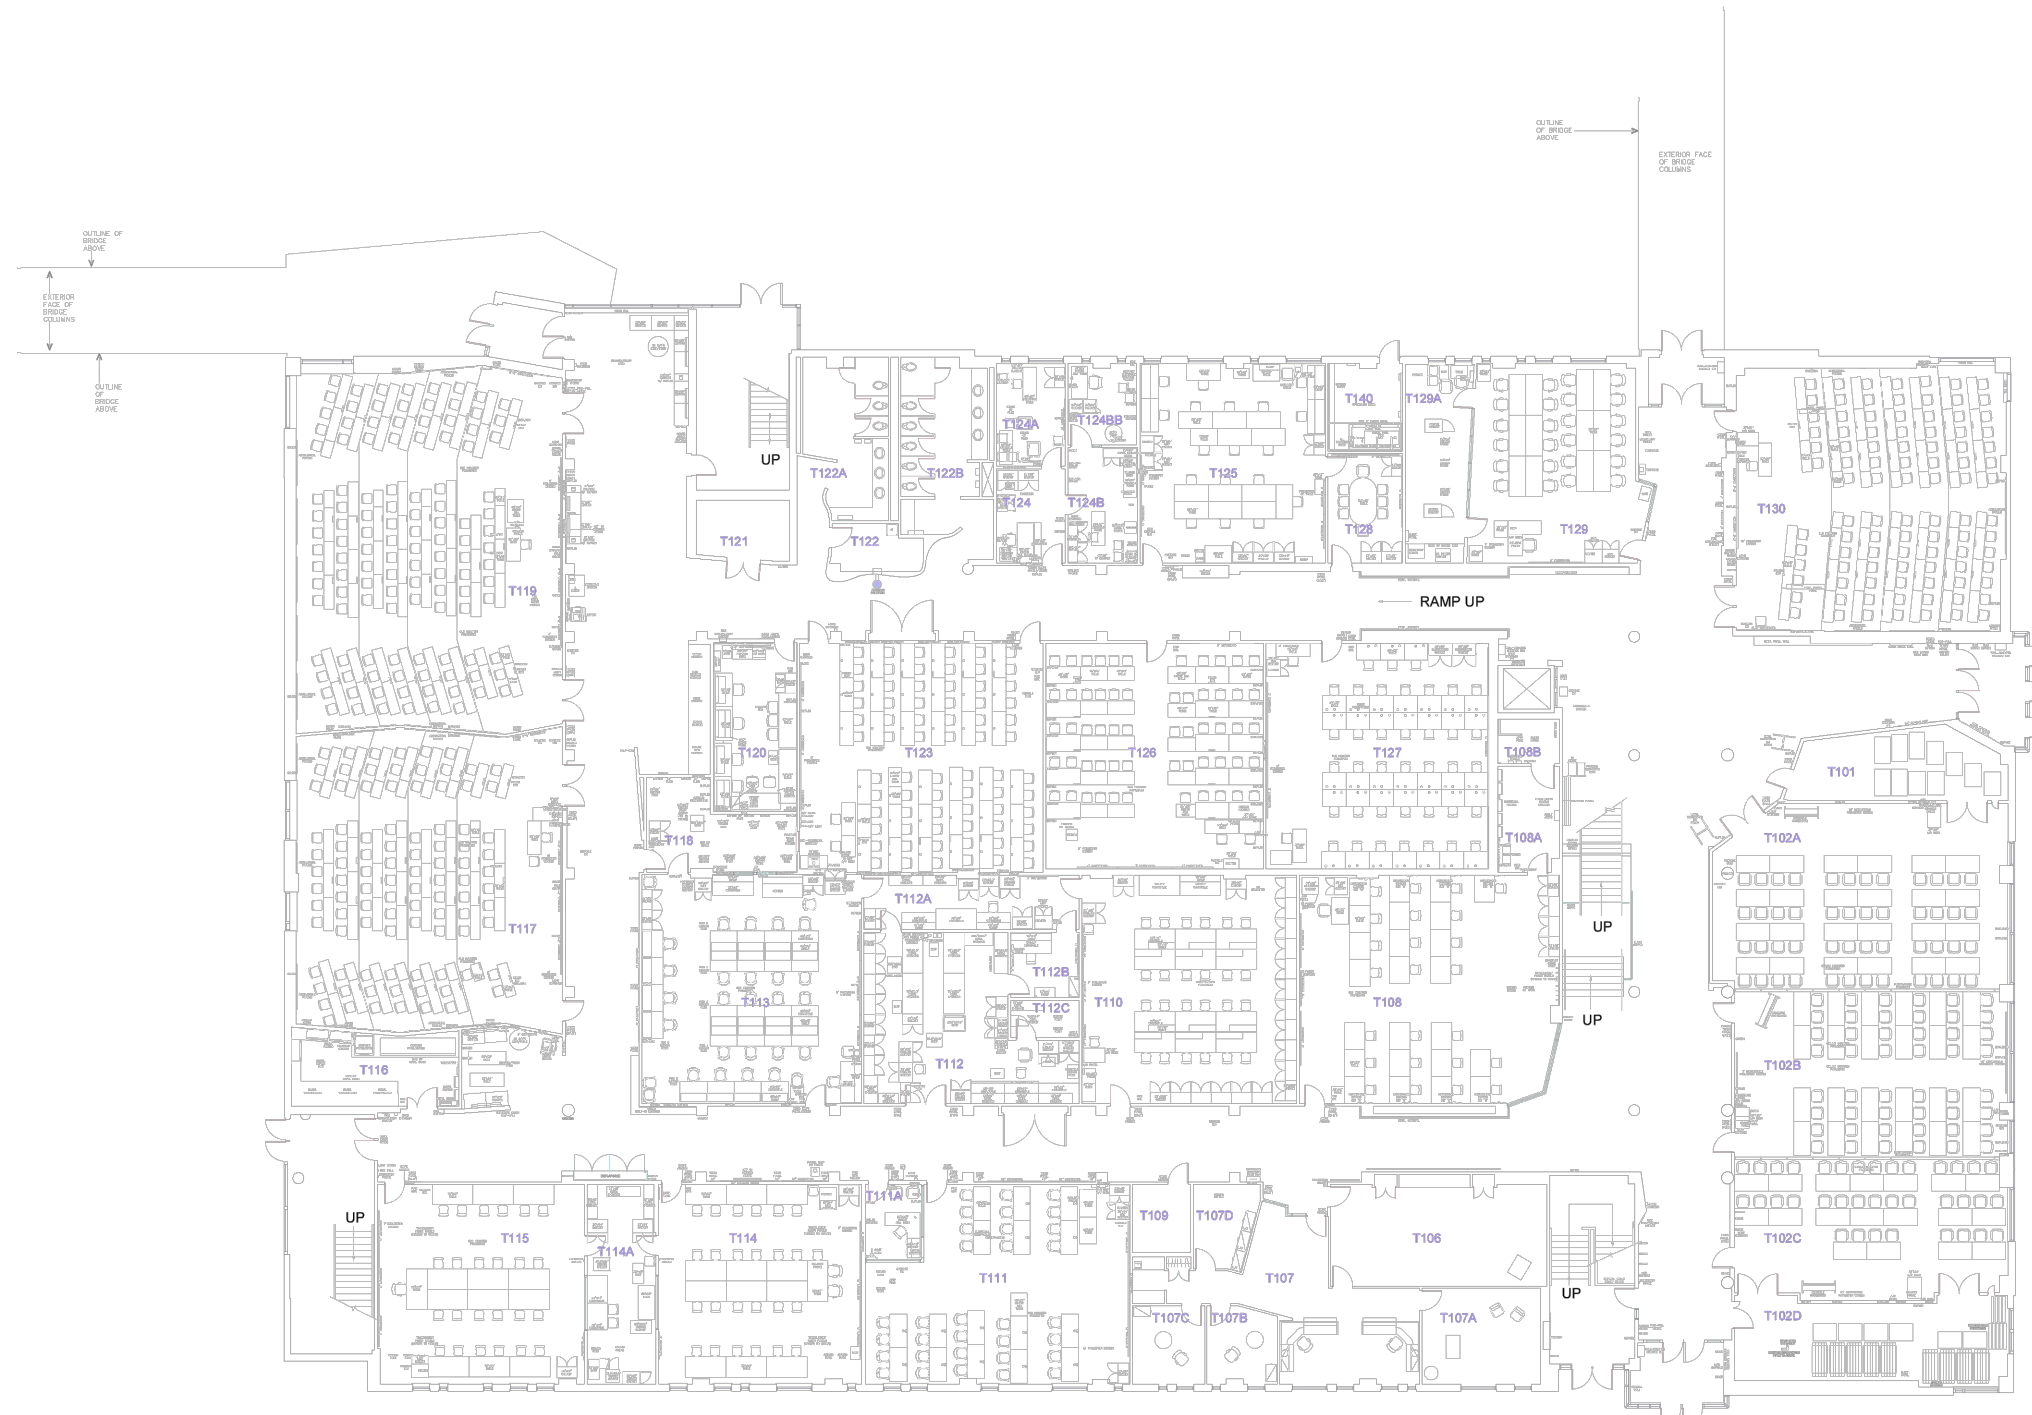
BUILDING T - 1st. FLOOR PLAN
NOT TO SCALE

NOTES:
- GIVEN THE AGE OF CONSTRUCTION THERE ARE NO CONCERNS WITH REGARDS TO ASBESTOS - CONTAINING MATERIALS.
- GIVEN THE AGE OF CONSTRUCTION THERE ARE NO CONCERNS WITH REGARDS TO LEAD CONTAINING PAINTS.

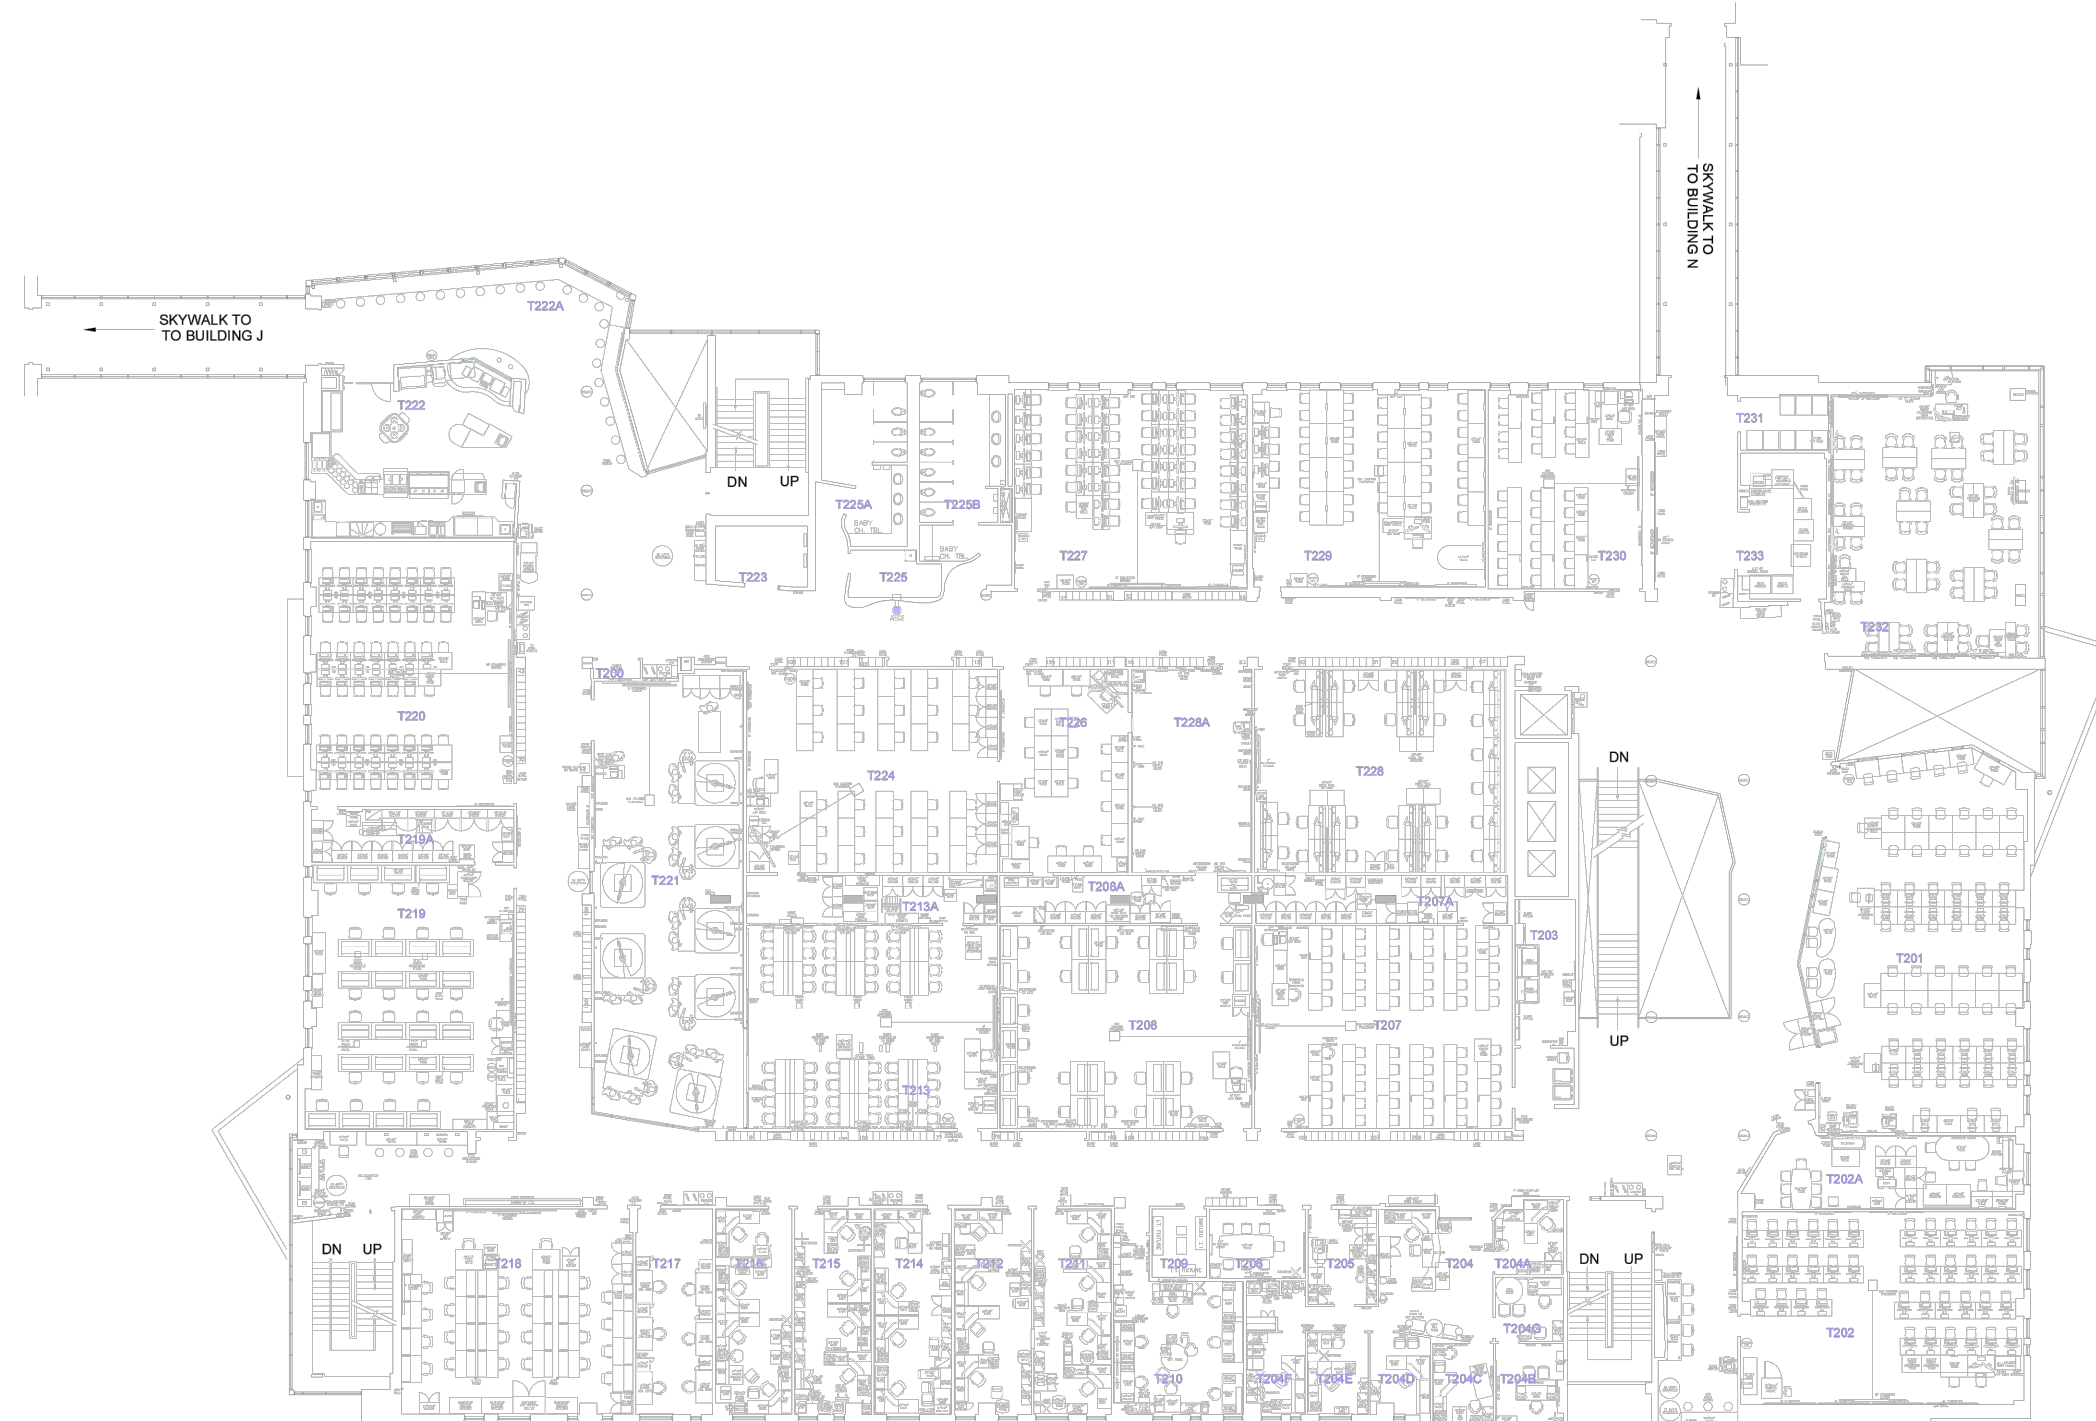
NOTES:
- GIVEN THE AGE OF CONSTRUCTION THERE ARE NO CONCERNS WITH REGARDS TO ASBESTOS - CONTAINING MATERIALS.
- GIVEN THE AGE OF CONSTRUCTION THERE ARE NO CONCERNS WITH REGARDS TO LEAD CONTAINING PAINTS.

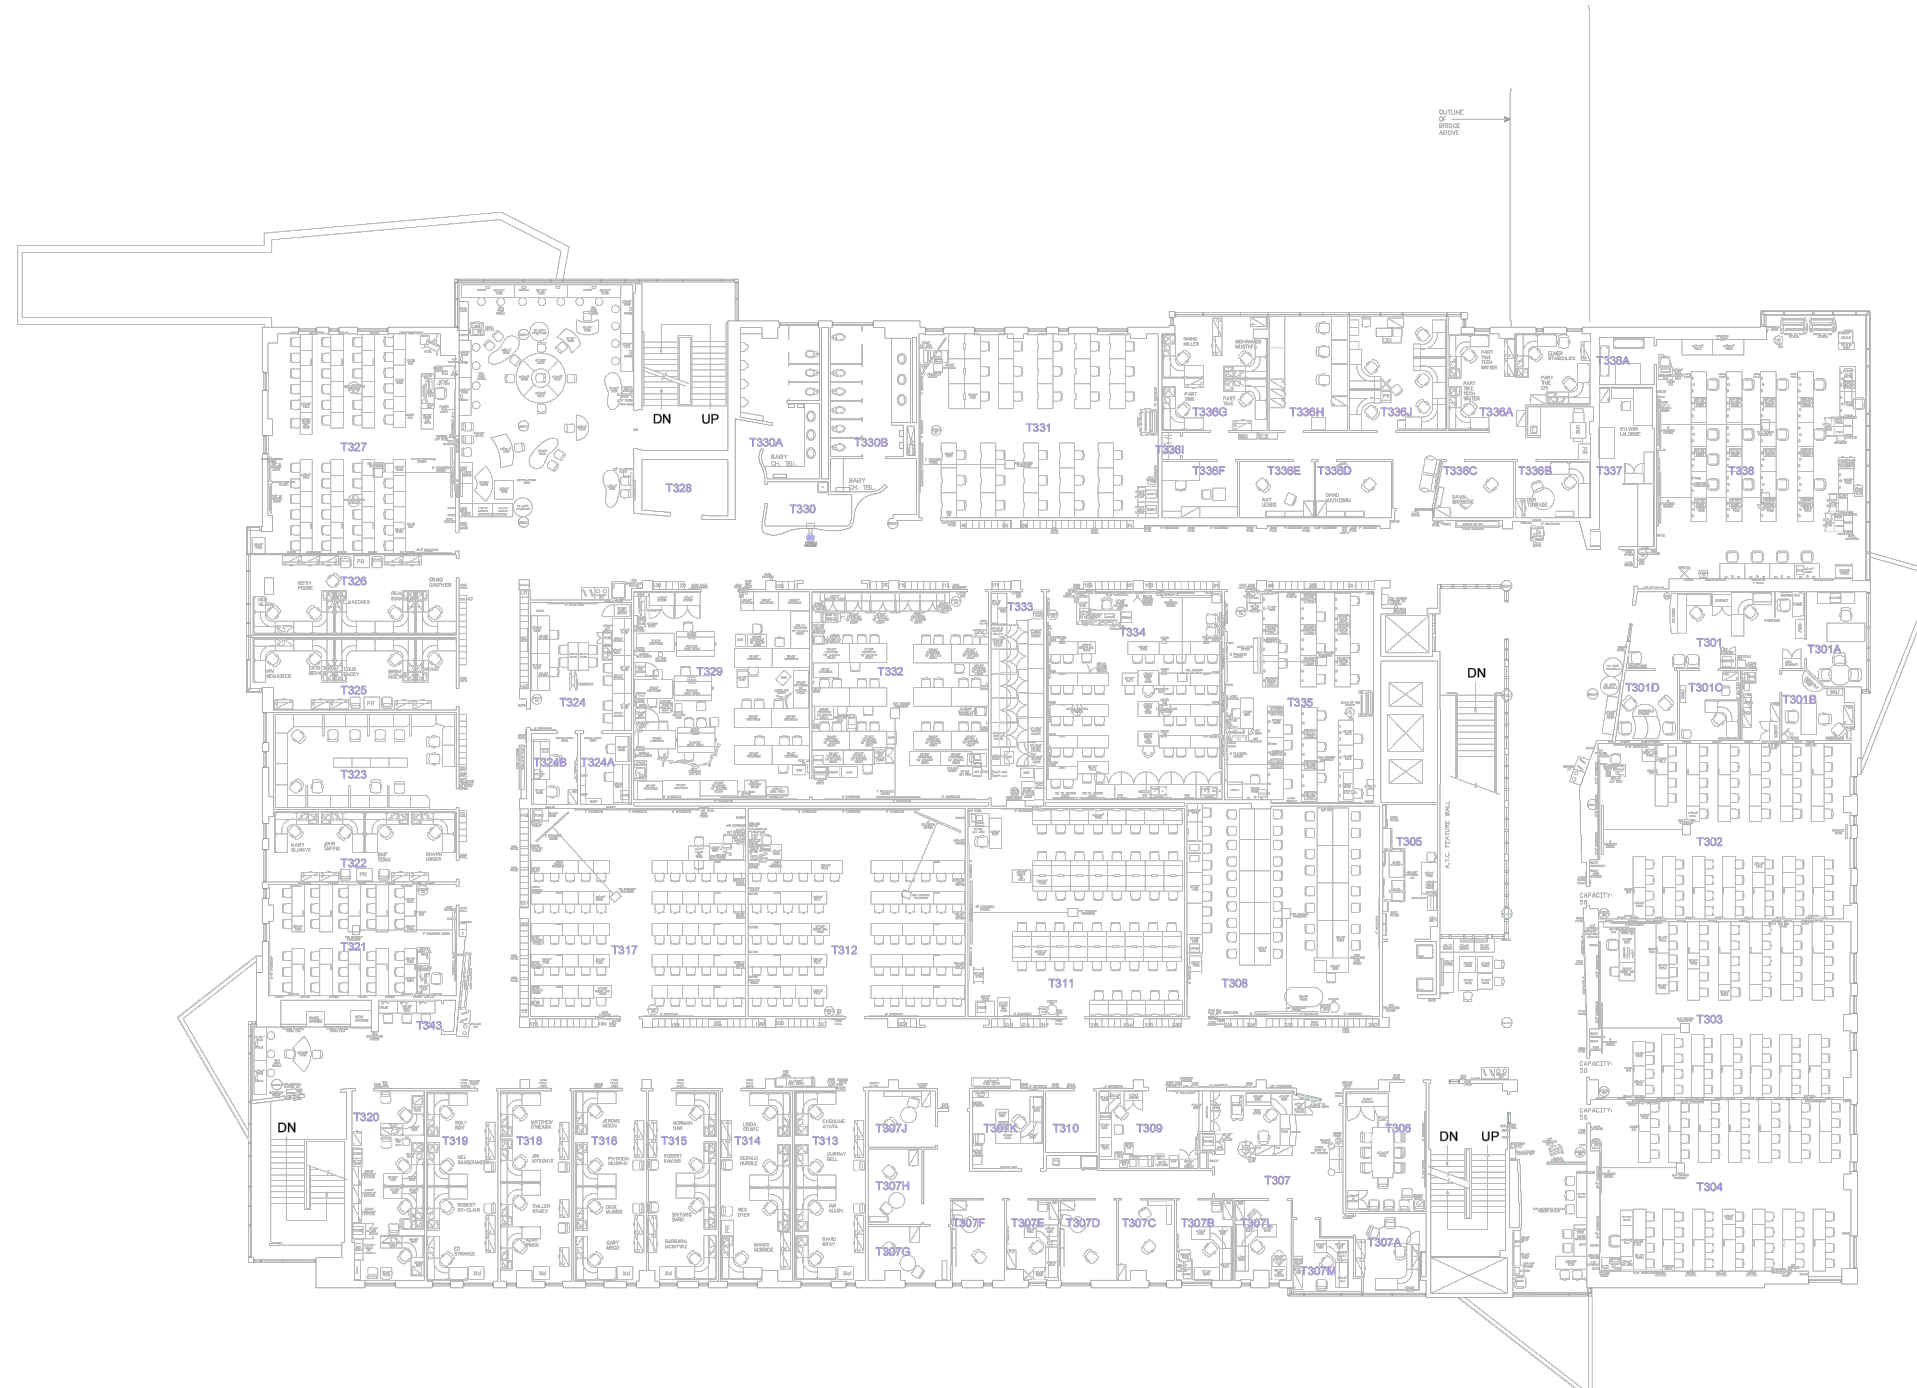
BUILDING T- 3rd. FLOOR PLAN

NOTES:
- GIVEN THE AGE OF CONSTRUCTION THERE ARE NO CONCERNS WITH REGARDS TO ASBESTOS - CONTAINING MATERIALS.
- GIVEN THE AGE OF CONSTRUCTION THERE ARE NO CONCERNS WITH REGARDS TO LEAD CONTAINING PAINTS.

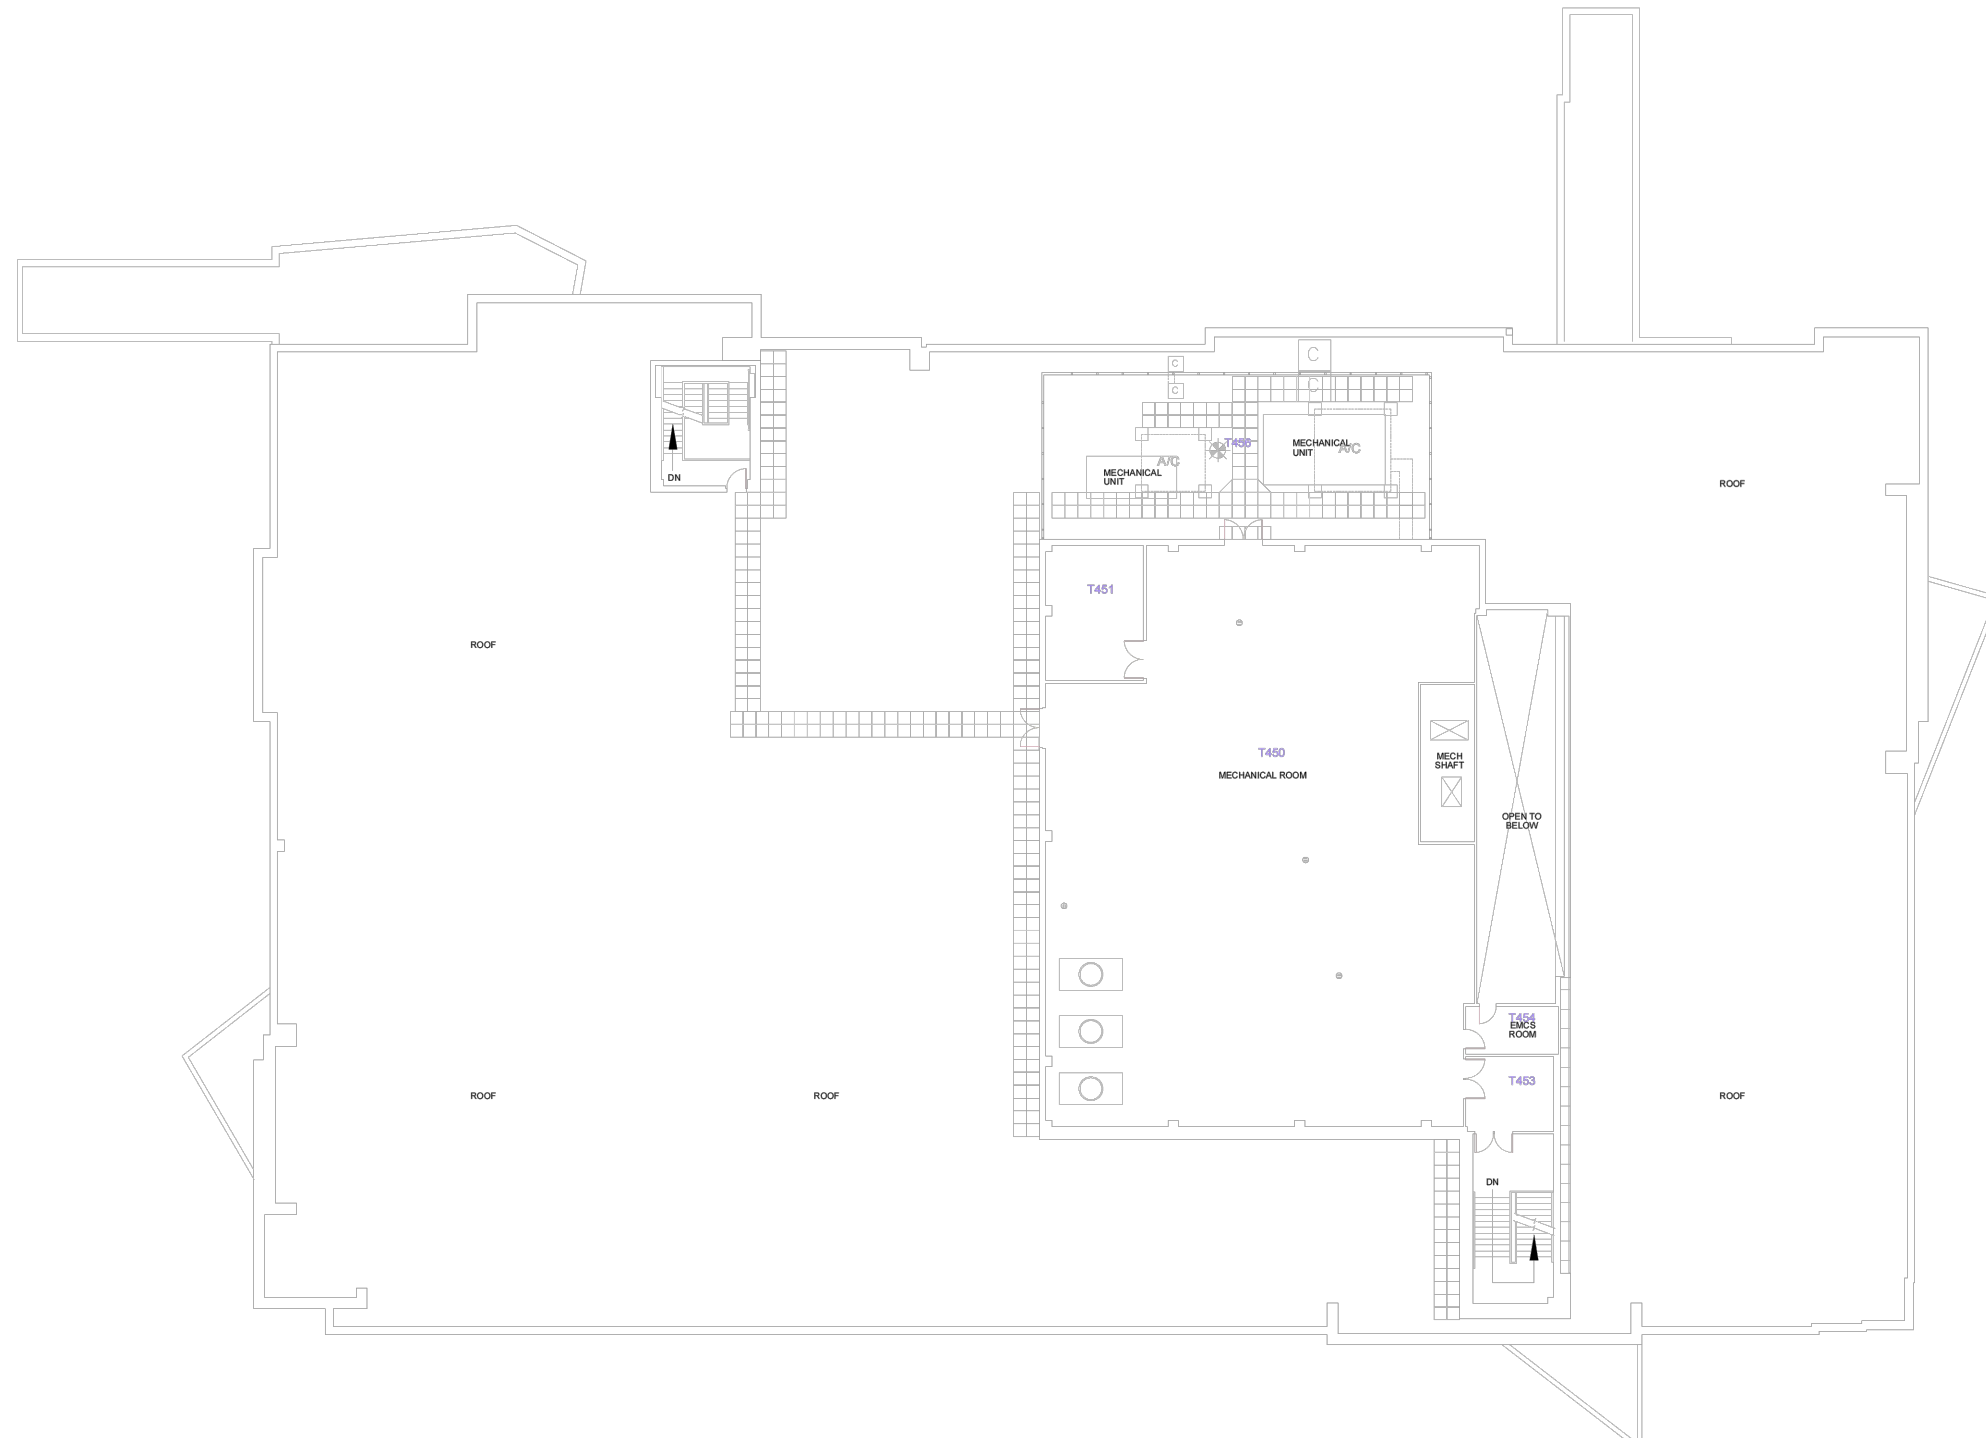
BUILDING T - 4th. FLOOR PLAN
NOT TO SCALE

NOTES:
- GIVEN THE AGE OF CONSTRUCTION THERE ARE NO CONCERNS WITH REGARDS TO ASBESTOS - CONTAINING MATERIALS.
- GIVEN THE AGE OF CONSTRUCTION THERE ARE NO CONCERNS WITH REGARDS TO LEAD CONTAINING PAINTS.
