DESIGNATED SUBSTANCE REPORT

Building K, Algonquin College Ottawa Campus 201 Adjidjàk Private, Ottawa, Ontario

March 2026

CM3 Project: TC1738

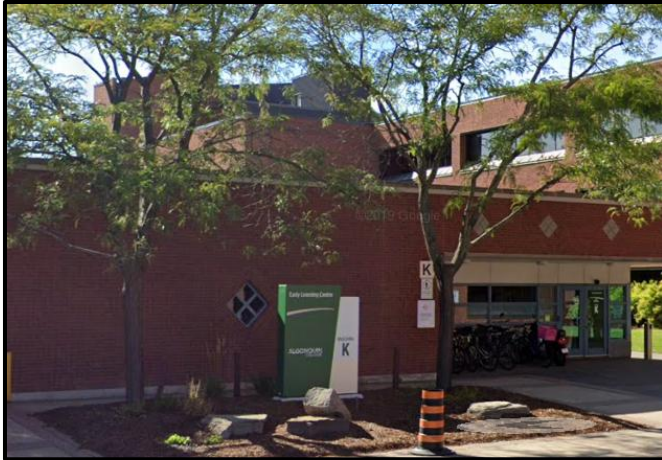
Photograph 1: Typical view of the exterior of the building.

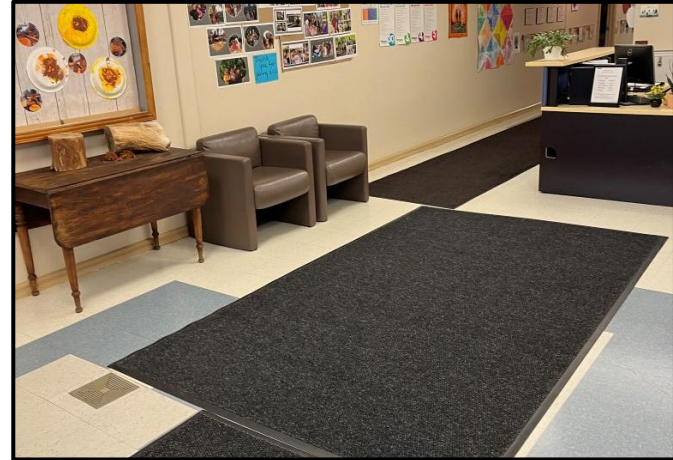
Photograph 2: View of main entrance reception area.

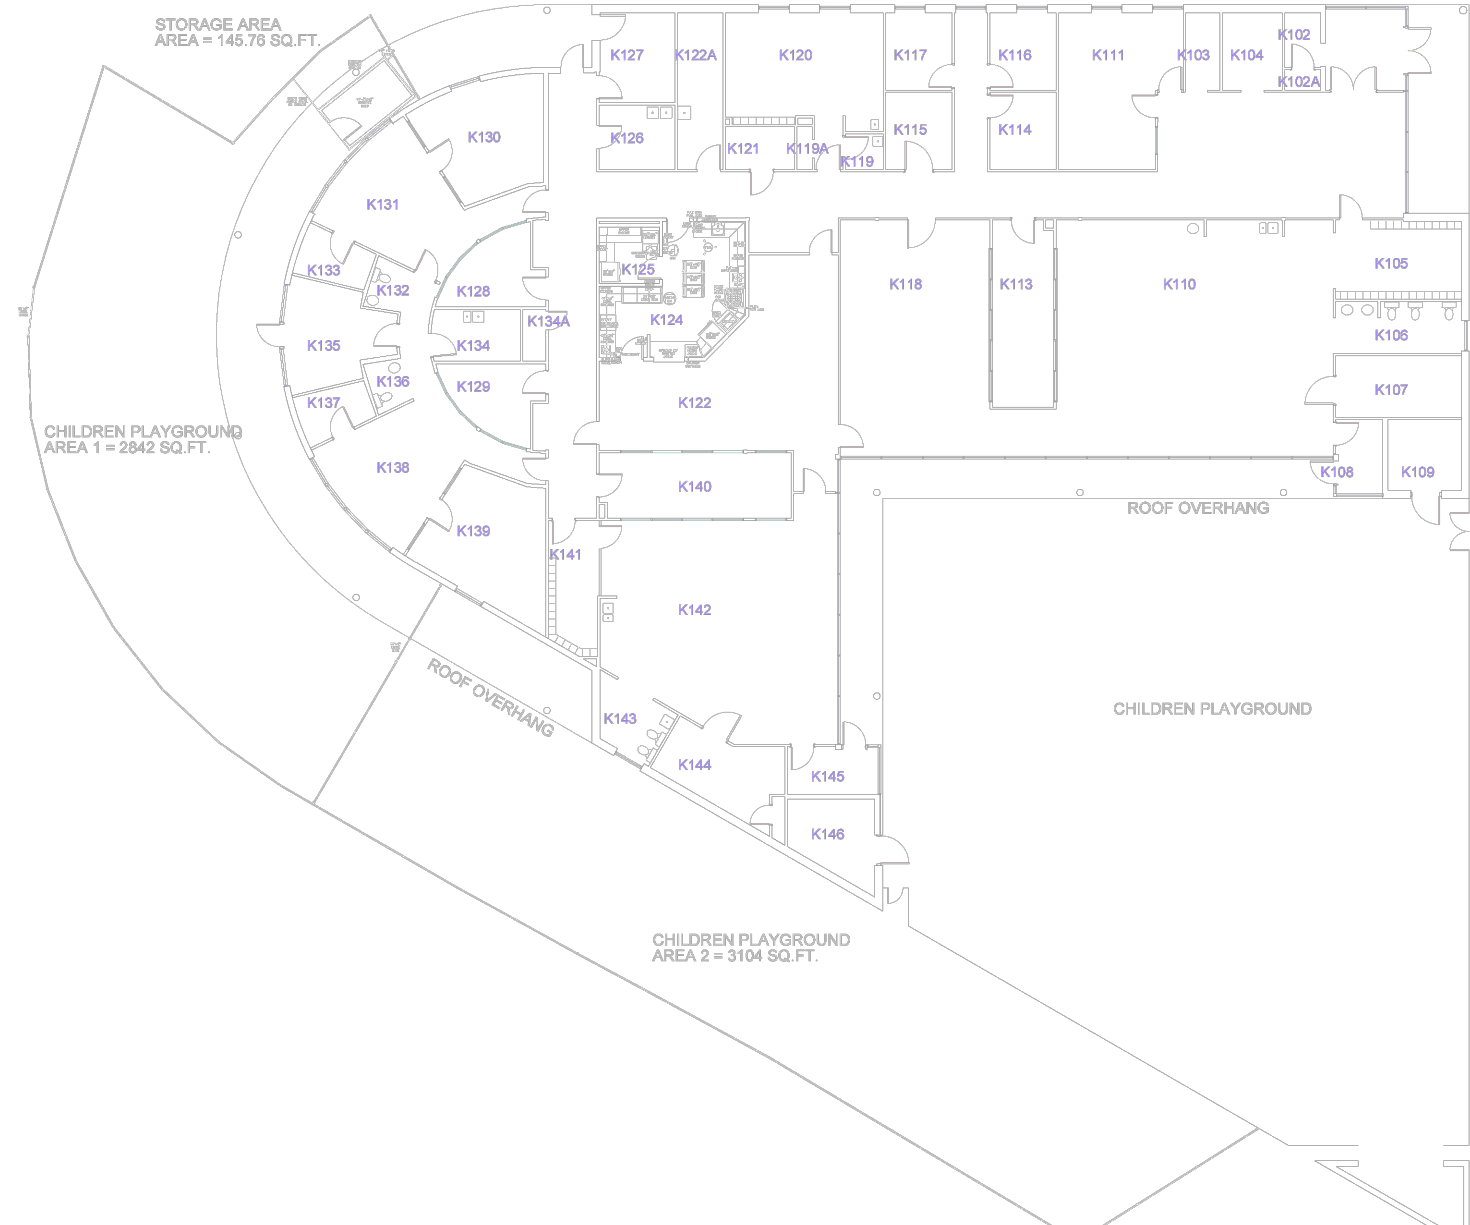
BUILDING K - 1st. FLOOR PLAN
NOT TO SCALE

NOTES:
- GIVEN THE AGE OF CONSTRUCTION THERE ARE NO CONCERNS WITH REGARDS TO ASBESTOS - CONTAINING MATERIALS.
- GIVEN THE AGE OF CONSTRUCTION THERE ARE NO CONCERNS WITH REGARDS TO LEAD-CONTAINING PAINTS.

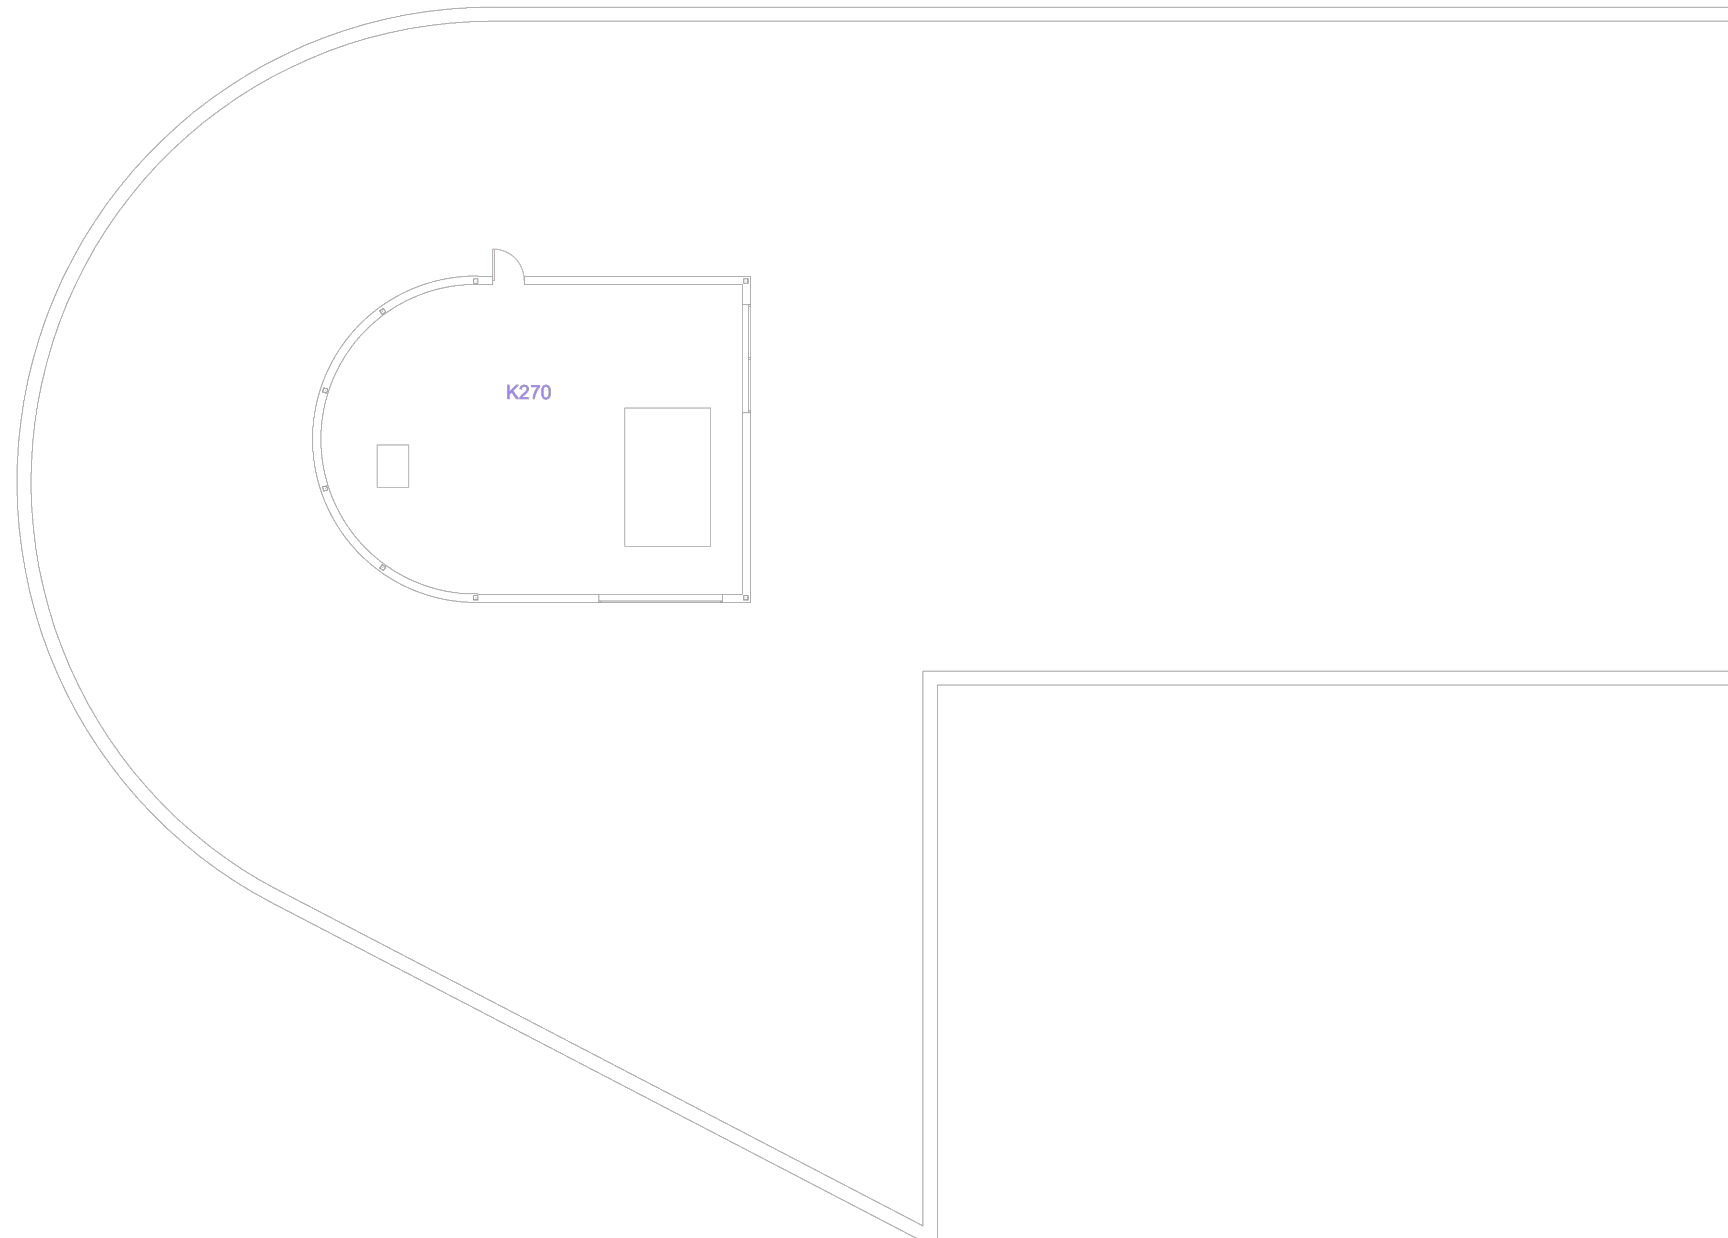
BUILDING K - 2nd. FLOOR PLAN
 NOT TO SCALE

NOTES:
 - GIVEN THE AGE OF CONSTRUCTION THERE ARE NO CONCERNS WITH REGARDS TO ASBESTOS - CONTAINING MATERIALS.
 - GIVEN THE AGE OF CONSTRUCTION THERE ARE NO CONCERNS WITH REGARDS TO LEAD-CONTAINING PAINTS.
