DESIGNATED SUBSTANCE REPORT
Building M, Algonquin College Ottawa Campus
200 Adjidjàk Private, Ottawa, Ontario

DESIGNATED SUBSTANCE REPORT
Building M, Algonquin College Ottawa Campus
200 Adjidjàk Private
Ottawa, Ontario

CM3 Project: TC1738

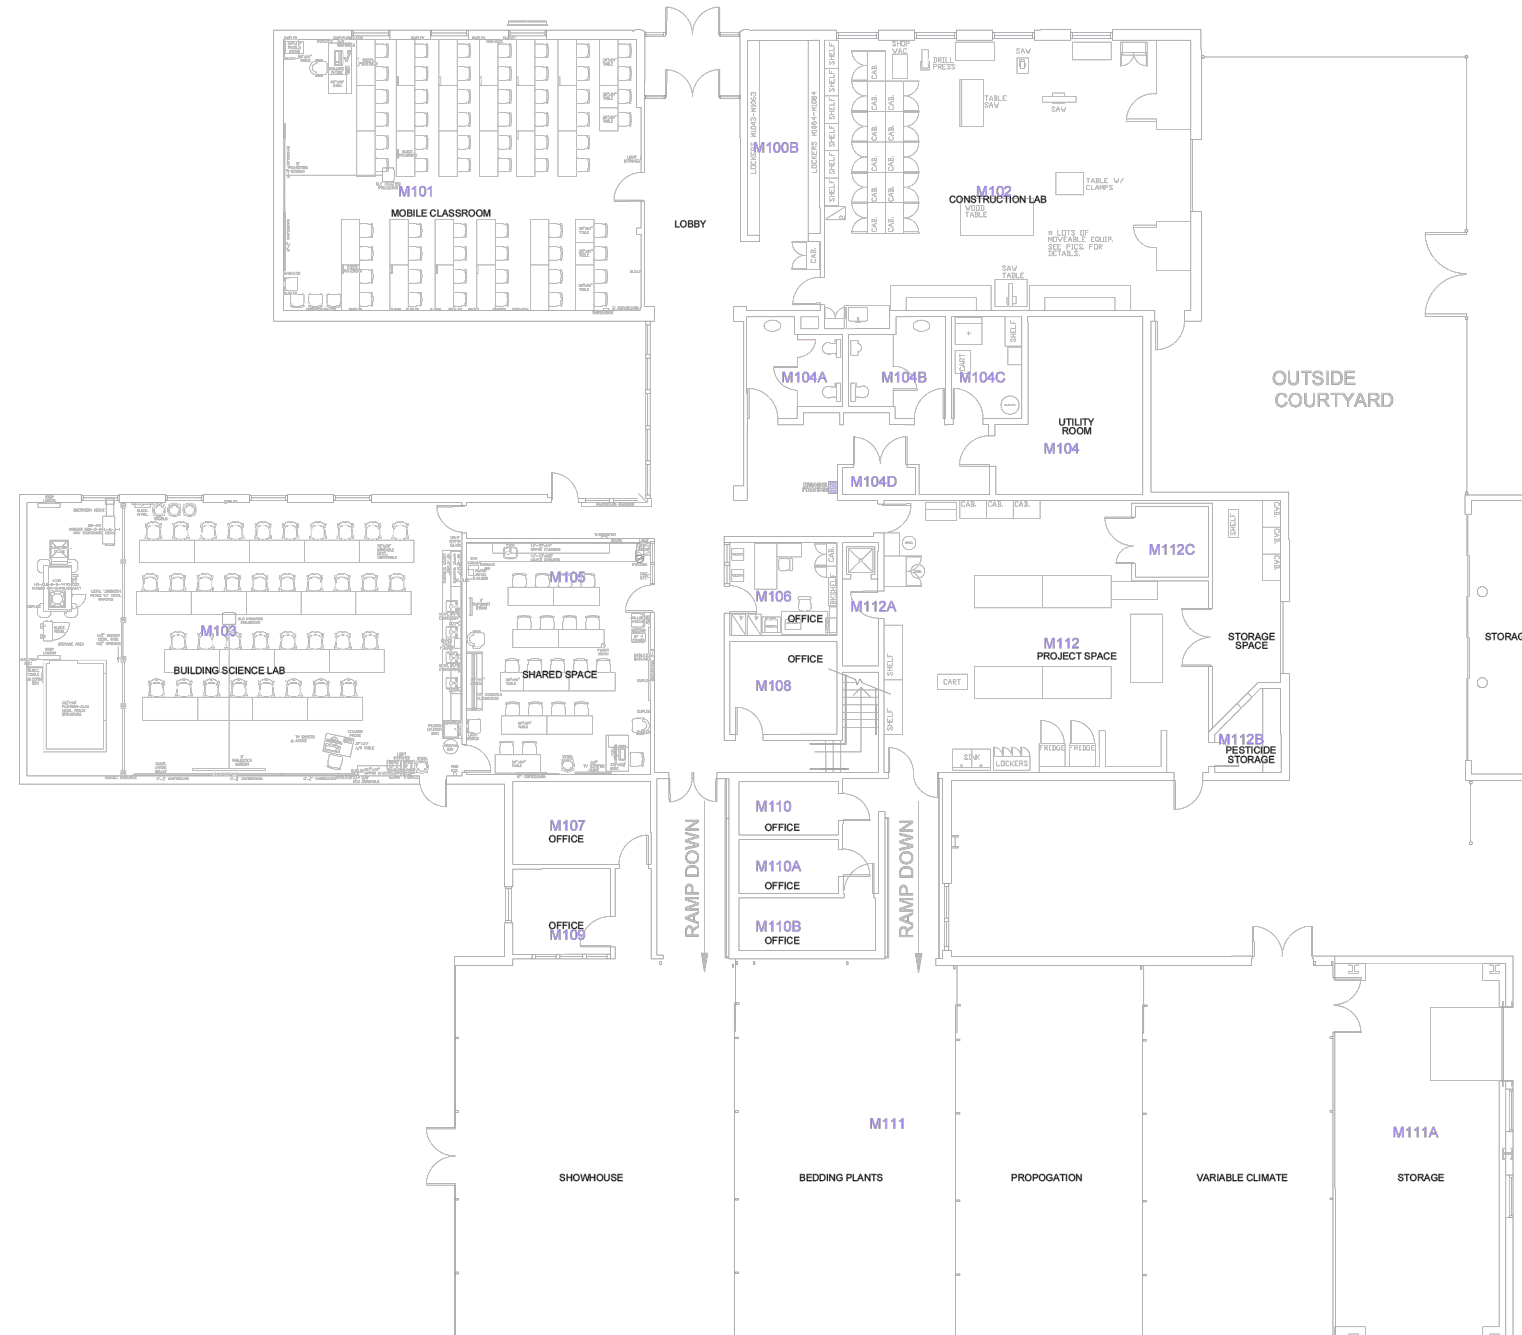
BUILDING M - 1st. FLOOR PLAN
 NOT TO SCALE

NOTES:
 - GIVEN THE AGE OF CONSTRUCTION THERE ARE NO CONCERNS WITH REGARDS TO ASBESTOS - CONTAINING MATERIALS.
 - GIVEN THE AGE OF CONSTRUCTION THERE ARE NO CONCERNS WITH REGARDS TO LEAD-CONTAINING PAINTS.

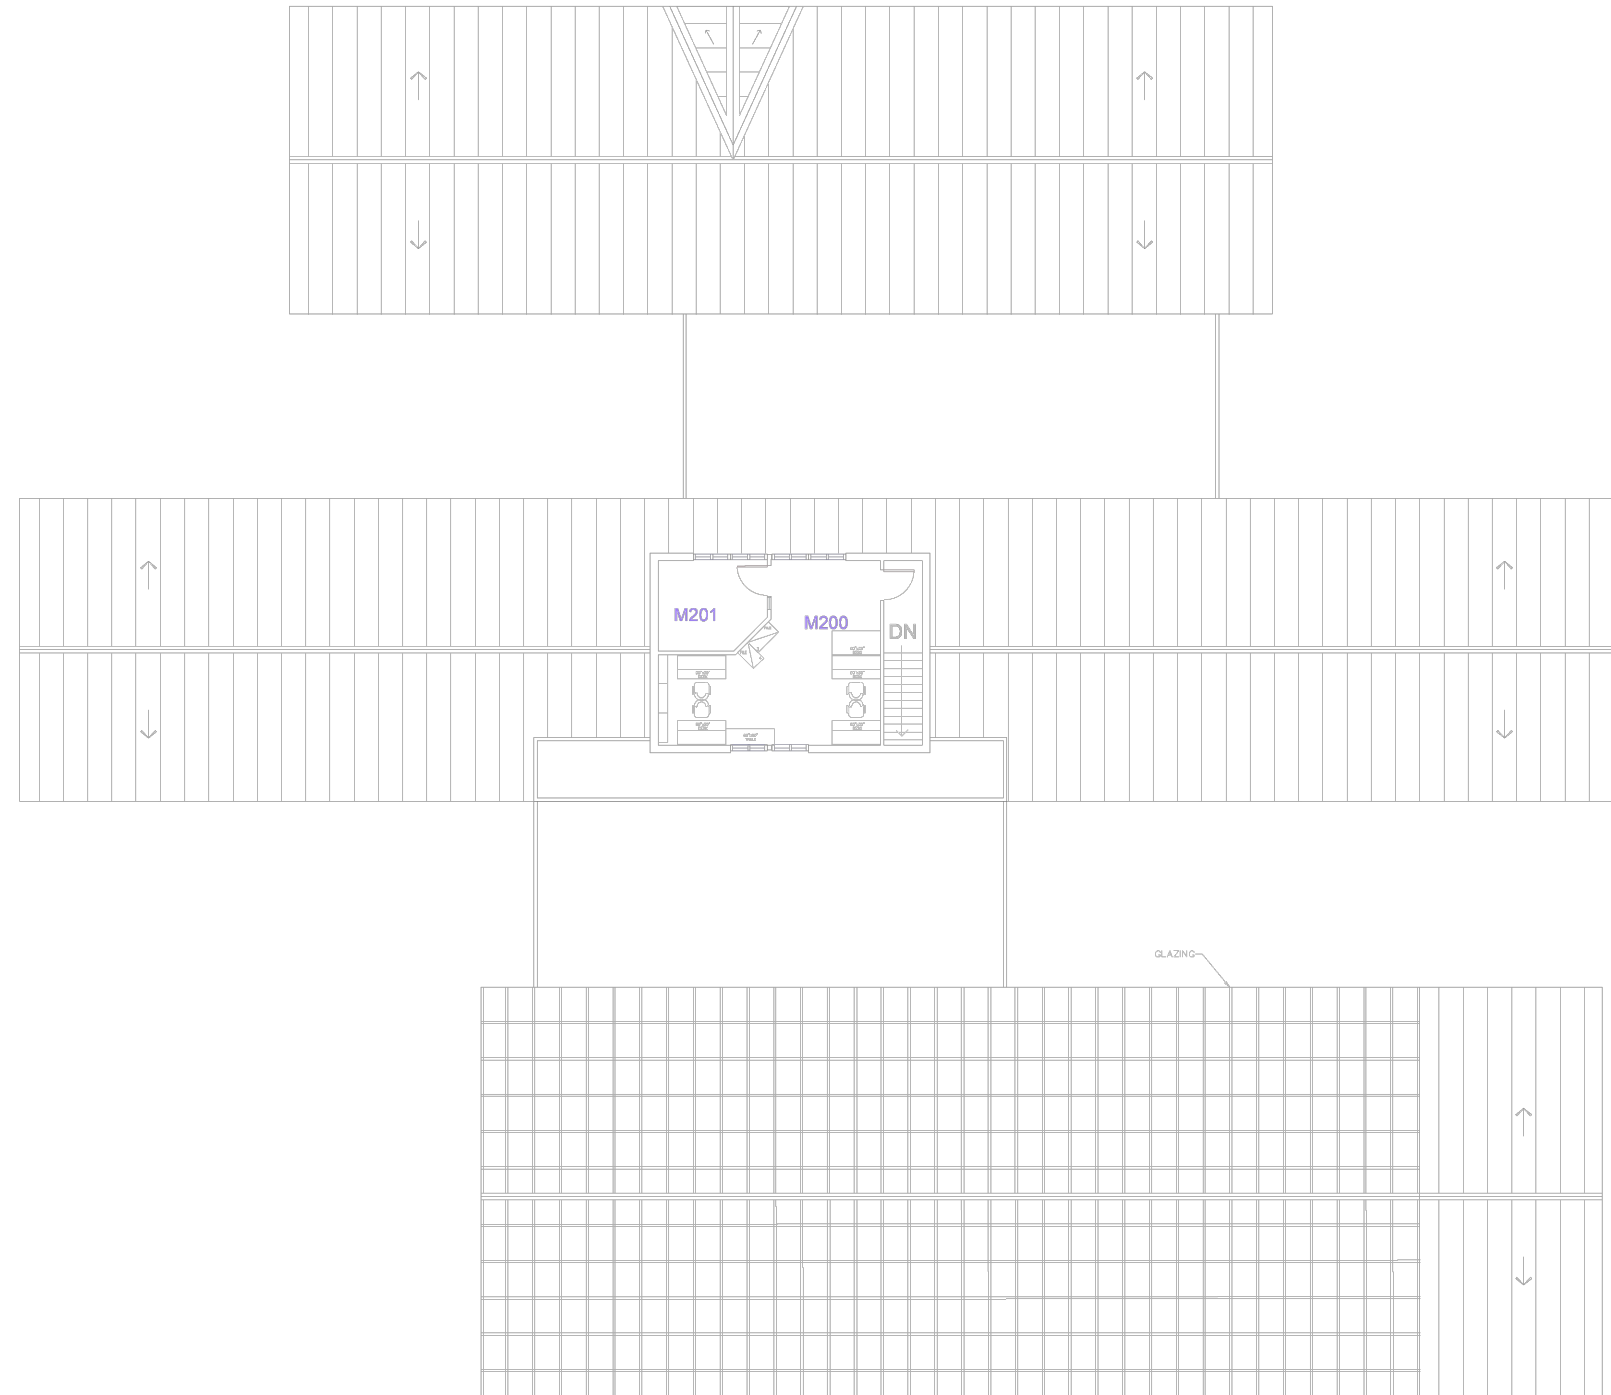
BUILDING M - 2nd. FLOOR PLAN
 NOT TO SCALE

NOTES:
 - GIVEN THE AGE OF CONSTRUCTION THERE ARE NO CONCERNS WITH REGARDS TO ASBESTOS - CONTAINING MATERIALS.
 - GIVEN THE AGE OF CONSTRUCTION THERE ARE NO CONCERNS WITH REGARDS TO LEAD-CONTAINING PAINTS.
