DESIGNATED SUBSTANCES AND HAZARDOUS MATERIALS REPORT
Building P, Algonquin College Ottawa Campus
520 Wabisheshi Private, Ottawa, Ontario

March 2026

CM3 Project: TC1738

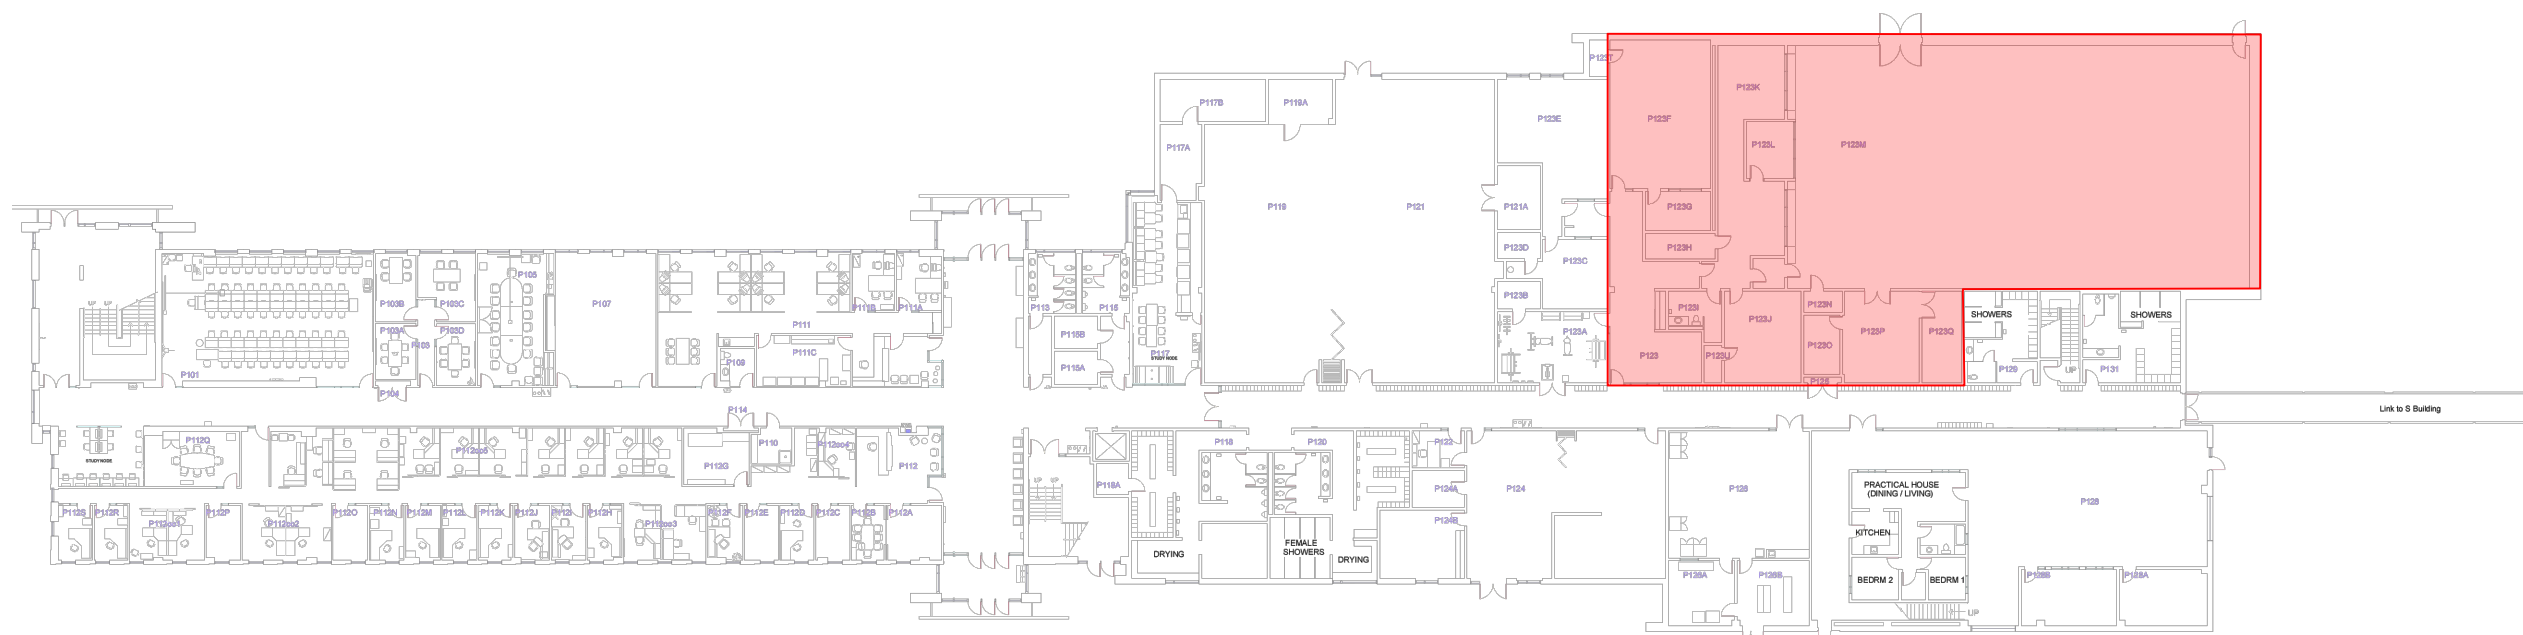
- GIVEN THE AGE OF CONSTRUCTION THERE ARE NO CONCERNS WITH REGARDS TO ASBESTOS - CONTAINING MATERIALS.
- GIVEN THE AGE OF CONSTRUCTION THERE ARE NO CONCERNS WITH REGARDS TO LEAD-CONTAINING PAINTS.

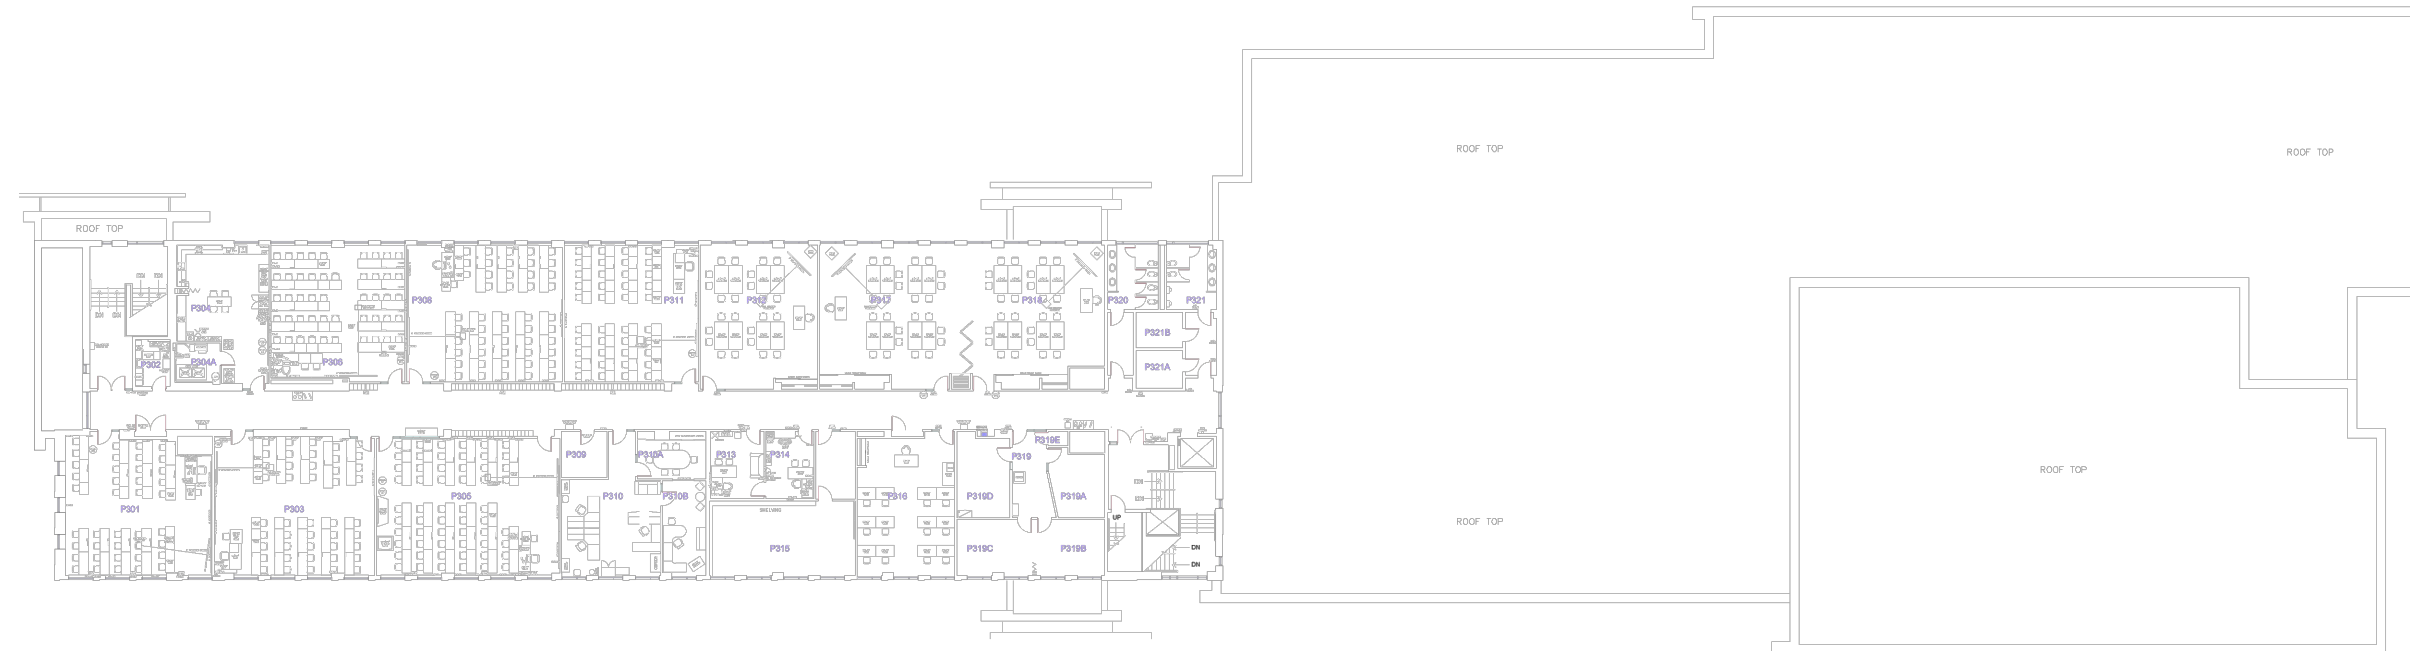
BUILDING P- 3rd. FLOOR PLAN
NOT TO SCALE

NOTES:
- GIVEN THE AGE OF CONSTRUCTION THERE ARE NO CONCERNS WITH REGARDS TO ASBESTOS - CONTAINING MATERIALS.
- GIVEN THE AGE OF CONSTRUCTION THERE ARE NO CONCERNS WITH REGARDS TO LEAD-CONTAINING PAINTS.

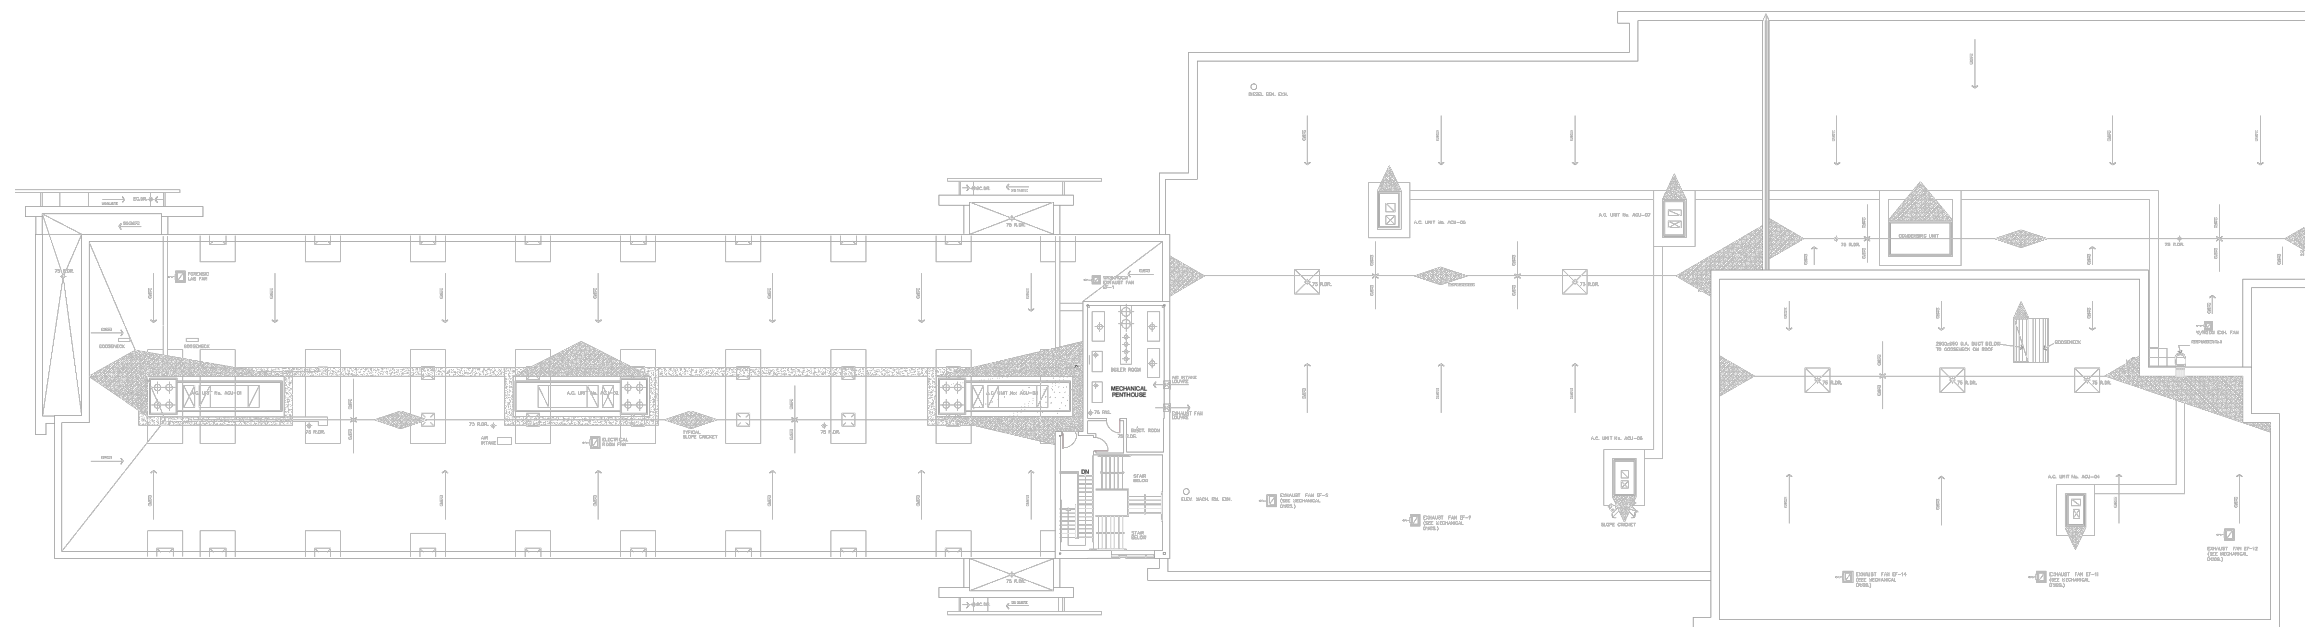
BUILDING P - 4th. FLOOR PLAN
 NOT TO SCALE

NOTES:
 - GIVEN THE AGE OF CONSTRUCTION THERE ARE NO CONCERNS WITH REGARDS TO ASBESTOS - CONTAINING MATERIALS.
 - GIVEN THE AGE OF CONSTRUCTION THERE ARE NO CONCERNS WITH REGARDS TO LEAD-CONTAINING PAINTS.
